Stream Restoration Hydraulics

Part 2: Applications

Chapter 5: Projects Restoring Pool and Riffle Channels

Design Example 1: Pool and Riffle 0.3% Gradient Stepped Channel for Walleye Spawning and Fry Returns to Downstream Lakes (Mink Creek MB 1985).

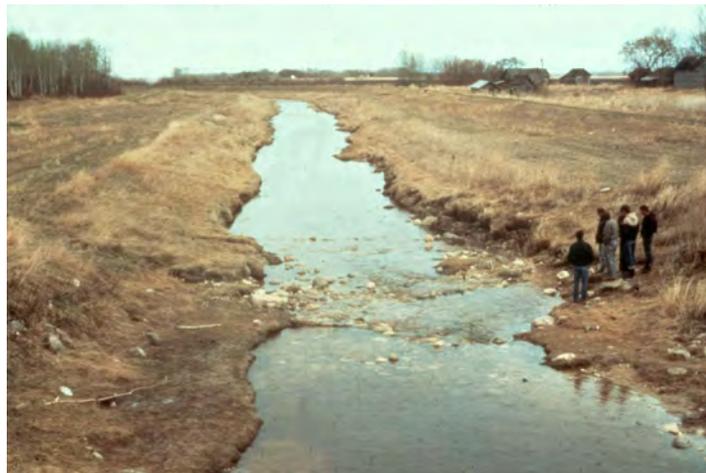
Figure 5.3: A channelized reach of Mink Creek in 1984 prior to pool and riffle restoration (see Figure 5.14).

For example, the meandering channel of Mink Creek, one of the western tributaries of Lake Dauphin, was straightened and channelized in 1951 (Figure 5.2, plans A and B). Natural walleye spawning riffles and connecting pools were destroyed by the uniform grading (Figure 5.3). The elimination of the pools and riffles stranded walleye fry in the channel in low flow years. They were unable to drift back to their rearing habitat in Lake Dauphin downstream leading to the closure of the commercial walleye fishery.

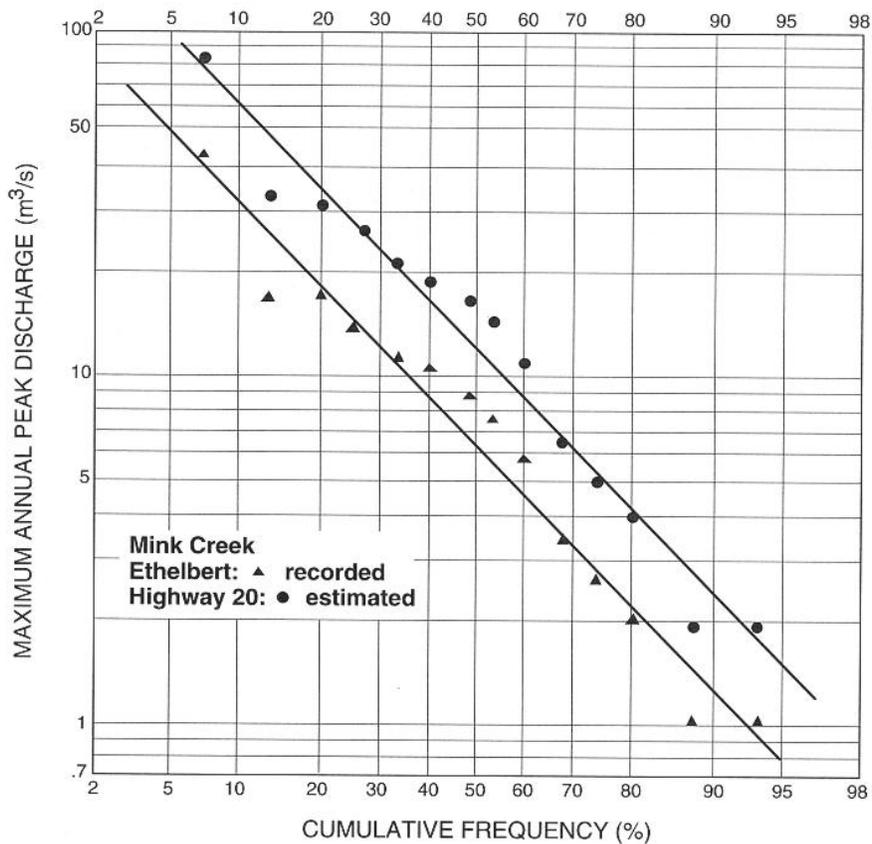
Figure 5.5: The annual flood frequency curve for Mink Creek near the Highway 20 restoration reach based on a nearby Water Survey of Canada station at Ethelbert MB (05LJ019).

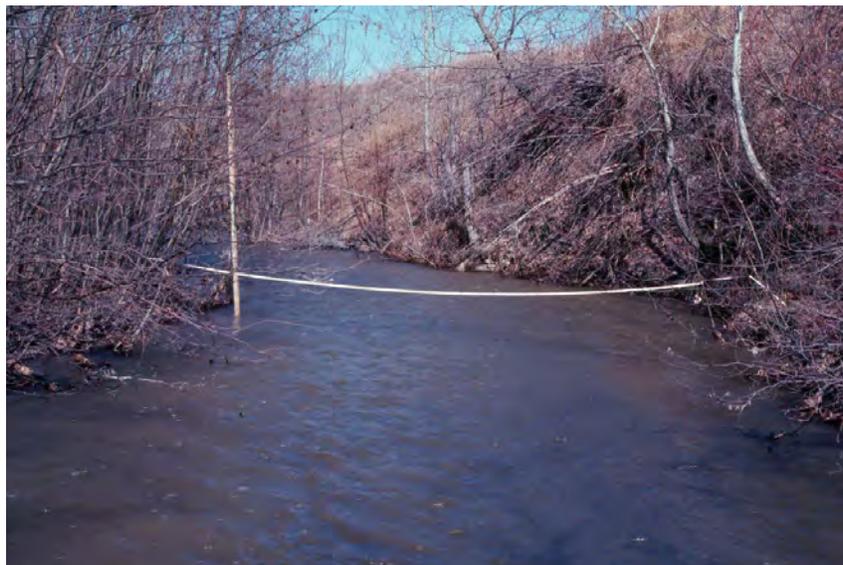
Figure 5.7: A Manning's "n" estimate of 0.045 for the pre-channelized Mink Creek reach was based on observations made in Wilson Creek MB in a similar sub-escarpment reach and on Hicks and Mason reference channel 40708 (1991).

A pre-channelization roughness value was determined by surveys in nearby natural streams (Figure 5.7). The pre-channelization bankfull velocity and discharge estimates are $V = 1.1^{2/3} (.0019^{1/2}) / .045 = 1.03 \text{ m/s}$ and $Q = 1.03 \times 1.1 \times 15.0 = 17.0 \text{ m}^3/\text{s}$.

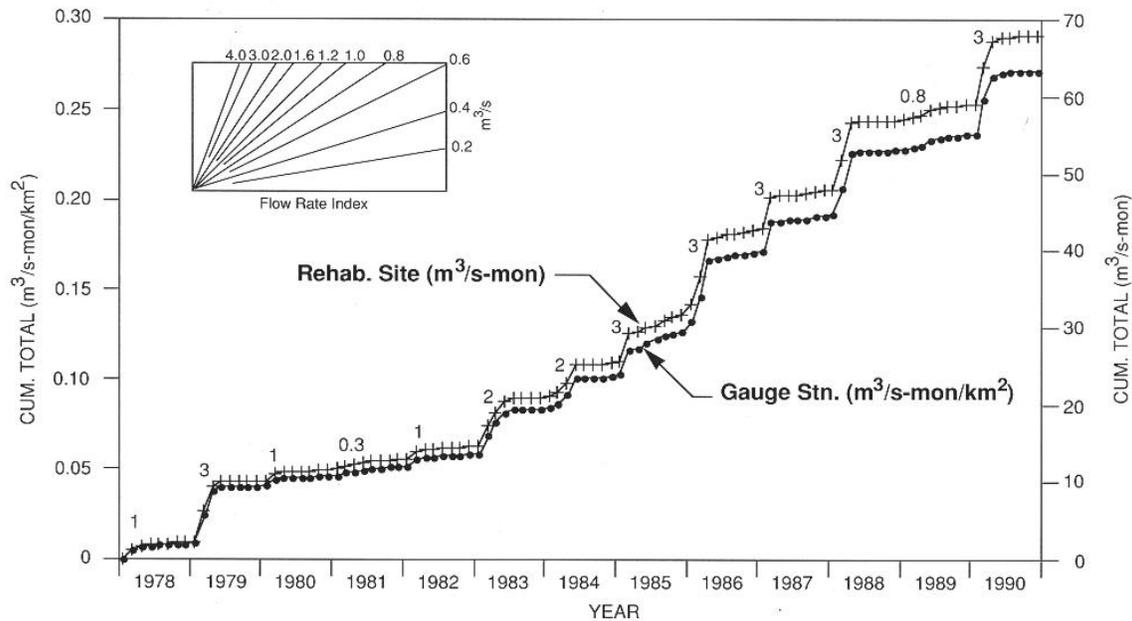
Figure 5.8: A mass curve of monthly flows for the Mink Creek restoration reach. Poor year-class catches in 1983-85 were attributed to low spawning and fry return flows. The dewatered channel prevented walleye fry from returning to the lake in 1980-82.

3. Design Goals and Constraints: To determine the minimum flows required for successful spawning, the discharges during the spring and early summer hatching periods were compared to the success of the same year-class commercial catch 3 years later in Lake Dauphin. It was found that poor year-class strengths corresponded to drought years in the stream when pools dried out before the fry had drifted back to the lake, for example in the 1980-1982 period (Figure 5.8).

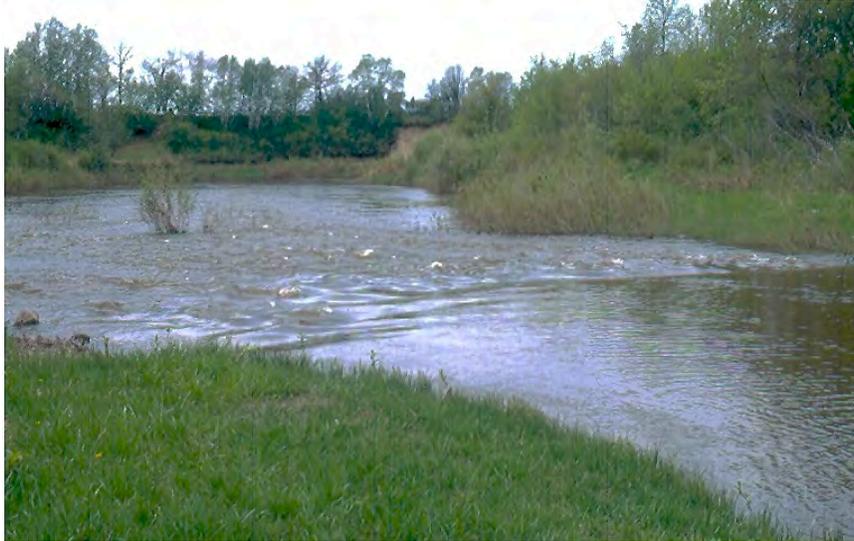
Figure 5.9: A natural spawning riffle on the Valley River MB during the high-flow Spring spawning period.

Natural Riffles: Walleye spawning riffles in similar but unaltered streams were surveyed to determine the dimensions of riffles that could be added to the channelized reaches. The profile of a typical walleye spawning riffle in the Valley River was found to rise 0.3 m above the bed in a steep 2:1 slope (Figure 5.9). The downstream face tapered back to the streambed at a shallow 20:1 slope (Figure 5.10). The pool depth at the downstream toe of the riffle varied from 0.2 to 0.3 m. Mid-summer surveys found the cross-section of the riffle to be slightly v-shaped, allowing a central channel to be maintained between pools under low flow conditions (Figure 5.11).

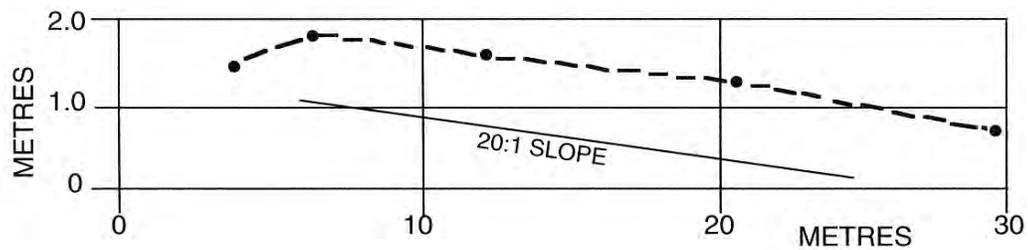
Figure 5.10: The bed profile surveyed on a typical Valley River MB spawning riffle (Figure 5.9). The surveyed riffles were found to be approximately as long as they were wide.

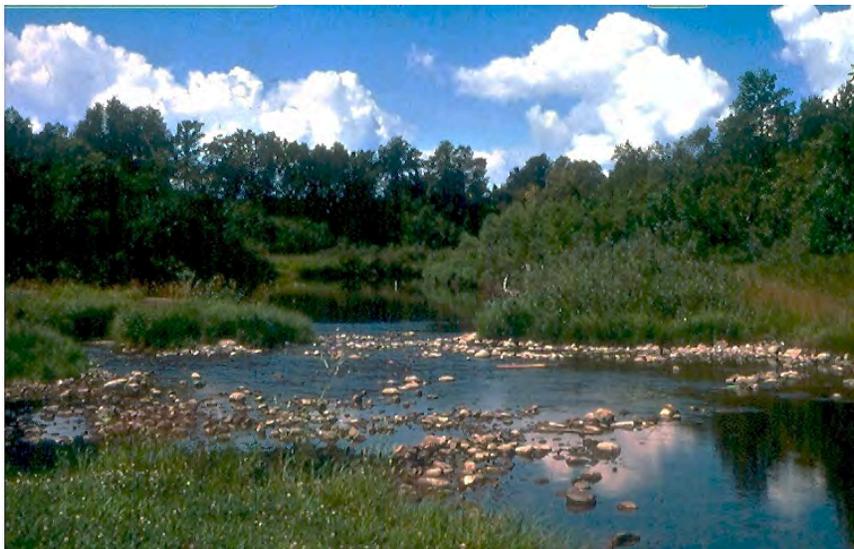
Figure 5.11: Mid-summer surveys found the cross-section of the rocky riffle to be slightly v-shaped, allowing a central channel to be maintained between pools under low flow conditions.

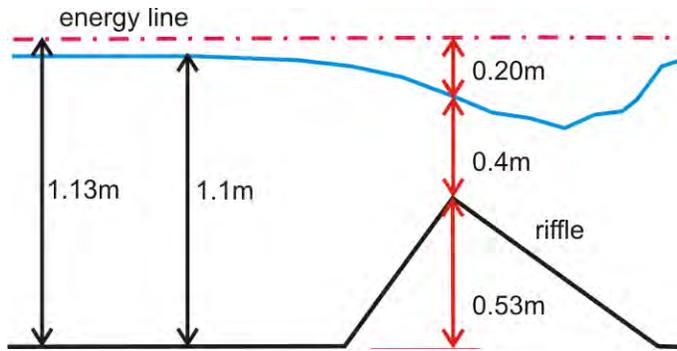
Figure 5.13: Idealized flow conditions predicted by the specific energy curve for a Mink Creek riffle at the bankfull discharge of 17 m³/s.

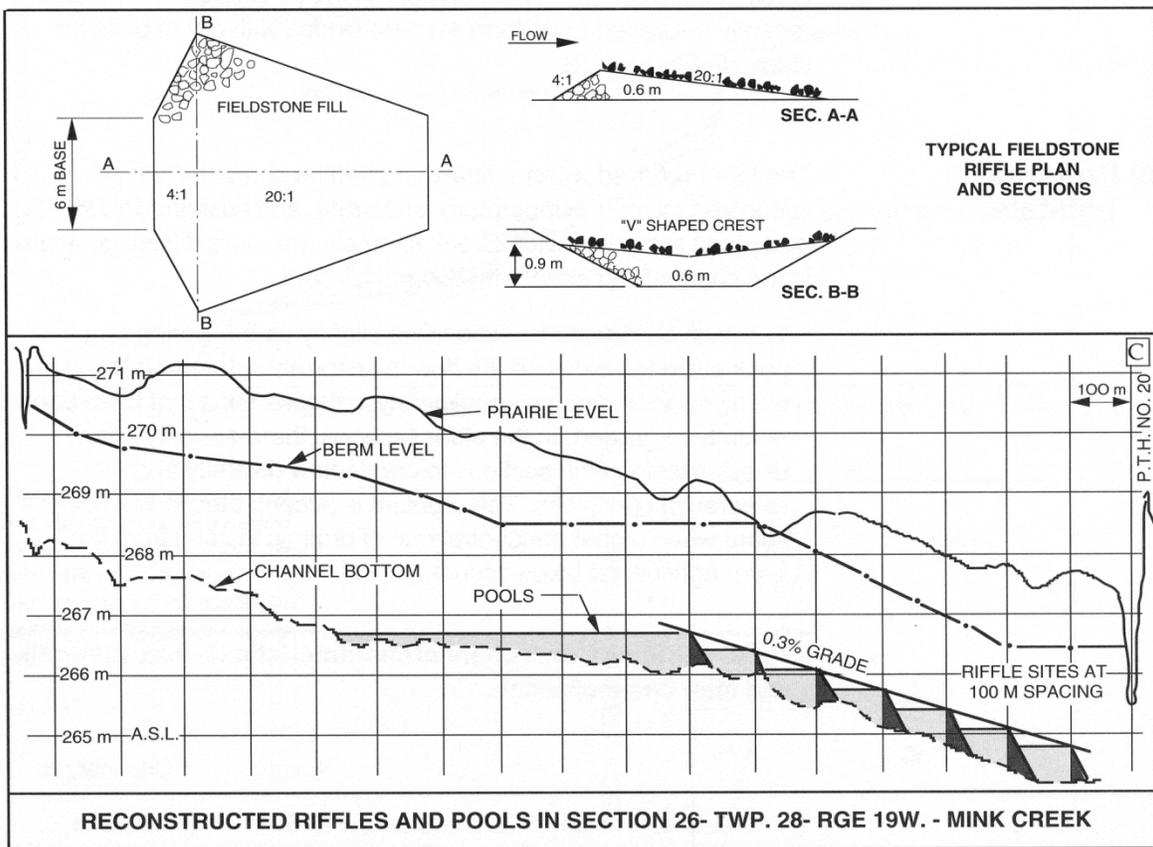
Figure 5.14: Pool and riffle profile design constructed in a typical reach of Mink Creek for walleye spawning and fry survival. The riffles crests were spaced at 100 m on average.

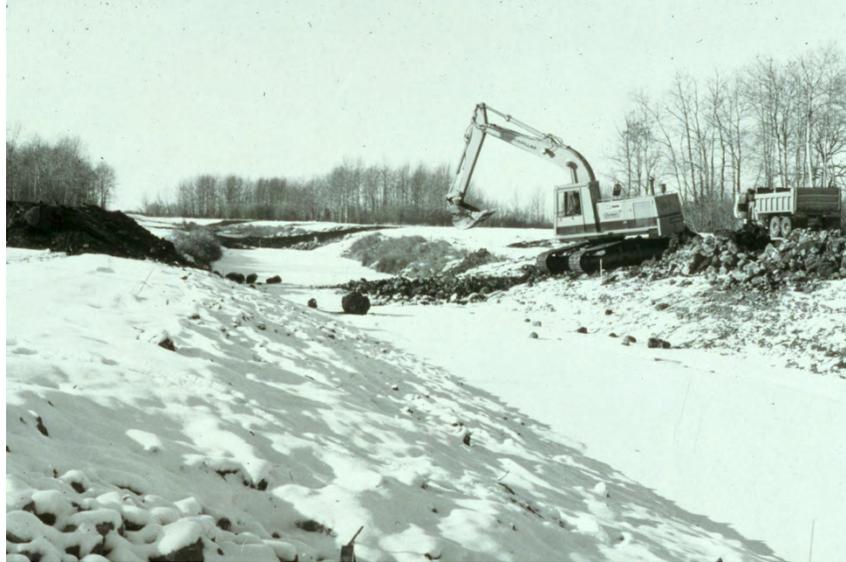
Figure 5.15: The Mink River riffles were built in the winter of 1985 using local fieldstone hauled to the site once the fields were frozen. Elevations were increased by 10 cm to allow for settling in the Spring.

The final construction profile for one of the restored segments is shown in Figure 5.14. The v-shaped crest was built to a height of 0.6 m to allow for settlement. Construction in this reach was undertaken in mid-winter 1985 (Figure 5.15).

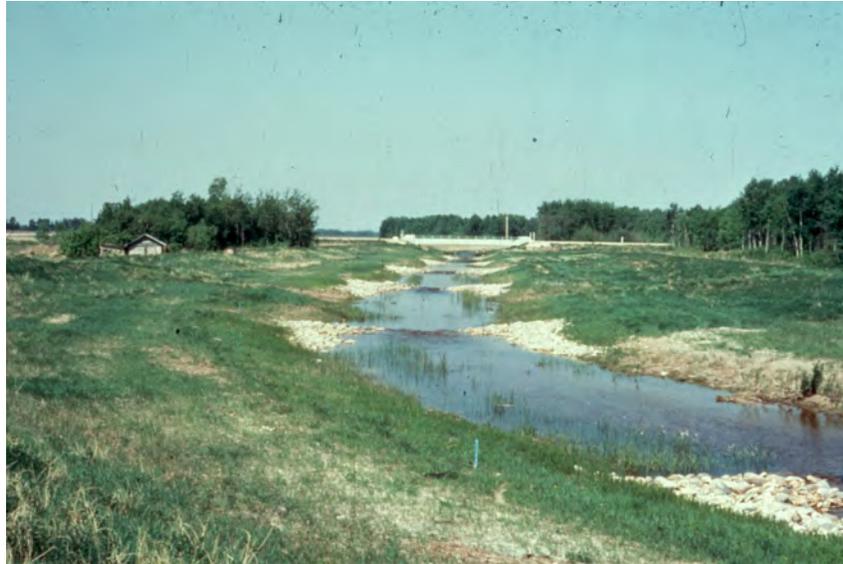
Figure 5.16: The Mink Creek pool and riffle reach in 1988, three years after construction (see pre-construction Figure 5.3).

Riffle Rock Sizing: Minimum stable rock sizes for the riffles were estimated using the maximum tractive force that would occur below the riffle crest at the bankfull stage assuming that the flow could rapidly achieve a slope of 20:1. The predicted cobble size at incipient motion was therefore: $D_{\text{mean}} = 1000 \times 0.4 \times .05 = 20$ cm. Larger rock was placed in and on top of the 20 cm materials to form low-flow channels and to provide a margin of safety. At greater than bankfull flows, the slope of the water surface decreases rapidly as the riffles become submerged. The increase in depth is limited in the larger cross-section that now includes the floodplains. No cut-off walls or filters were used in the riffle core but the riffle was sealed by packing the materials in layers with the machine treads and infilling the front slope with shale gravels scraped from the upstream pond. A reach of constructed riffles is shown in Figure 5.16.

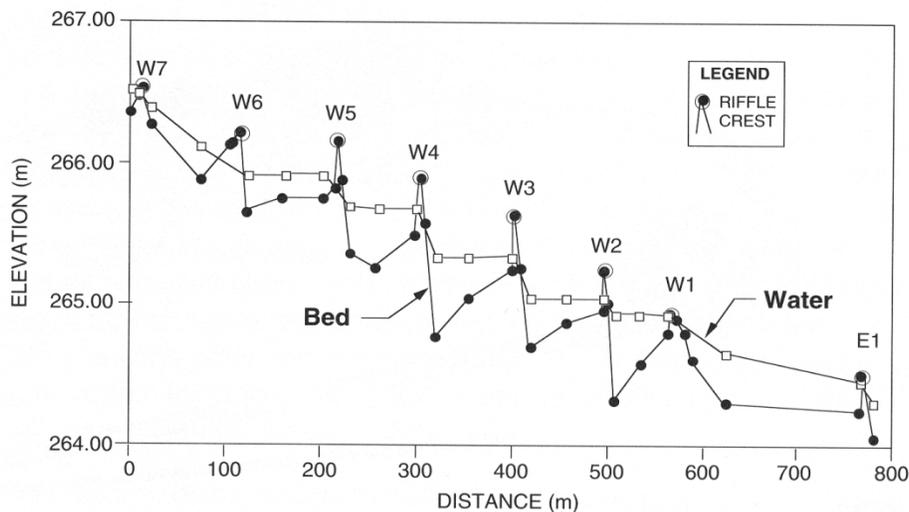
Figure 5.17: The pool and riffle profile of the Mink River restoration reach three years after construction. The initial flood flows formed pools in the soft shale gravel bed.

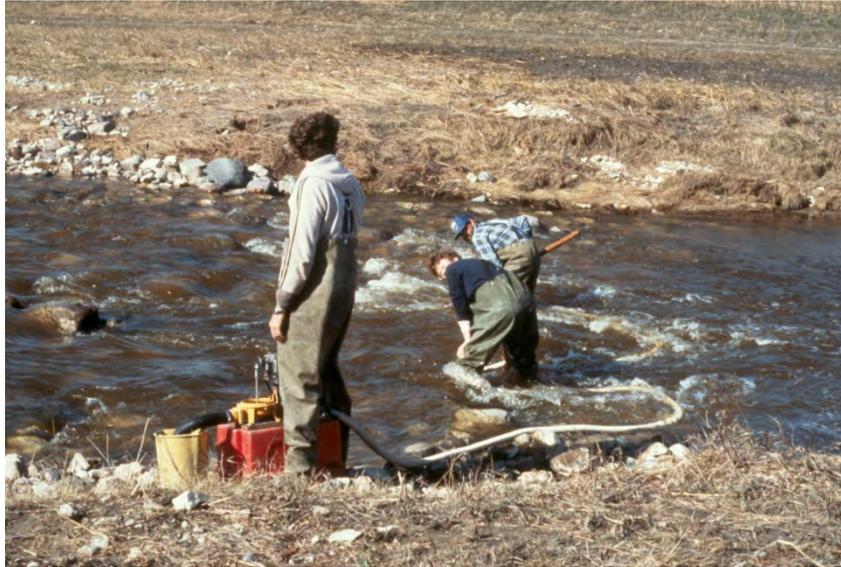
Figure 5.18: Walleye eggs deposited in the built riffles are being sucked from between the rocks with a diaphragm pump after the spring spawning period. The eggs are filtered and examined to determine their survival (M. Gaboury, L. and R. Janusz).

Walleye egg densities and fry drifting to Lake Dauphin were sampled following each spring spawning period (Figures 5.18 and 5.19). Fry production and drift in the reach was similar to that observed in natural reaches (Newbury and Gaboury 1994). Other species, suckers and pike in particular, were observed spawning on the riffles and on the rapidly re-generating reeds growing in the new pools (Figure 5.20)

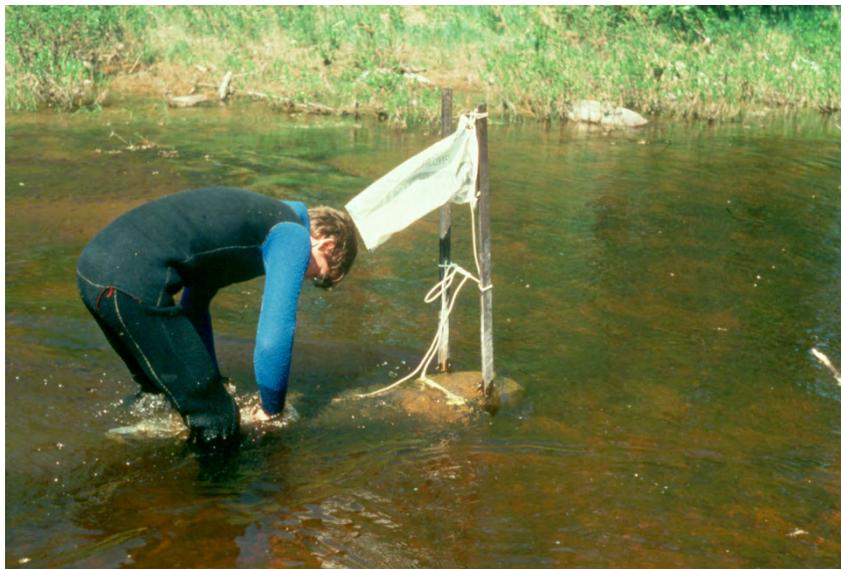
Figure 5.19: Drift traps in the pools were used to sample fry movement back to Lake Dauphin (L. Janusz).

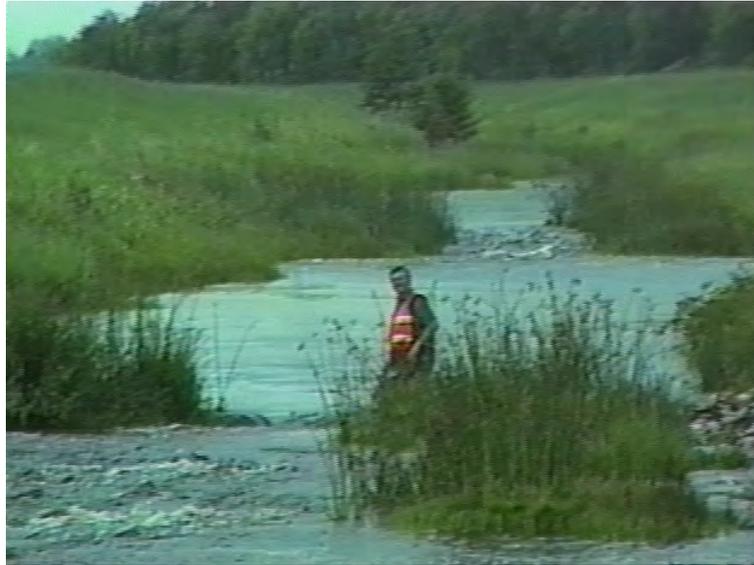
Figure 5.20 (1994): Pools and constructed riffles in Mink Creek nine years after construction (D. Roseboom).

Surveys undertaken nine and fifteen years after construction found no riffle failures. The small deep pools and continuous low flow water connections have been naturally maintained. Riparian grasses and reeds all but obscured the riffles. Figure 5.20 was taken nine years and Figure 5.21 twenty eight years after construction in the reach.

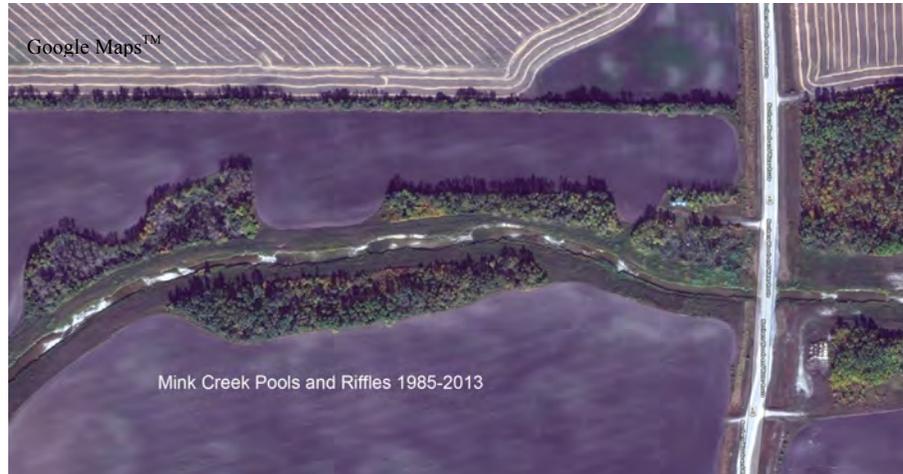
Figure 5.21 (2013): The pool and riffle profile was maintained and shifted a few metres downstream in twenty eight years (Google Earth Image 2013).

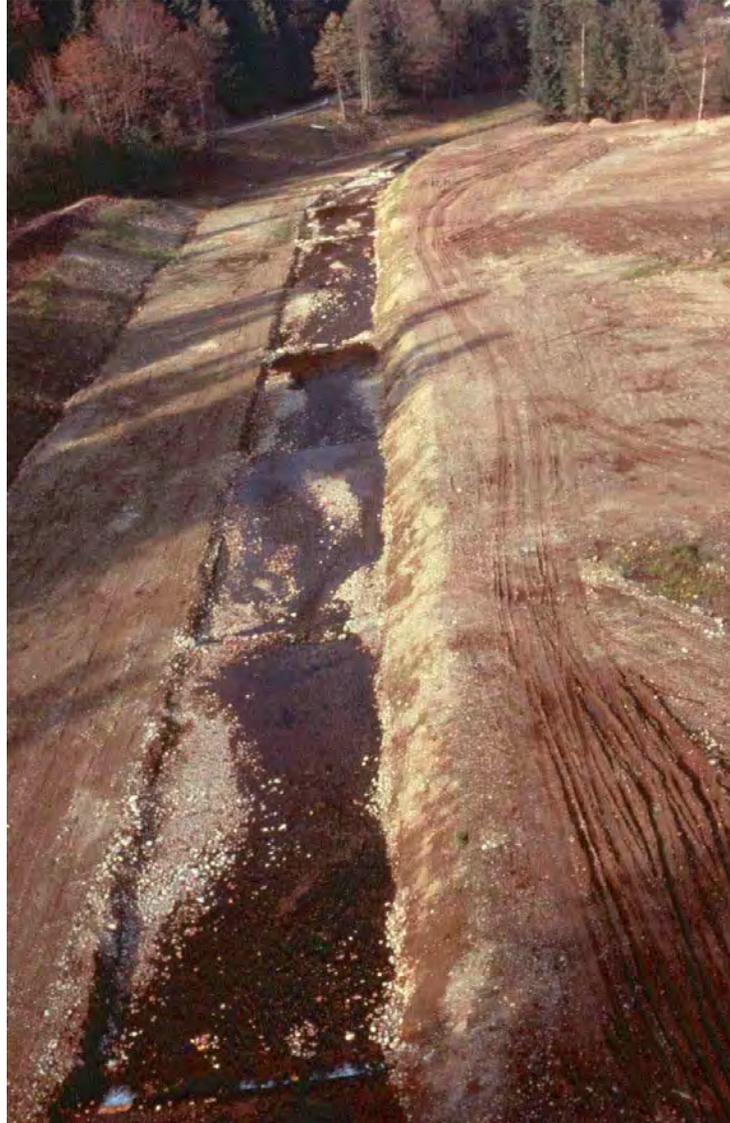
Figure 5.22: The new Oulette Creek diversion channel immediately after construction in 1978.

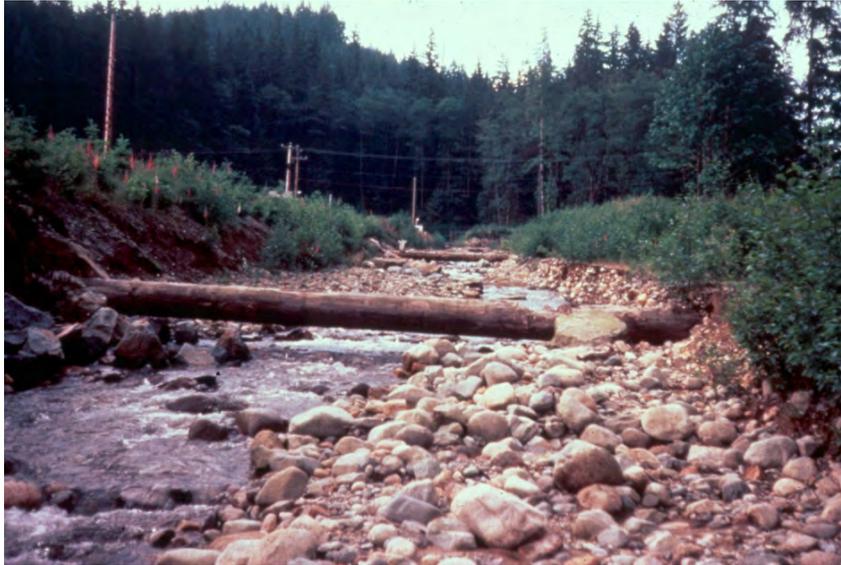
Figure 5.23: The Oulette diversion channel in 1982, four years after construction. Single “digger” log and rock drop structures contributed to the rapid down-cutting.

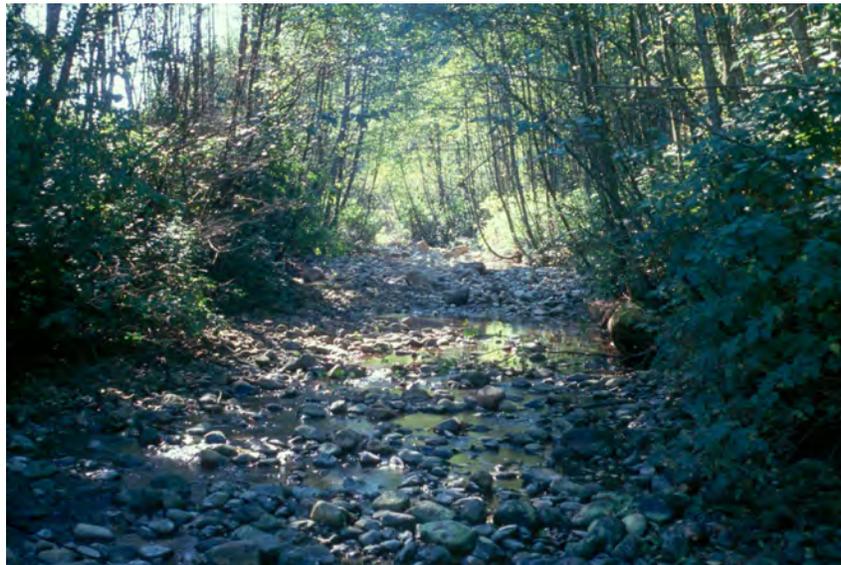
Figure 5.24: The uniform boulder and cobble channel of Oulette Creek in 1993 fifteen years after construction prior to the addition of pools and riffles.

1. Background: The meandering channel of Oulette Creek was straightened and diverted in 1978 to create a large dry-land log sorting yard in Howe Sound BC on the alluvial fan of the stream. The new 600 m long trapezoidal diversion channel was stepped with alternating single log and single row boulder drop structures every 30.5 m (Figure 5.22). The additional shear stress in the shortened channel rapidly eroded the fan materials. The bed elevation stabilized with boulder lag deposits 1.1 m below the constructed grade in two seasons, collapsing or under-cutting the drop structures (Figure 5.23). Coho salmon spawning riffles and rearing pools were destroyed. Pink and chum spawning platforms in the lower reaches were in-filled with large cobbles transported by the steeper channel (Figure 5.24).

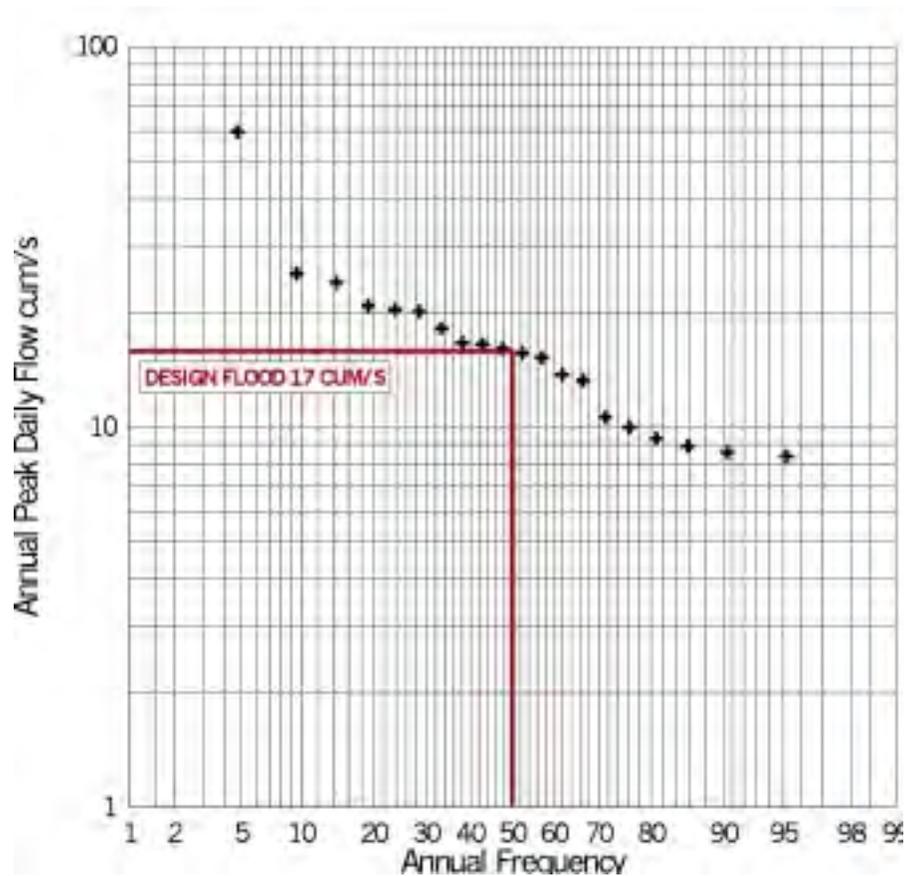
Figure 5.26: The annual flood frequency curve for Oulette Creek BC based the nearby WSC gauging station (Rainy River 08GA020). The depth of the median annual flood corresponds to the vegetation trim line elevation in the natural channel upstream.

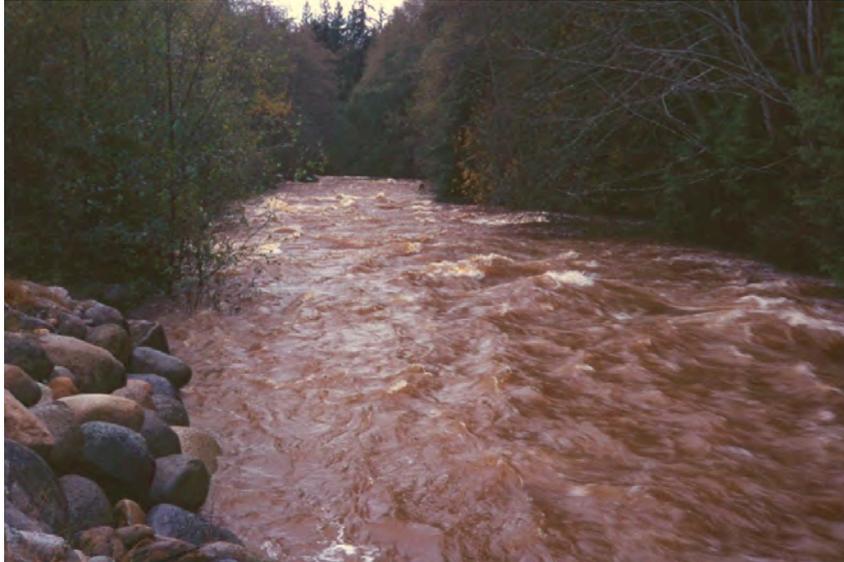
Figure 5.27: Surveys in Chapman Creek BC at the trim-line flood stage were used to predict a Manning's "n" estimate of 0.04 for the natural channel of Oulette Creek (similar to Hicks and Mason reference channel number 9065 (1991)).

The bankfull discharge estimate is approximately equal to the median annual flood peak based on a nearby gauging station frequency curve adjusted exponentially for the difference in drainage areas (Figure 5.26). The roughness characteristics were estimated from the reference channel shown in Figure 5.27.

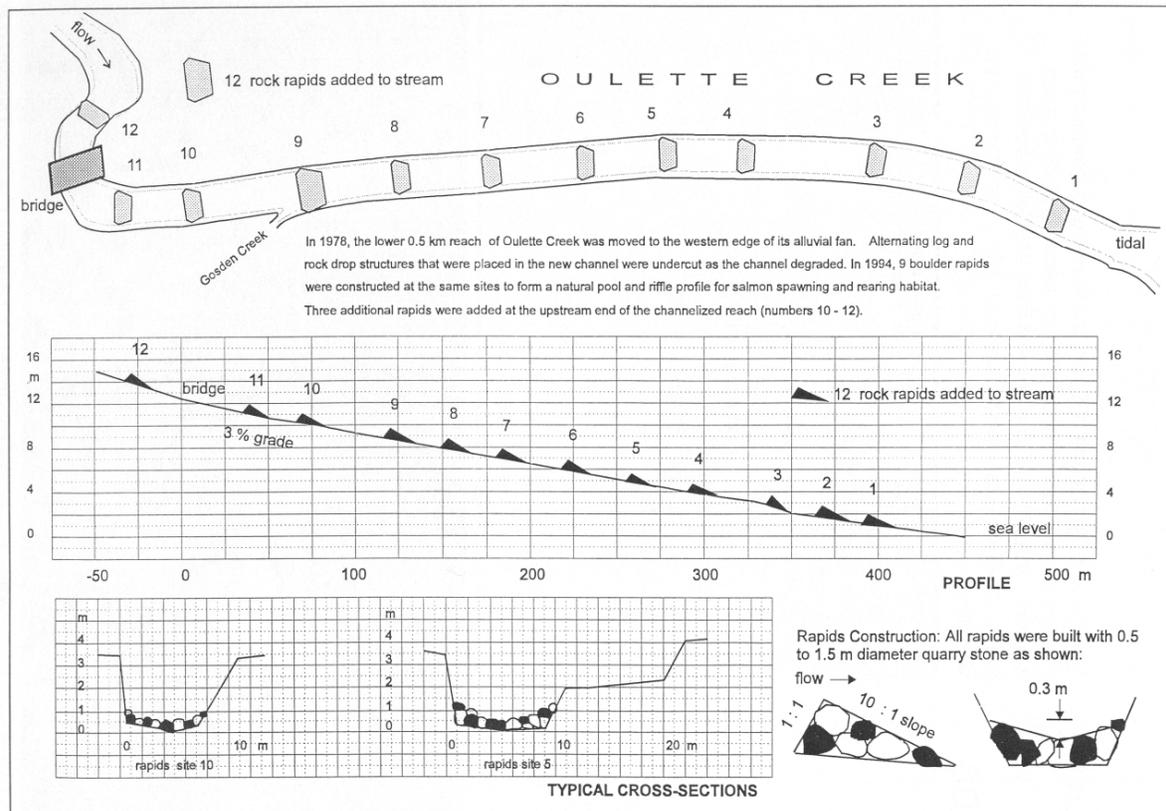
Figure 5.28: Pool and riffle plan constructed in the diverted reach of Oulette Creek BC.

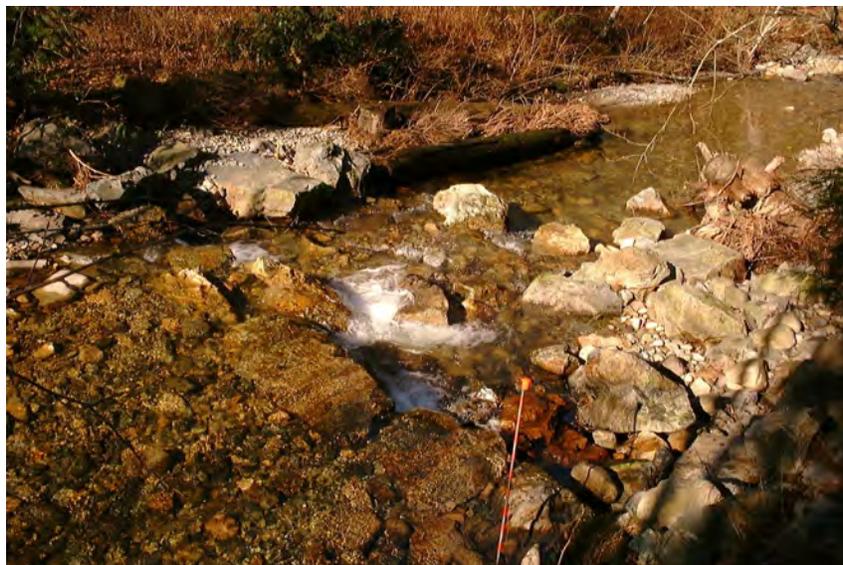
Figure 5.29: The upper Oulette Creek riffles were deepened and narrowed to concentrate the flow and scour a deep central pool that is used by Coho and Steelhead fry as over-wintering habitat.

By the year 2000, large cobbles and boulders in the bed load from the steep upstream reach above the fan (10% gradient) began to fill the upper pool in the restored reach. This upper fan deposition would normally cause an avulsion of the stream into a new channel. However as this channel must remain confined between the diversion dykes the deposition is removed from the upper pool when it is filled. This has occurred once in the first 15 years of the project.

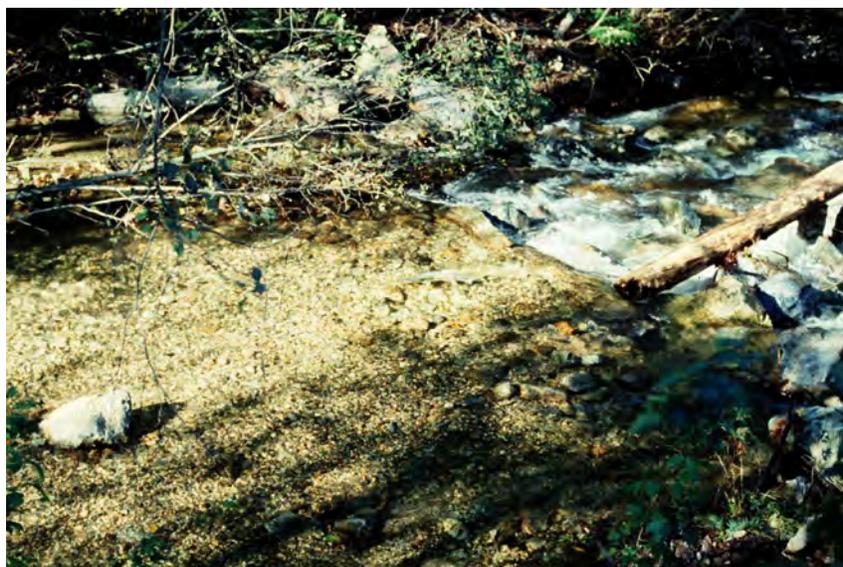
Figure 5.30: The lower Oulette Creek riffles with level crests have formed spawning platforms used by Pink and Chum salmon in the shallow upstream pool. The shallow exit flows do not form a scour hole below the riffle. Spawning Chum salmon are near the riffle crest and in the upper left portion of the photograph.

In 1997 the upper riffle crests were re-constructed to deepen and narrow the flow so that a central torrent was formed to scour 1.0 to 1.5 m deep section in the upper pool for Coho fry (Figure 5.29). The broad crest of the lower two riffles was not modified to maintain shallow spawning areas above and below the riffles for Chum and Pink salmon (Figure 5.30).

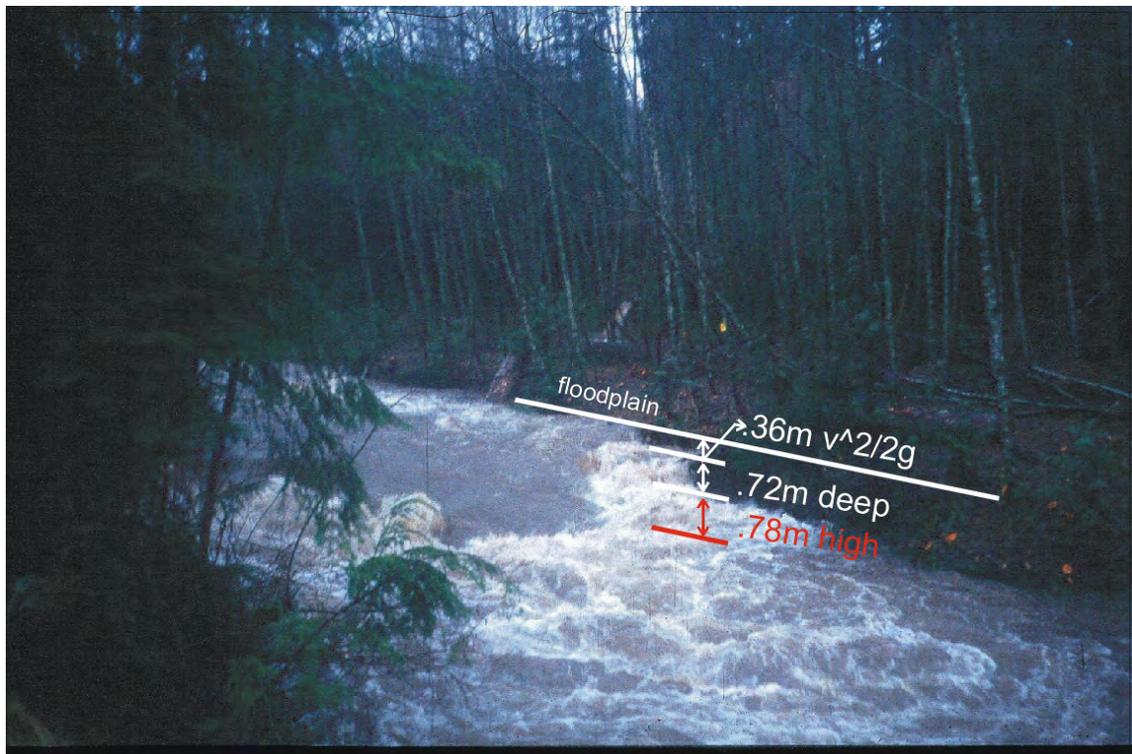
Figure 5.31: Oulette Creek flowing at $17 \text{ m}^3/\text{s}$ over a 9 m wide riffle. The upstream pool just approaches the floodplain level.

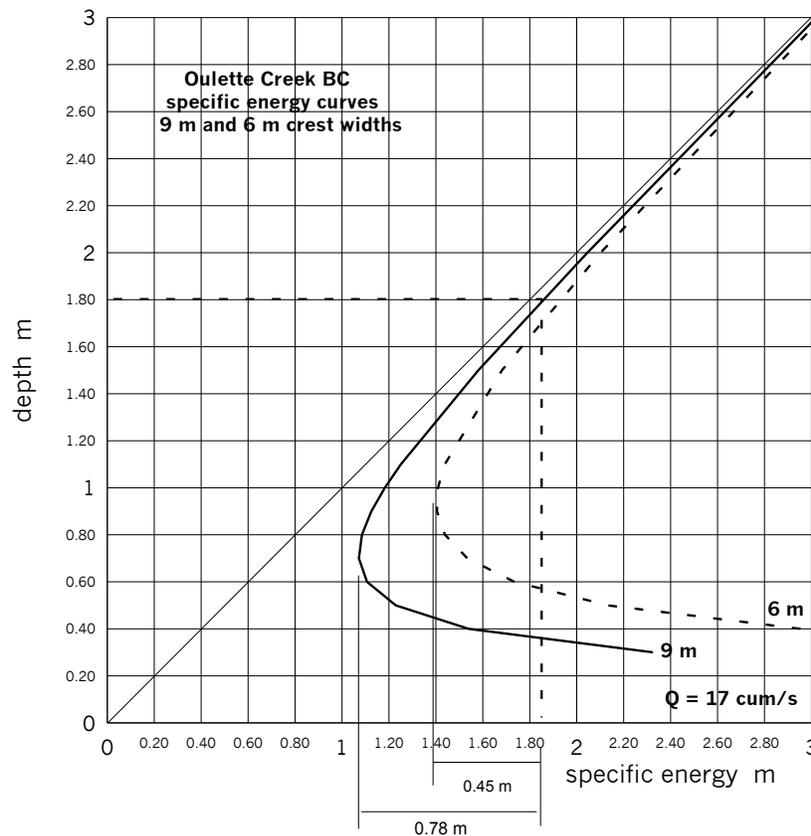
Figure 5.32: Specific energy curves for the Oulette Creek channelized reach (9m width, solid line and 6m wide, dashed line). The corresponding riffle heights are 0.78 and 0.46 m resp.

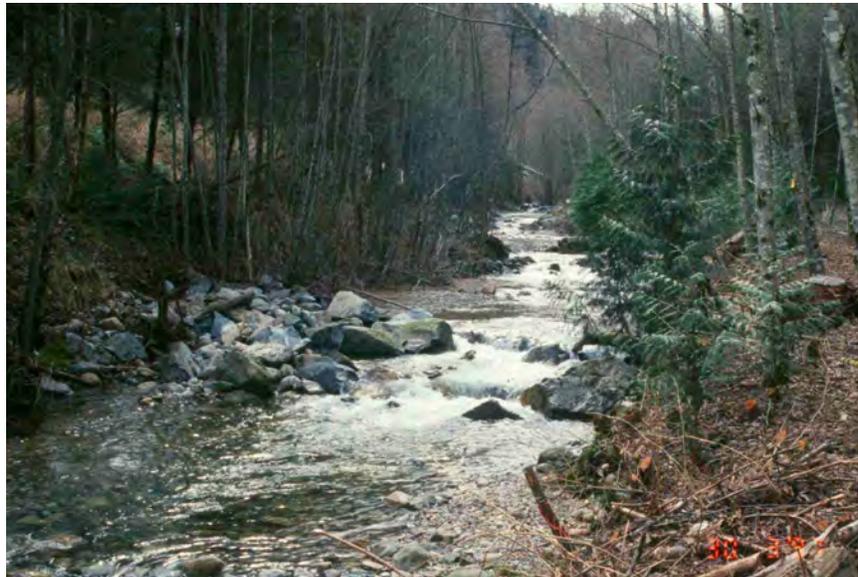
Figure 5.33: Scoured pools caused by large boulders placed on the riffle crests to narrow the flow in the Coho spawning and rearing reach of Oulette Creek. The photo was taken 10 years after construction.

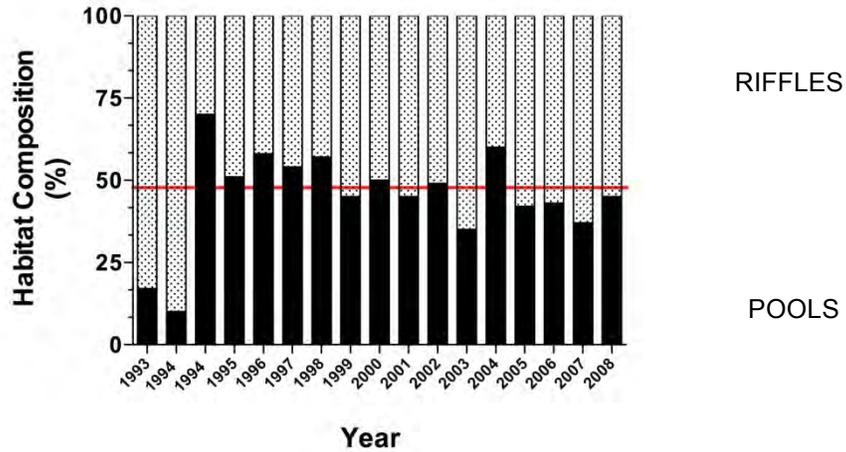
Figure 5.34: The distribution of riffles and pools in the Oulette Creek diversion channel before and after the addition of riffles in 1994 (Bates, FSCI Consulting, pers. com 2010).

5. Monitoring: Annual biophysical and topographic surveys are undertaken in the re-constructed reach of Oulette Creek. The surveys have shown that approximately equal areas of pool and riffle habitats have been maintained by the narrowed riffles (Figure 5.34). The biomass of fish in the upper Coho and Cutthroat trout reaches increased dramatically following restoration (Figure 5.35). Spawning Pink and Chum salmon have been observed every year in the pools above the lower two riffles.

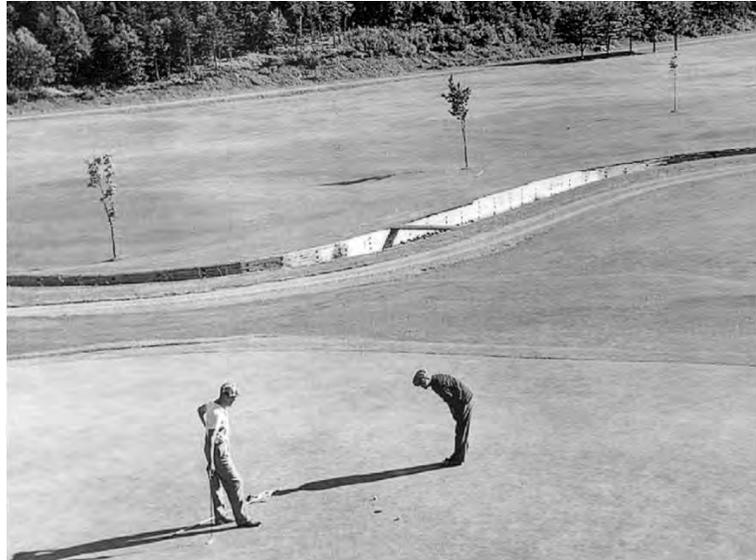
Figure 5.36: Dickson Brook was re-aligned as a water hazard in plank-lined channels in the initial Fundy National Park golf course layout (photo mid 1950's).

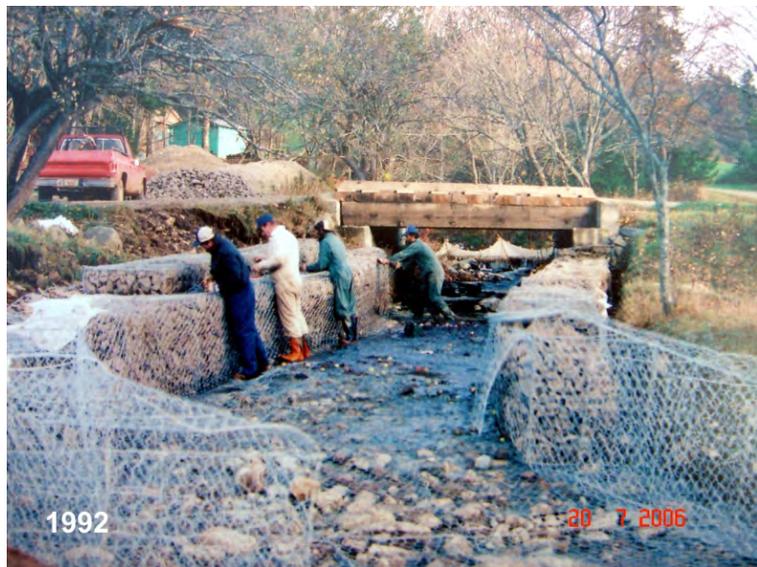
Figure 5.37: Rock wall, gabion and wire mesh lined channels replaced the failing plank lined channels throughout the course.

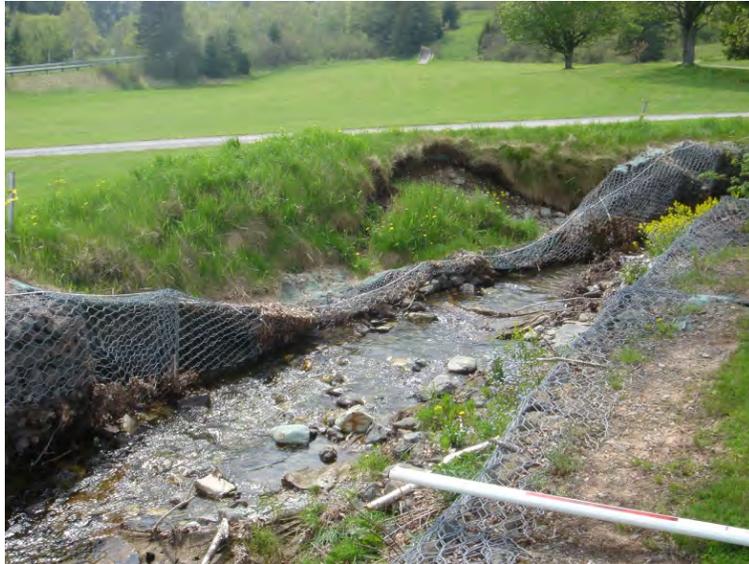
Figure 5.38: Typical gabion basket and bed-lined channel failure 10 years after installation.

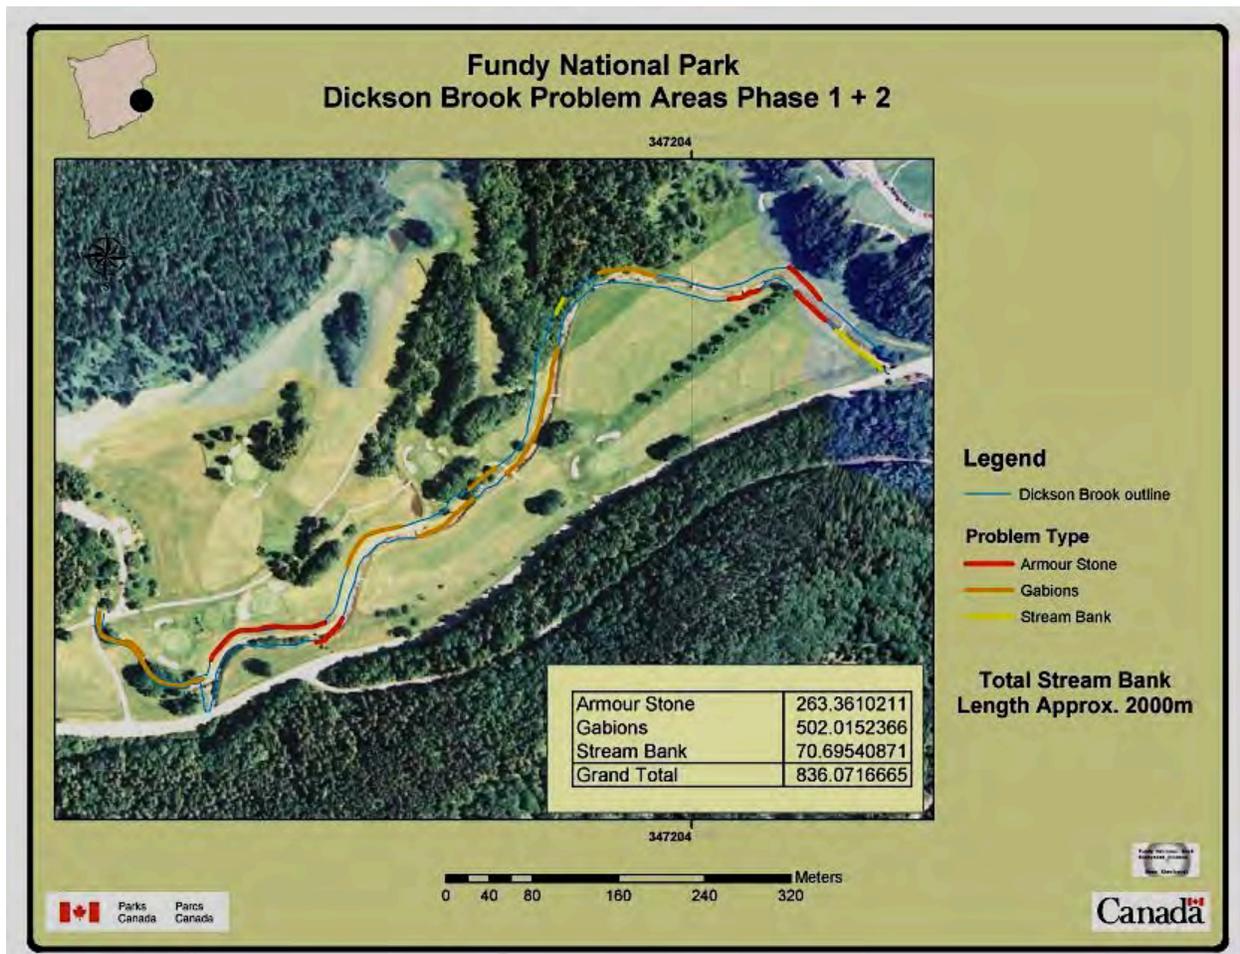
Figure 5.39: Areas with failing armour stone, gabions and banks (Parks Canada 2002).

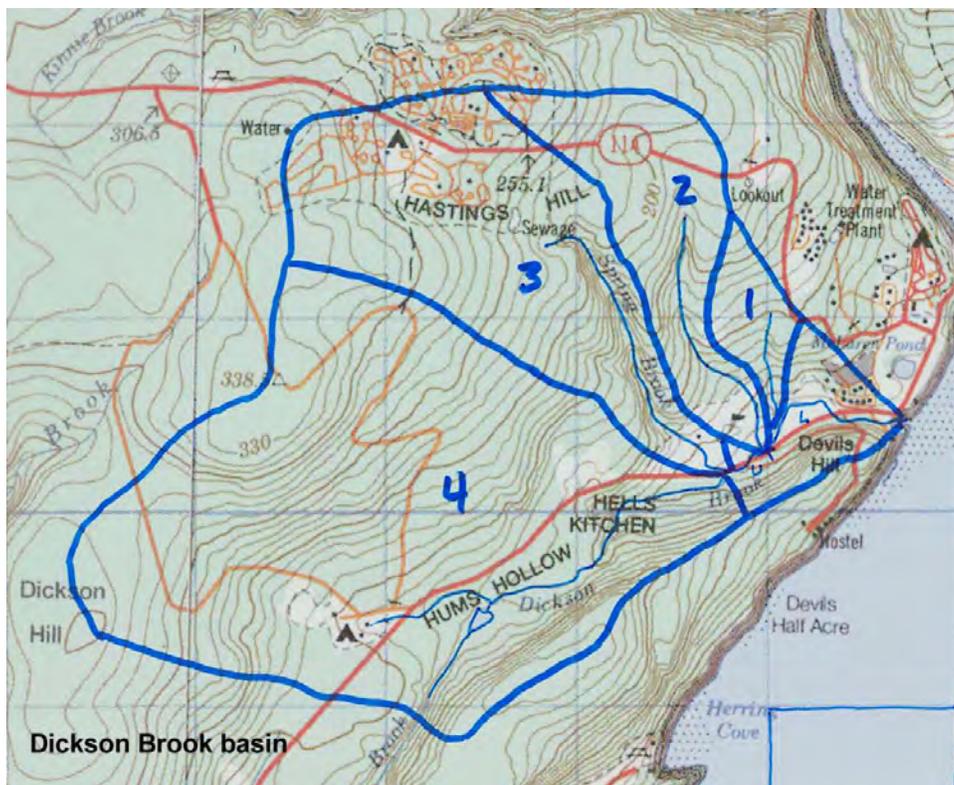
Figure 5.40: Dickson Brook watershed and tributary profiles from 1:50,000 map contours.

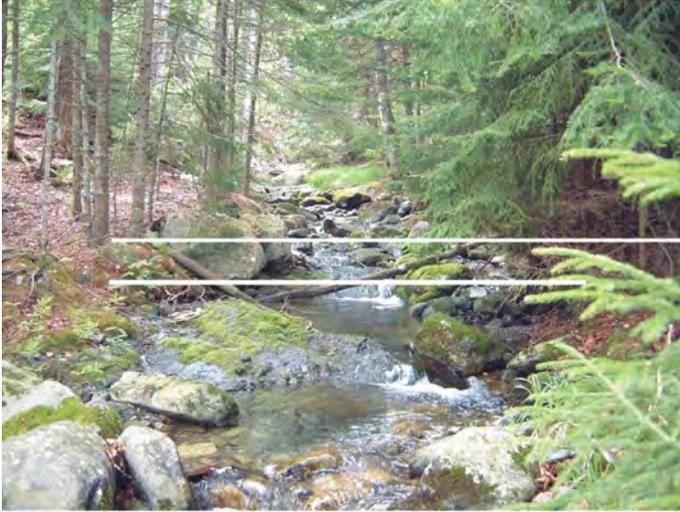
DICKSON BROOK REFERENCE REACHES

floodplain
trim-line

TRIBUTARY 2
width 3.3 m

2. Natural Channel Dimensions: The Dickson Brook watershed consists of 4 sub-basins (Figure 5.40). The hydraulic geometry (width, depth, velocity and flood capacity) was determined in reference reaches in three unaltered tributaries with similar channel slopes to the golf course reaches (Figures 5.41 and 5.42).

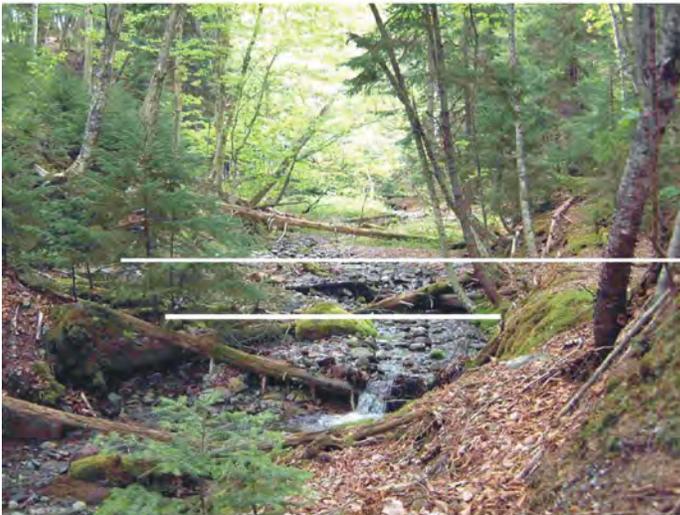
floodplain
trimline

TRIBUTARY 3
width 5.3 m

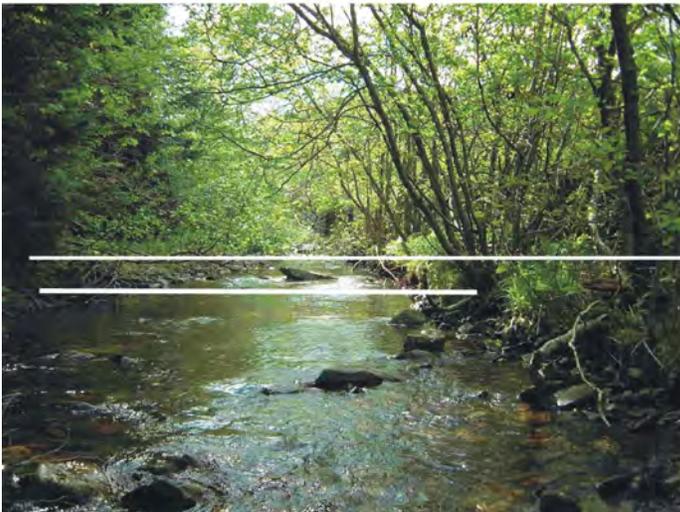
floodplain
trimline

TRIBUTARY 4
width 9.3 m
