Stream Restoration Hydraulics

Part 2: Applications

Chapter 5: Projects Restoring Pool and Riffle Channels

Design Example 1: Pool and Riffle 0.3% Gradient Stepped Channel for Walleye Spawning and Fry Returns to Downstream Lakes (Mink Creek MB 1985).

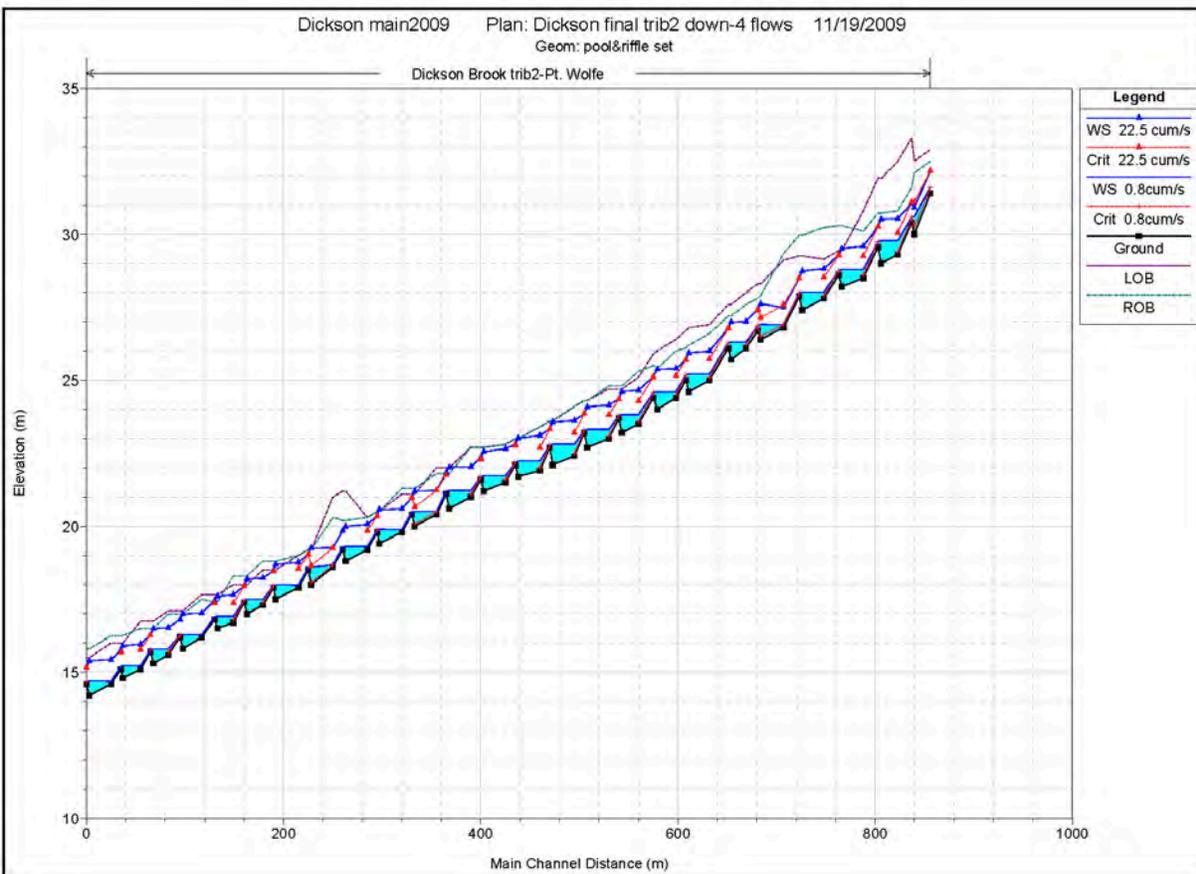
Figure 5.45: HEC-RAS profile of the Dickson Brook mainstem. Riffle elevations and spacing were adjusted to create continuous fish passage at low flows (0.8 m³/s) and flood breakout points in areas of least damage to the golf course (greens, tees, and bridges for example). The maximum post-project recorded flood is 22.5 m³/s

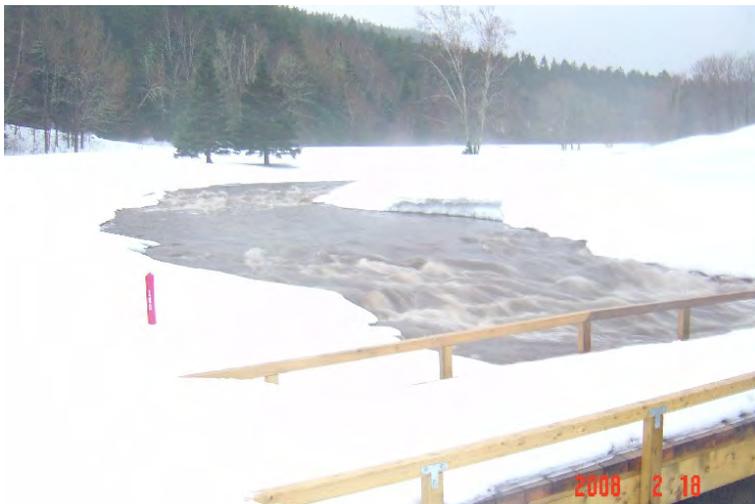
Figure 5.46: Dickson Brook flowing above the floodplain level between 1 m high snow banks (Feb. 18, 2008). Direct runoff was observed from the snow surface.

Unique flood events that exceed the bankfull elevation but not enter the floodplain may also occur in mid-winter during rain on snow events (Figure 5.46).

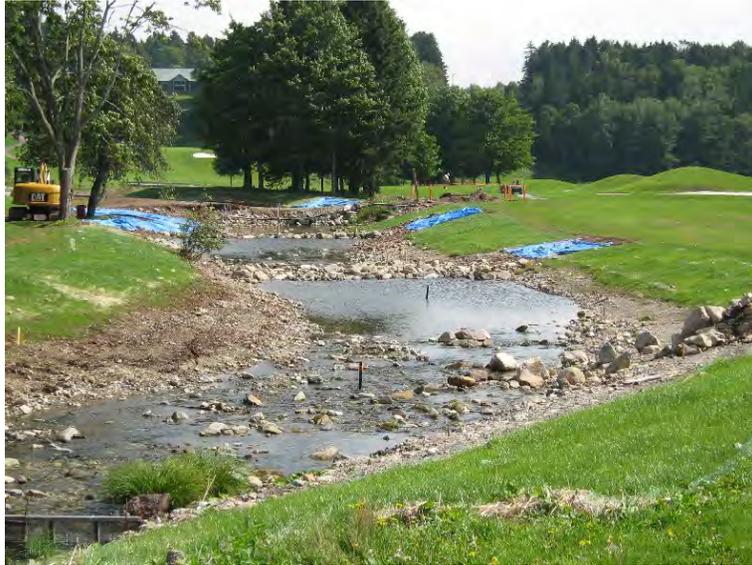
Figure 5.47: Dickson Brook riffles on the lower mainstem under construction (2008). The banks are covered and grassed as construction proceeds. The end of the upper fish fence is shown in the left corner.

Construction: Areas under construction were fenced off and cleared of fish (Figure 5.47). Open banks were covered with seeded mats or sod and replanted with riparian shrubs as the construction proceeded. Emergent boulders up to 50 cm diameter were added to the riffles to provide low flow channels (Figure 5.48). Boulder clusters and cabled logs were added to pools to increase habitat diversity (Figure 5.49).

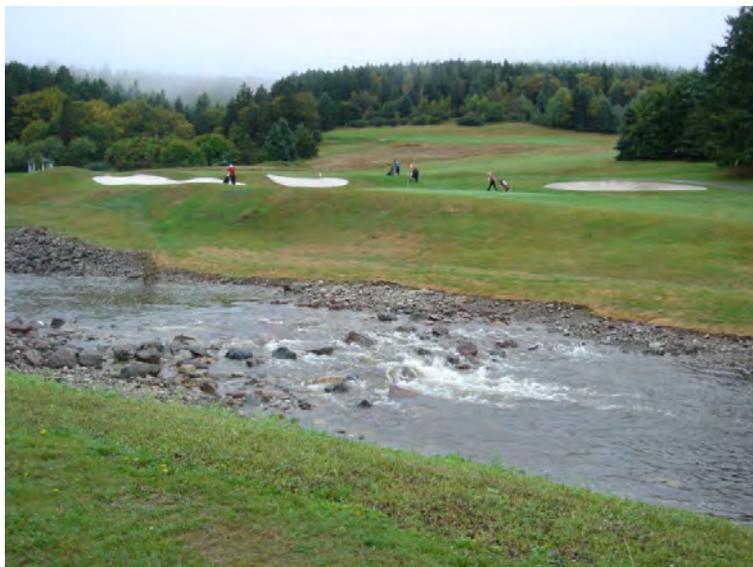
Figure 5.48: Emergent boulders were added to the riffle surfaces to create low flow fish passage channels.

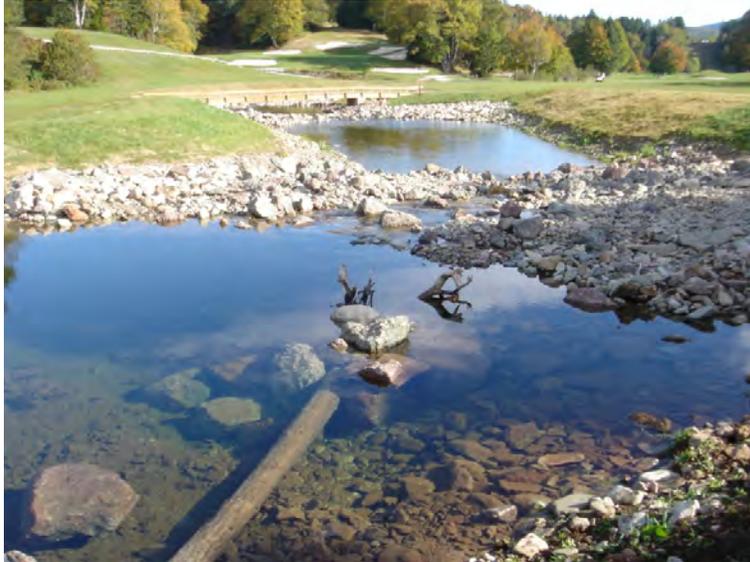
Figure 5.49: Boulder clusters and root clumps were added to pools to create covered habitats .

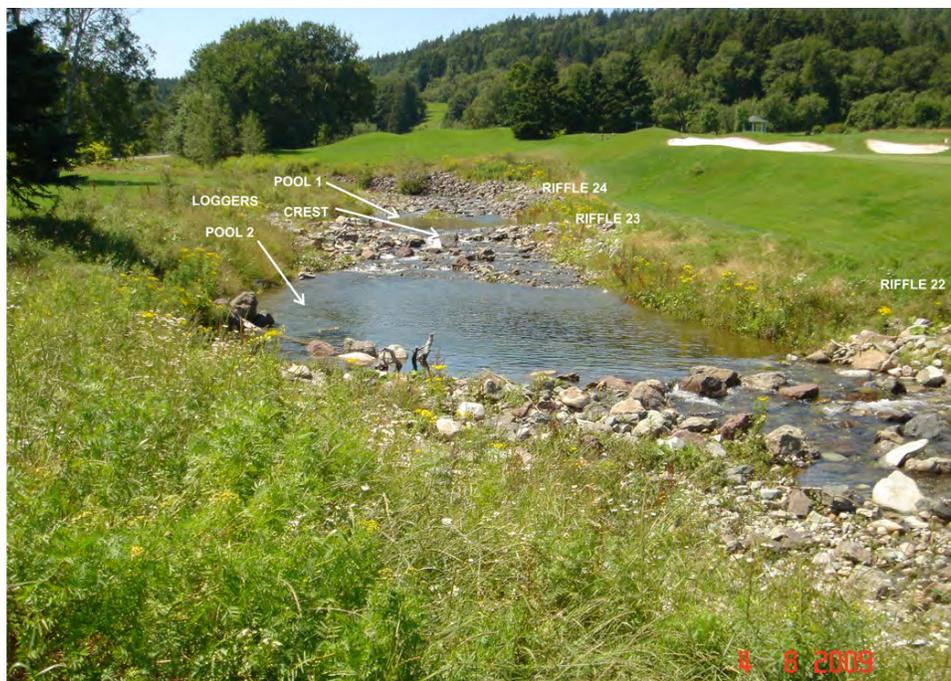
Figure 5.50: Hourly water level records were monitored with ONSET pressure transducer recorders installed on the riffle crests and pools.

Monitoring: Hourly water levels were monitored in 2009 in the upper mainstem between riffles 22 and 24 (Figure 5.50). Roughness values for the pools and riffles based on HEC-RAS modeling were determined from the profile observed during a $20 \text{ m}^3/\text{s}$ storm event (Figures 5.51 and 5.52).

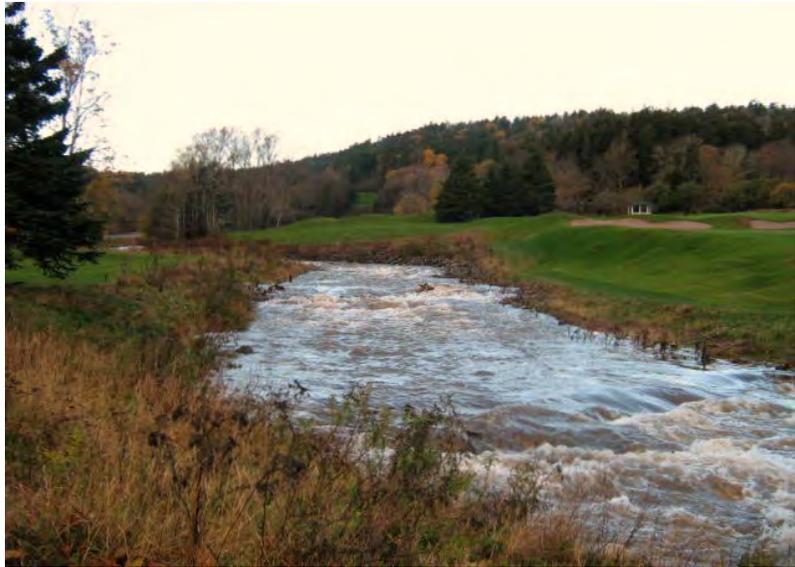
Figure 5.51: The monitored reach at a near bankfull flow $20 \text{ m}^3/\text{s}$ on October 24, 2009

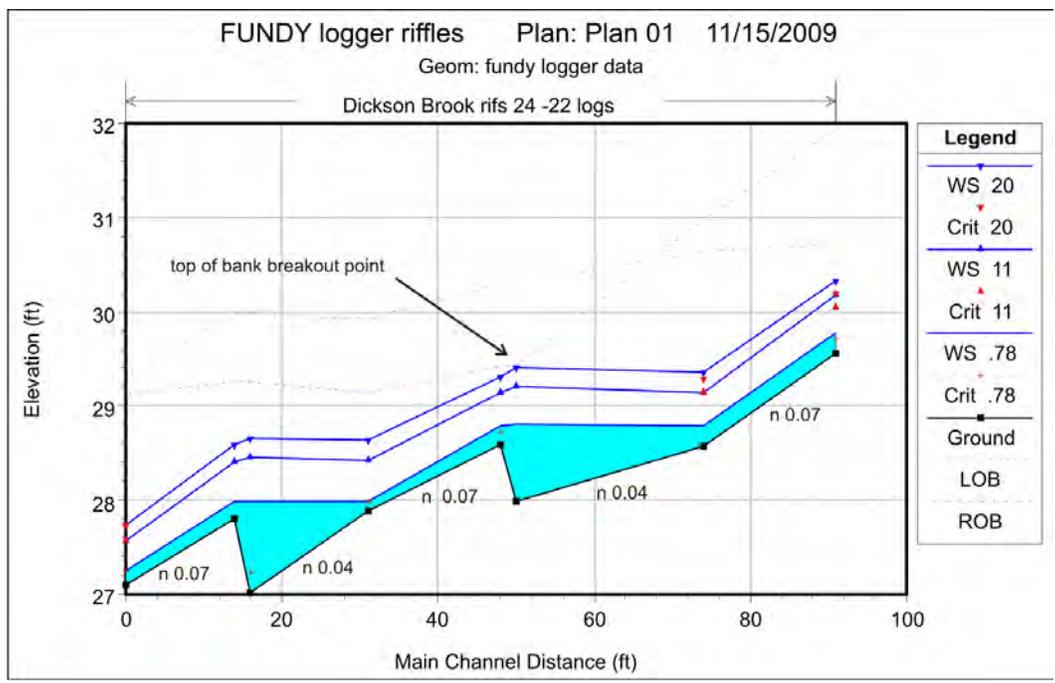
Figure 5.52: The HEC-RAS flow profile and consequent roughness values based on the observed water levels between riffles 22 and 24 at a floodplain breakout flow of $20 \text{ m}^3/\text{s}$ in this reach.

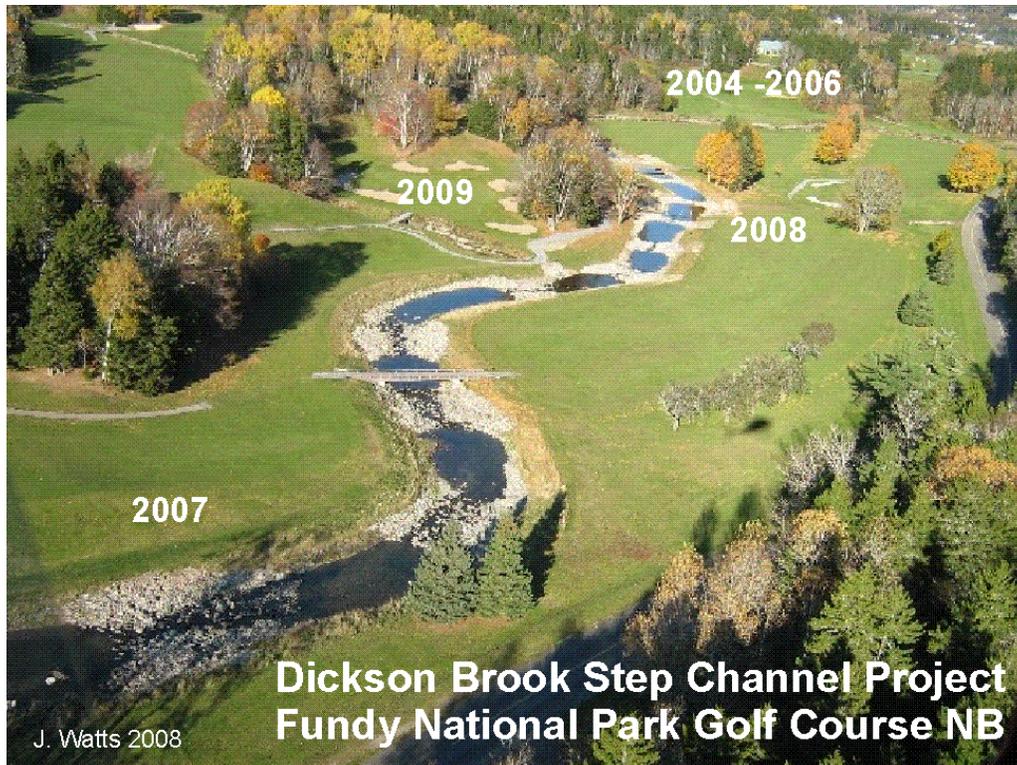
Figure 5.53: Aerial view of the Dickson Brook mainstem channel and restoration dates.

Schools of brook trout and occasional eels and stocked Atlantic salmon are observed in the lower brook (Figure 5.53). Fish density is slightly lower than in natural reaches but age-class sizes are larger (pers. com. Jane Watts, Fundy National Park).

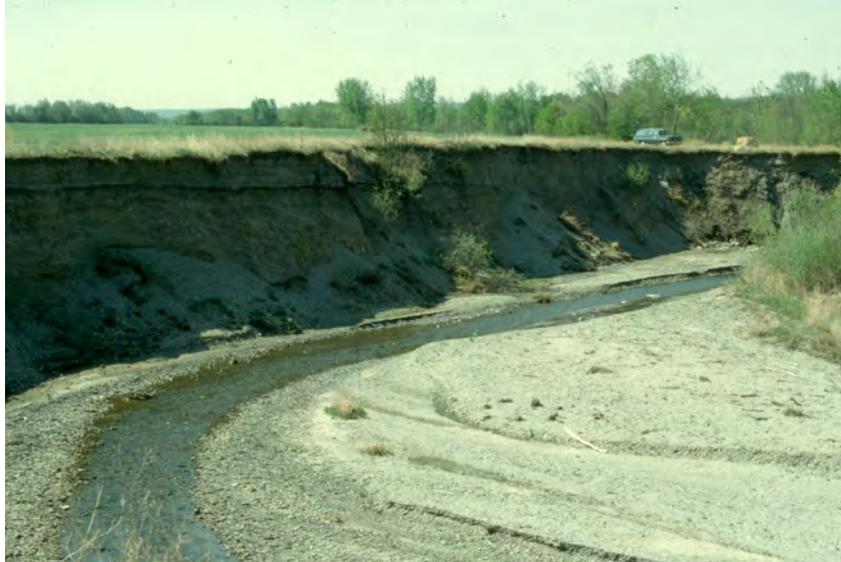
Figure 5.54: The pre-project Wilson Creek headcut channel 50 years after a horse and scoop drainage ditch was constructed across the alluvial fan surface in the 1920's.

1. Alluvial Fan Headcut Stabilization 1977: One of the first projects was built in 1977 on the alluvial fan of Wilson Creek MB to stop a deep headcut from progressing into Riding Mountain National Park. The original channel was cut across the alluvial fan with a horse and scoop in the early 1900's. A 100 m wide 10 m deep canyon eroded in the ensuing 50 years (Figure 5.54).

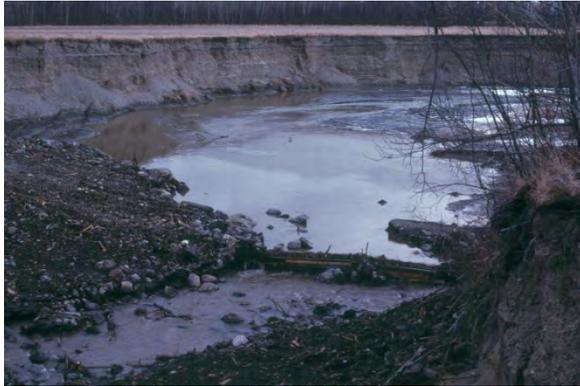
Figure 5.56: Crest wall of riffle drop structure.

Three 2.5 m high rock riffles were designed as drop structures to create a stepped channel below the headcut. A vertical timber crest wall was built across the canyon to guide the construction for the first riffle (Figures 5.56 and 5.57). The riffle materials were graded in size and packed in layers to prevent seepage.

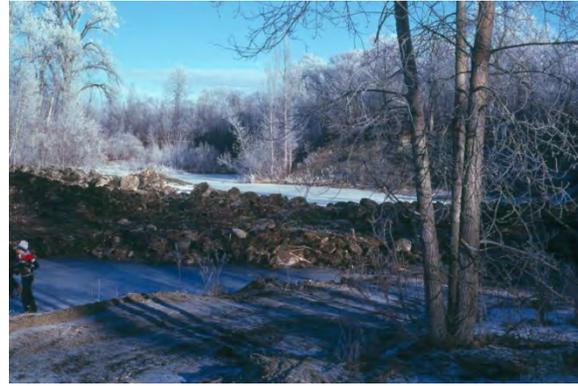
Figure 5.57: A completed Wilson Creek riffle.

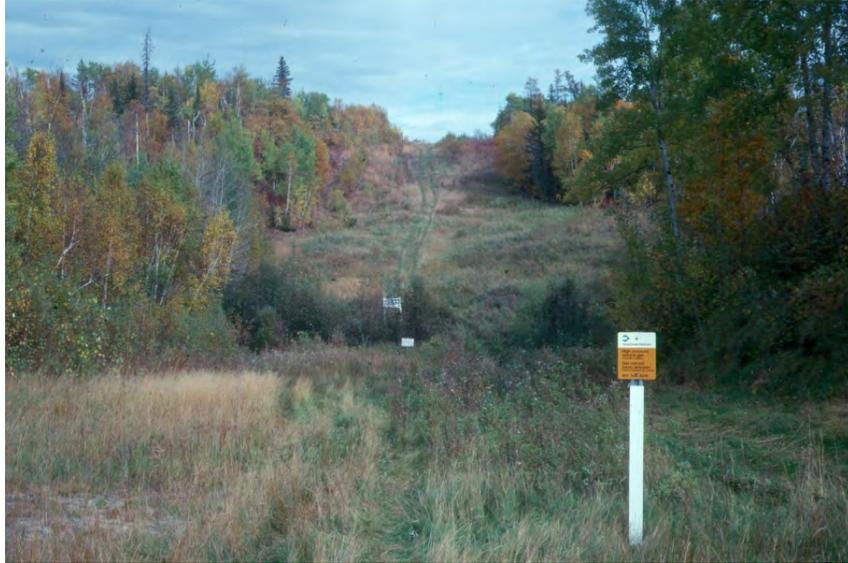
Figure 5.59: The gas pipeline right-of-way crossing Hamilton Creek near Falcon Lake MB.

2. Pipeline Stream Crossing 1990: Smaller projects were also undertaken to stabilize streambeds disturbed by construction. For example, walleye spawning riffles were hand-built on trenched and back-filled pipeline crossings on Hamilton Creek MB to stabilize the bed and prevent erosion of the infilled channel (Figures 5.59 and 5.60).

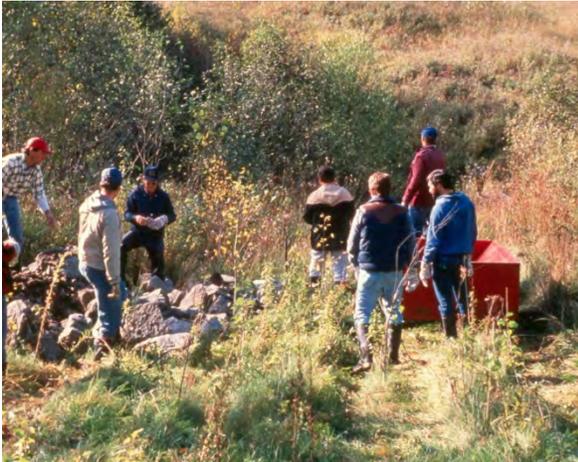
Figure 5.61: hand-building pipeline crossing riffles.

The riffles were hand-built with rocks and gravel brought to the site on ATV trailers (Figures 5.61 and 5.62). A completed pool and riffle several years later is shown in Figure 5.63.

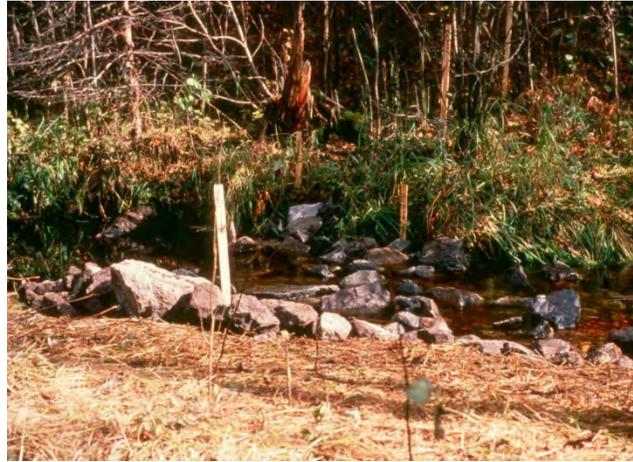
Figure 5.63: Completed riffle over pipeline.

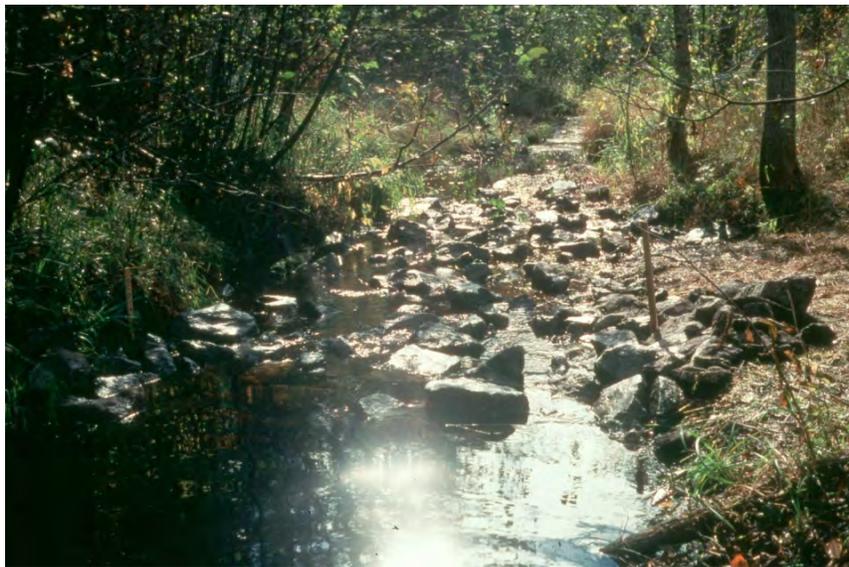
Figure 5.63: Hamilton Creek pipeline crossing riffle 3 years after construction.

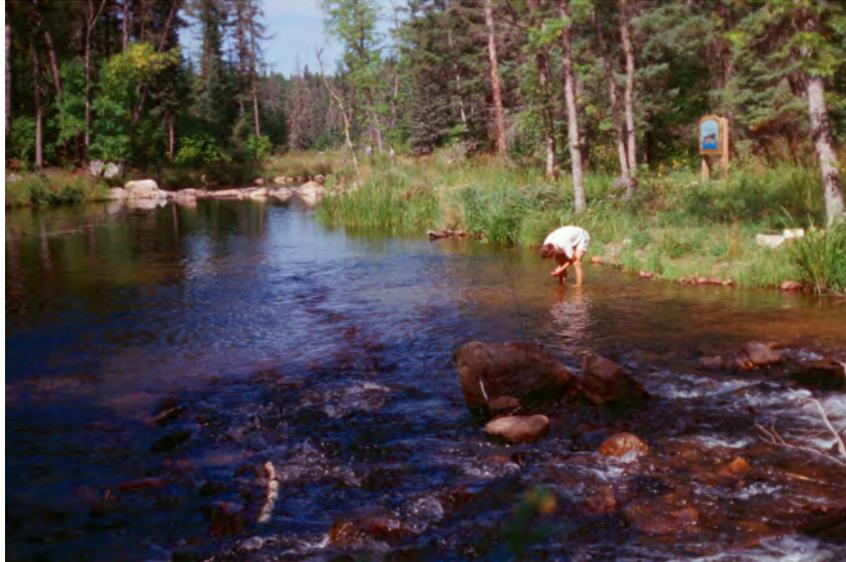
Figure 5.64: Riffle and trout holding pool constructed on the Whiteshell River MB in 1991.

3. Trout Fishing Pools 1991: Adult trout are released from the Caddy Lake hatchery into the Whiteshell River in eastern Manitoba. The hatchery reach is used for sport fishing and as a classroom for budding anglers by the Manitoba Fly Fishers Association. Seven riffles were added to along the reach to create deeper pools and increase benthic habitats in the shallow bedrock channel in 1991 (Figure 5.64). The profile and pool depths are shown in Figure 5.65.

Figure 5.67: Whiteshell River project assessment survey undertaken in 2008 in the reach shown in Figure 5.64 (1991) by AAE Tech Services Winnipeg, MB (photo: M. Lowdon).

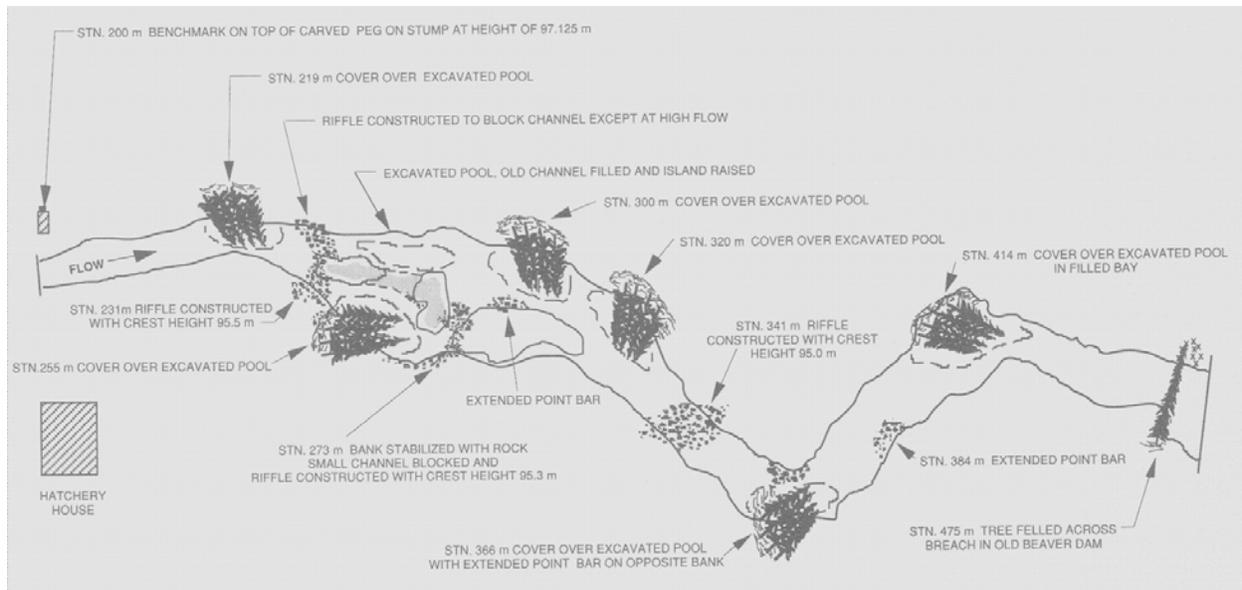
Figure 5.66: The central section of the Whiteshell River hatchery reach showing the location of tree clusters overhanging the newly created riffles and pools.

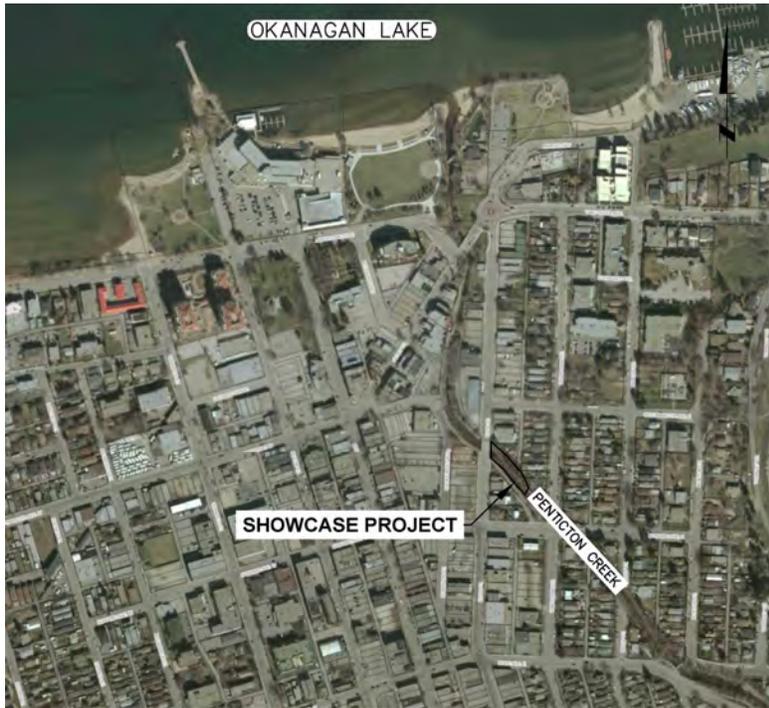
Figure 5.68: The lower reach of Penticton Creek in the downtown city core. A short restoration reach was constructed in 2015 as a “showcase” for a larger master plan.

After drastic urban flooding in the 1940's Penticton Creek was collected in a single channel running directly into Lake Okanagan on the northern flank of the city core (Figure 5.68). The lower reaches of the high gradient channel (1.8 %) were lined with concrete (Figure 5.69). Over 30 drop structures were added to steeper upstream reaches (3.8%) to control erosion.

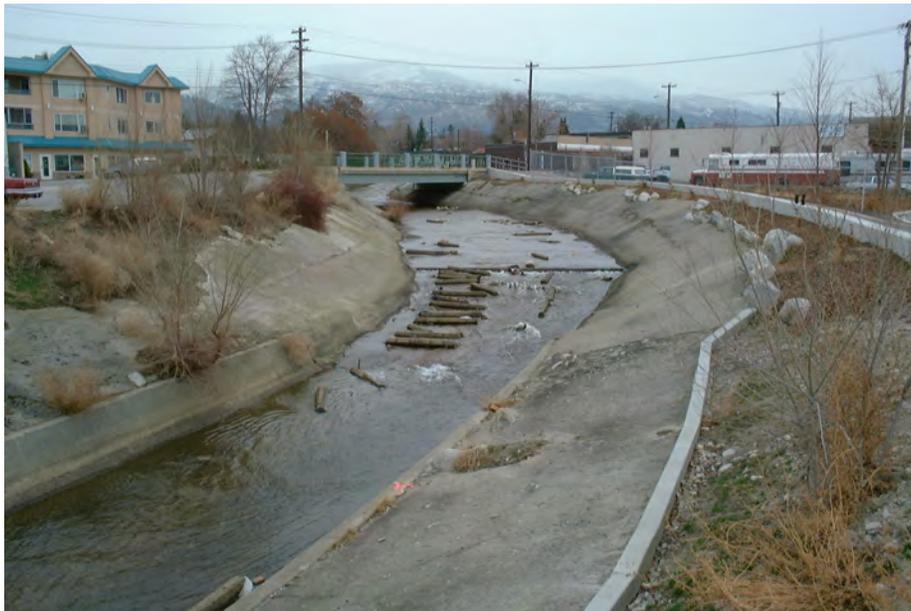
Figure 5.69: The channelized and concrete lined lower reach of Penticton Creek. Parking barriers are placed on the stream bed to provide resting refuge for spawning kokanee as they struggle to move through the shallow and fast flowing lower reach.

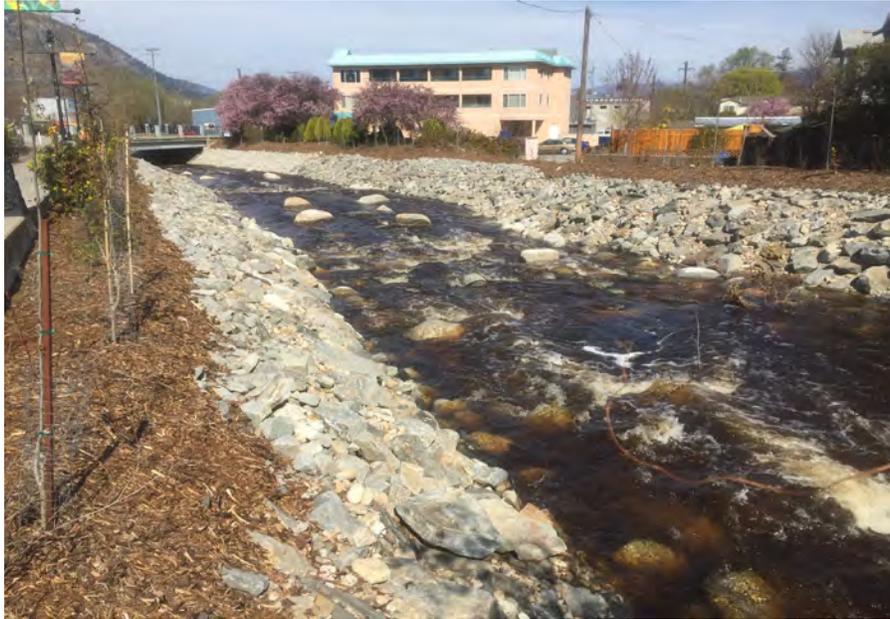
Figure 5.70: A rocky pool and riffle channel replaced the concrete-lined channel in the Pentiction Creek showcase project.

In 2015 the concrete lining in a 90m “showcase” reach was replaced with a rocky bed of shallow pools and short riffles. The channel banks were riprapped with coarse rock (Figure 5.70).

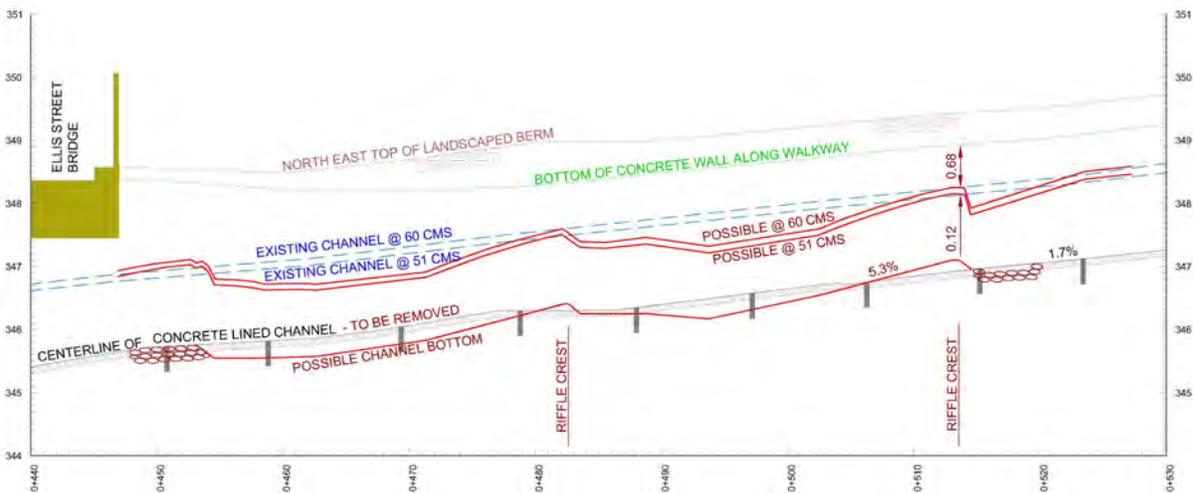
Figure 5.71: The showcase reach was widened by 2m to achieve similar flood stages in the rougher channel.

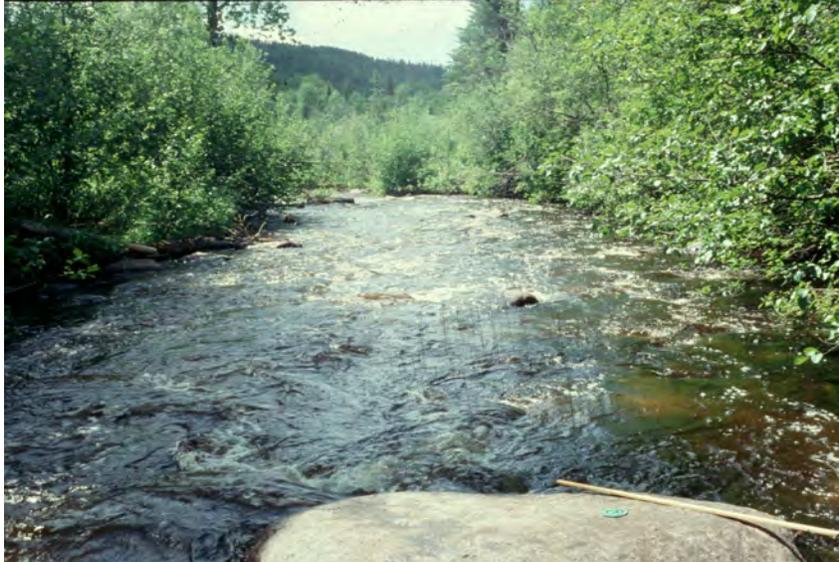
Figure 6.1: The straightened reach of the North Pine River approaching the PTH #20 bridge crossing.

Trout habitats in the Pine River are reach specific and limited, occurring where there are well-developed meander pools that are often coincident with up-welling groundwater on the channel bed (Newbury and Gaboury 2003). The restoration project was undertaken in 1990 in a straightened groundwater-fed reach at one of the highway crossings (Figure 6.1).

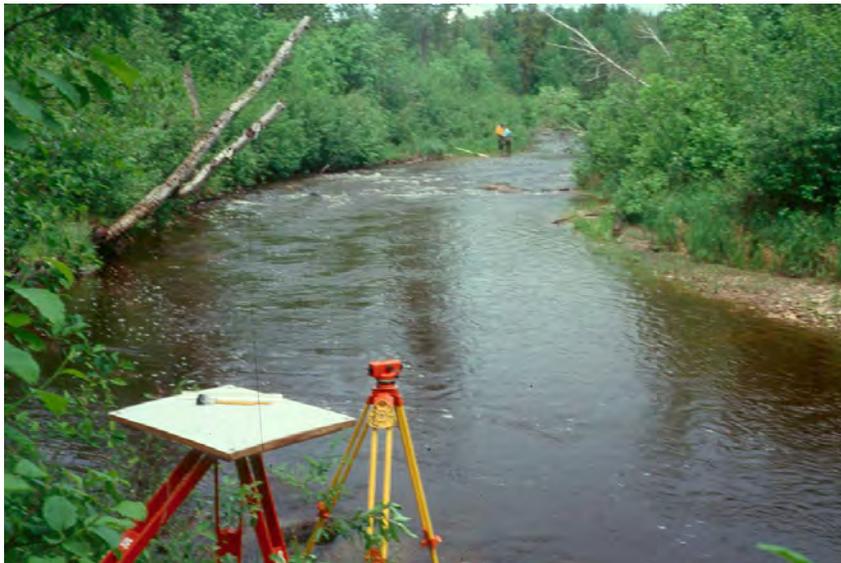
Figure 6.2: Channel surveys and habitat mapping in a typical adult trout habitat. The rate of translation down the valley bottom is slow enough to allow the riparian vegetation to correct its growth habit by curving upwards as the outer banks slump in the meander.

To determine the habitat dimensions and configuration, reference reaches with proven trout populations were surveyed on the Pine River and similar escarpment rivers (Figure 6.2). It was found that the habitats shared a common trait of being in a meander bend with an average spacing of $6w$ and radius of curvature of $2.3w$ where w is the trimline width.

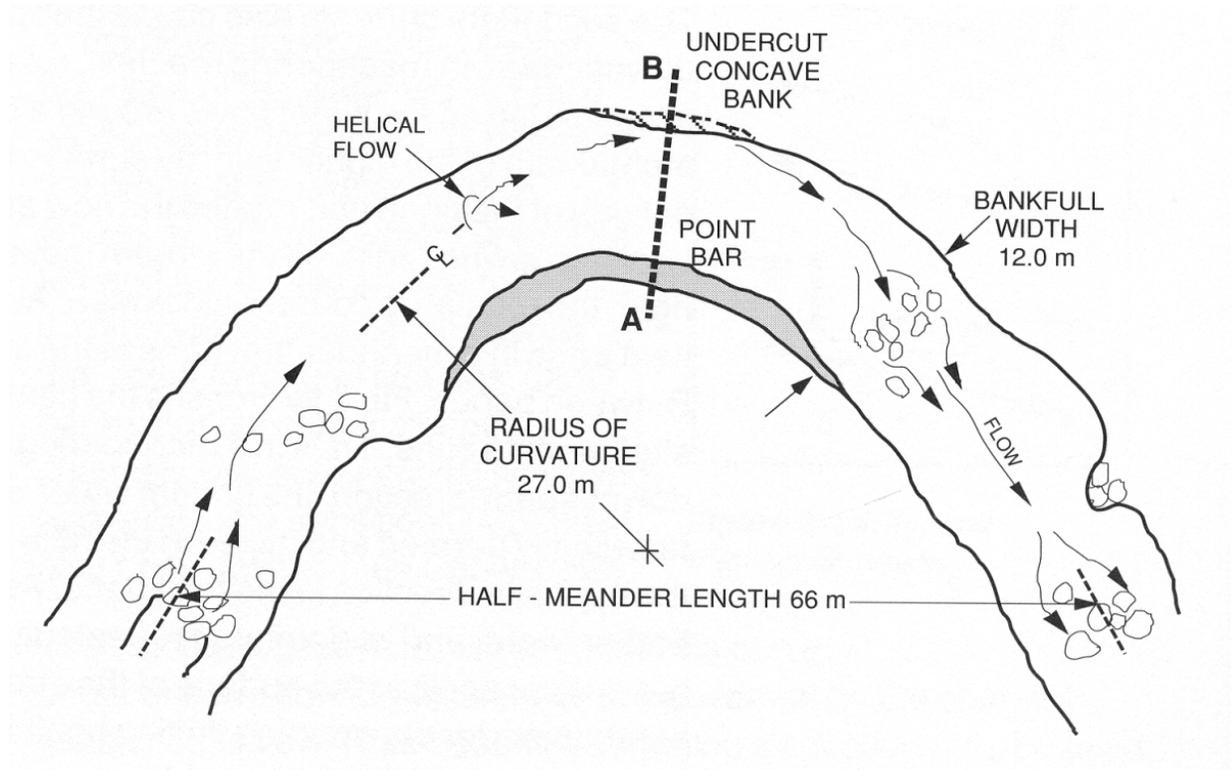
Figure 6.3: Plan view of the meander shown in Figure 6.2. Helical rotation causes up-welling at A and down-welling at B in the same cross-section.

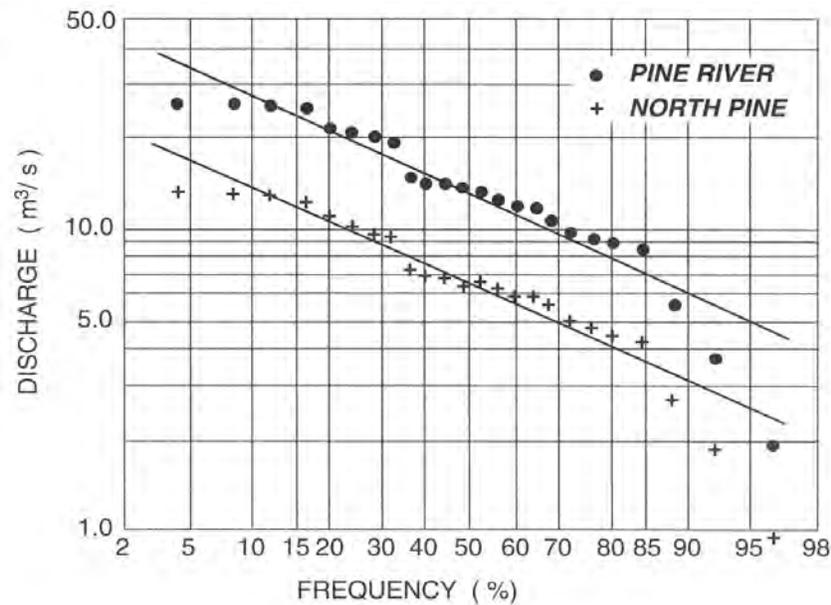
Figure 6.4: Annual flood frequency curve adjusted for the tributary area of the North Pine River restoration reach (based on WSC station 05G001, Pine River).

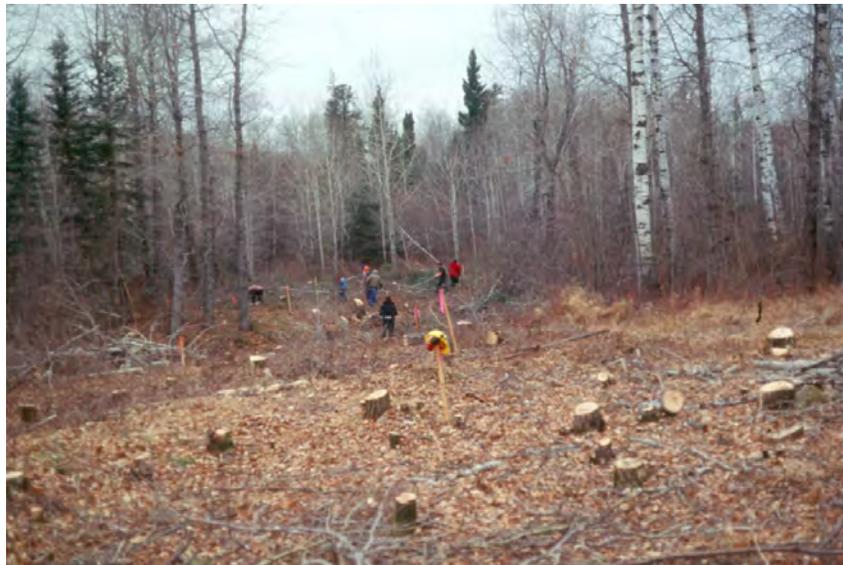
Figure 6.5: Clearing and staking the centreline of the new meandering channel on the adjacent floodplain.

3. Channel Design and Construction: A meandering channel was designed to replace the straightened reach using the average meander characteristics observed in the trout habitat reference reaches. The cleared path on the floodplain, plan, profile and the new channel being excavated are shown in Figures 6.5, 6.6 and 6.7.

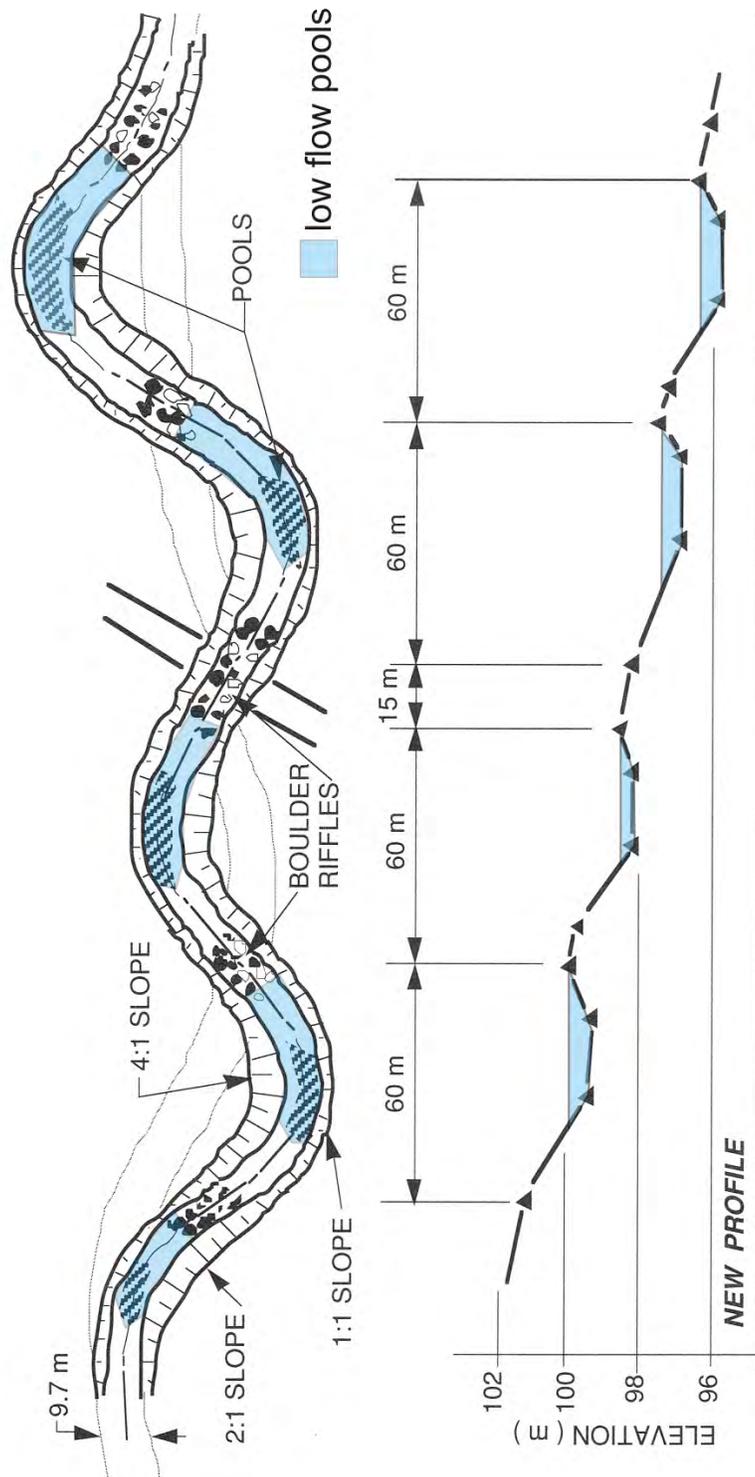
Figure 6.6: Plan and profile for the North Pine River restoration reach. Low flow pools extend to the midpoint of the meanders.

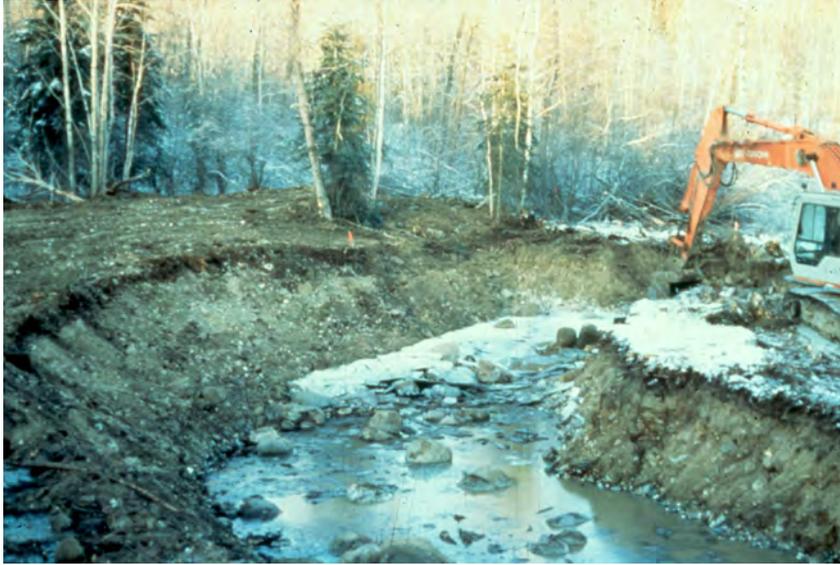
Figure 6.7: Initial excavation of a North Pine River meander. Boulders and cobbles found in the till were collected in riffles as the cross-sections were finished and graded.

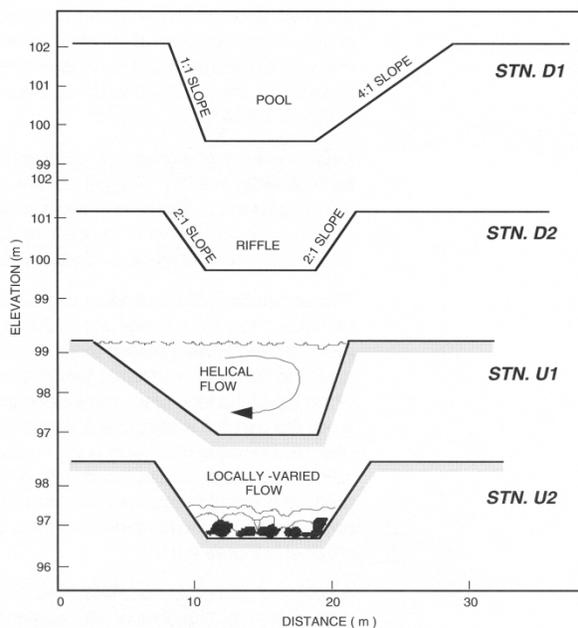
Figure 6.8: Cross-sections excavated in the meander restoration reach. D1 and U1 are in meanders. D2 and U2 are in riffles.

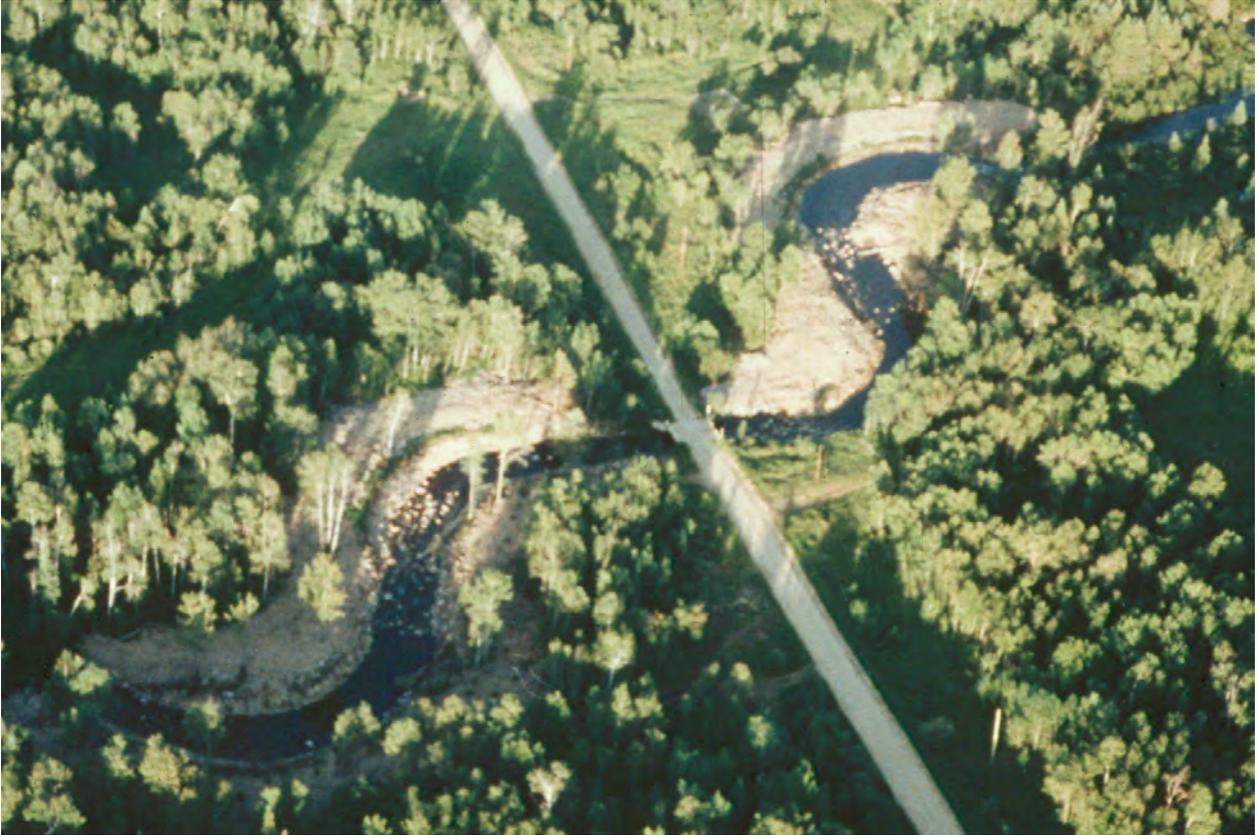
Figure 6.9: The restored North Pine River trout habitat restoration reach as constructed in 1990.

In the restored reach, the meander length of 120 m was 12.4 times the bankfull width of 9.7 m. The meander amplitude was governed by cut-banks and terraces located on either side of the floodplain. The radius of curvature of the meanders was 2.3 times the bankfull width or 22 m. This was reduced to 18 m to align the channel squarely with the bridge abutments. The channel cross-sections were uniform in the riffles and skewed in the meanders to approximate point bars and steep outer banks (Figure 6.8). The completed project is shown in Figures 6.9 and 6.10 (20 years later).

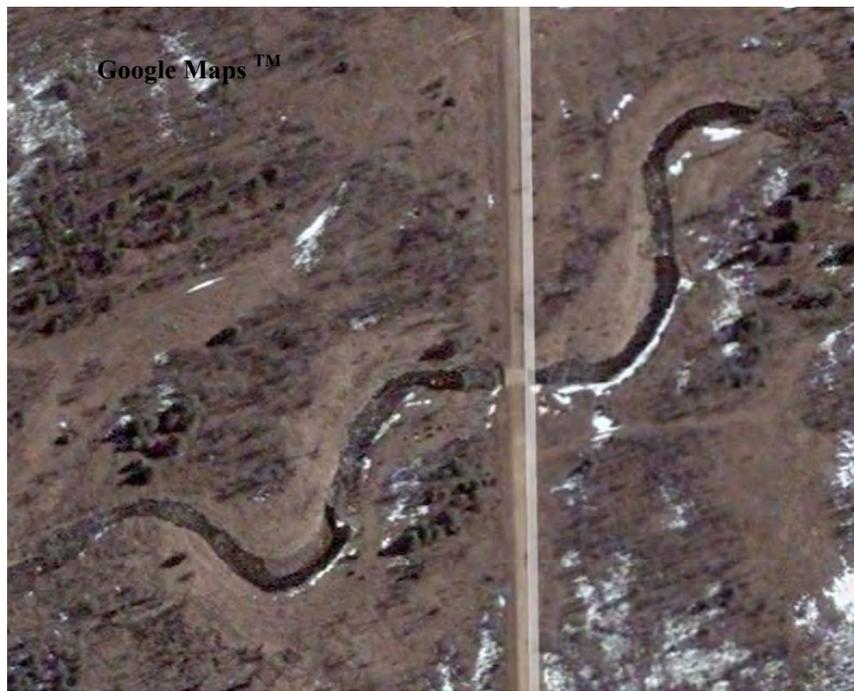
Figure 6.10: The North Pine River restoration reach 20 years later in 2010 (Google Maps™).

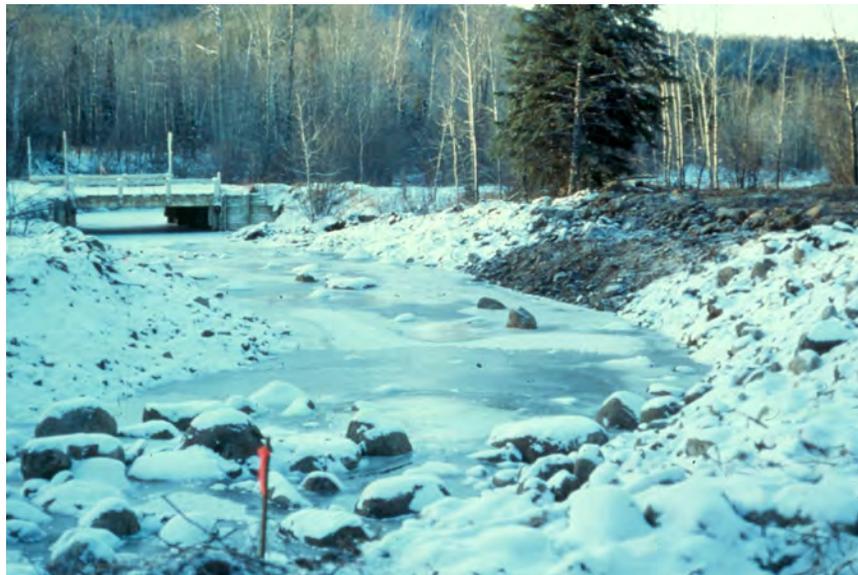
Figure 6.12: North Pine River completed meander midwinter 1990.

The minimum boulder sizes selected for the riffle crest were based on a 15:1 riffle downslope. Assuming the bankfull flow would achieve this slope as it passes the crest, the tractive force is 24.7 kg/m^2 , equivalent to a riprap size of 24.7 cm diameter. Many of the lag deposit boulders put aside for riffle construction were larger (Figure 6.12).

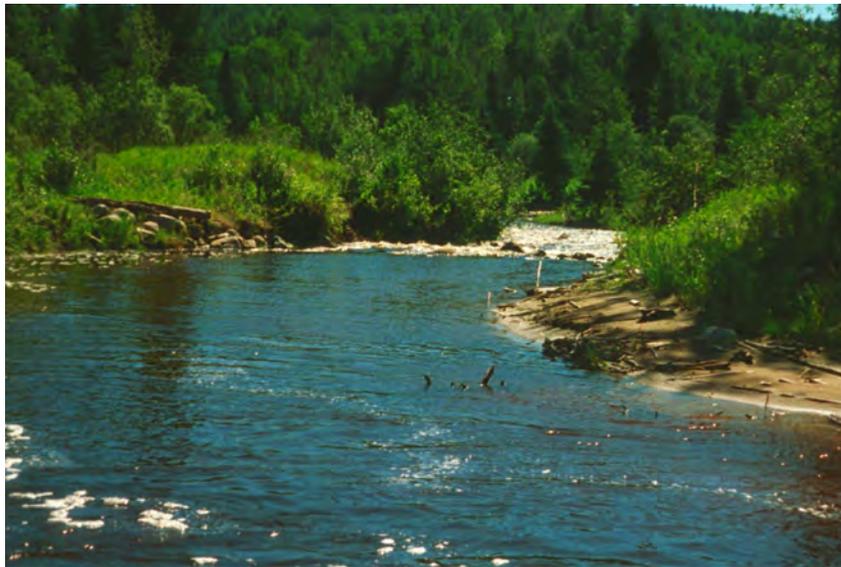
Figure 6.13: North Pine River restoration reach following a 1:40 year flood peak in 1994.

4. Monitoring: Moderate floods in the first year following construction removed silts and fine sands from the riffles and an outside thalweg was formed in the meander bends. In 1994, a 1:40 year flood peak occurred that scoured the pools and riffles and began undercutting the outside of the meander bends (Figure 6.13). The peak flow accessed the floodplain without damage. The crest elevations of the riffles and channel alignment was not altered significantly although other non-aligned skewed bridge crossings on the highway were washed out or damaged by the flood event.

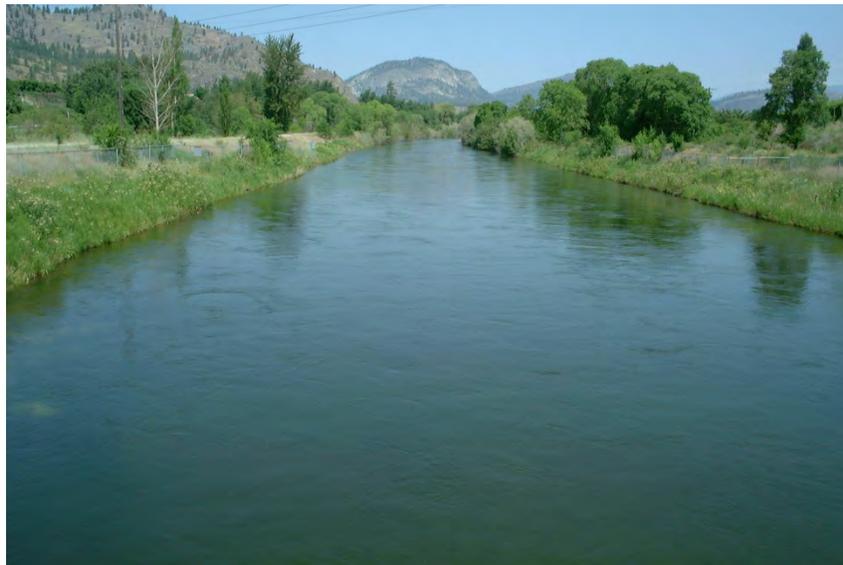
Figure 6.14: The channelized project reach of the Okanagan River in 2006 before restoration. The reach runs from Vertical Drop Structure 13 (VDS 13) to the unaltered natural spawning reach 1 km upstream.

1. Background: The Okanagan River (Okanagan in the USA) is a northern tributary of the Columbia River. Over 90% of the river in Canada was straightened and dyked in the mid 1950's (Figure 6.14) to provide irrigation water and access to the rich floodplains in the bottom of the Okanagan valley. Approximately half of the remaining Columbia River sockeye salmon return to the river to spawn after migrating 1200 km and being transported over nine power dams (Long 2004). A 6 km long natural reach at the head of the channelized section near Oliver BC provides 95% of the spawning habitat. The reach is classified as “unimproved” in the 1950's plans.

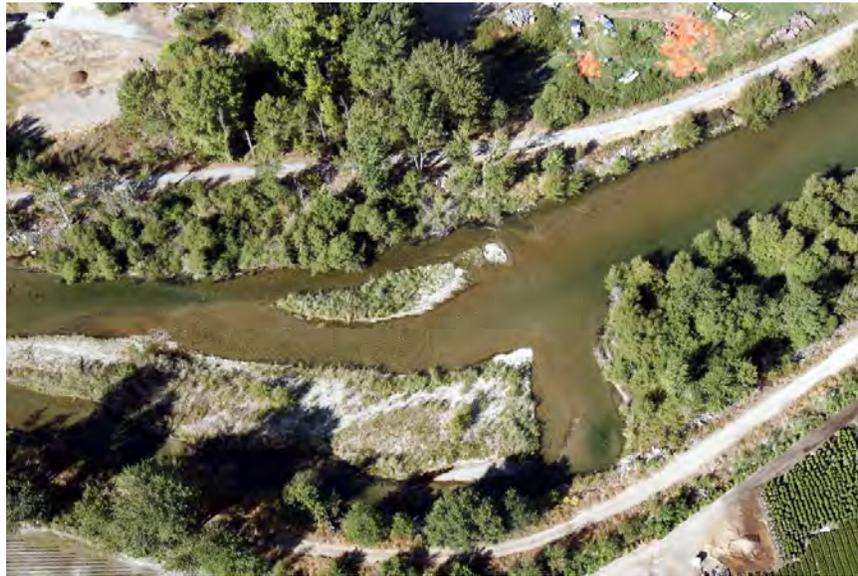
Figure 6.15: A dual channel segment in the natural reach of the Okanagan River 1 km upstream from the project reach. The entrance riffle to the side channel and the long gravel bar in the mainstem are heavily used by spawning sockeye salmon (Wild Earth Photography 2006).

2. Reference Channel Configuration: Two design options were evaluated; a single thread meandering channel and a dual channel with approximately a 50-50 split in discharge between the reconnected meanders and the existing channel. Both options are limited in gradient because of backflooding by VDS 13. The dual channel option was adopted because more pool and spawning areas similar to those observed in the natural reach could be constructed. A dual channel segment in anastomosing section of the natural reach was used as a template for the reconnections and spawning bar features (Figure 6.15, as constructed Figure 6.23).
