Stream Restoration Hydraulics

Part 2: Applications

Chapter 5: Projects Restoring Pool and Riffle Channels

Design Example 1: Pool and Riffle 0.3% Gradient Stepped Channel for Walleye Spawning and Fry Returns to Downstream Lakes (Mink Creek MB 1985).

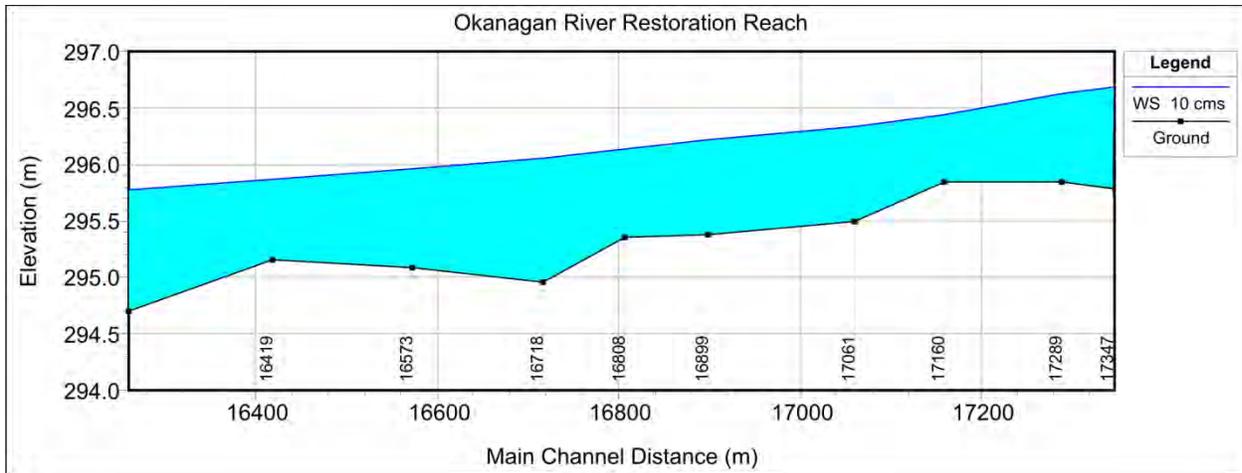
Figure 6.18: The uniform HEC-RAS profile of the pre-restoration channelized restoration reach.

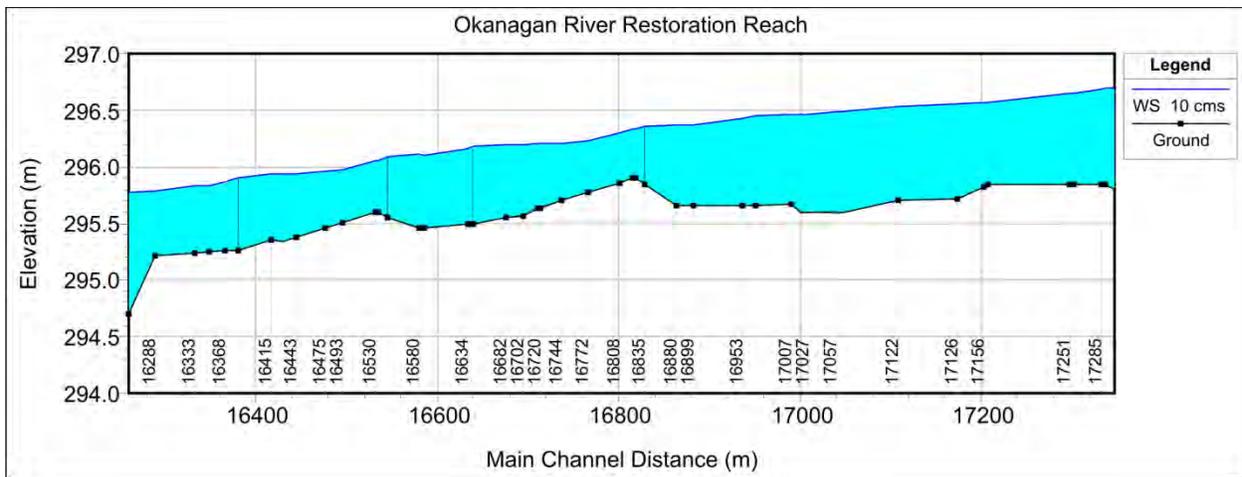
Figure 6.19: The restored HEC-RAS mainstem profile (Mould Engineering 2009).

The design challenge with such a small amount of energy to allocate was difficult. Many profile iterations were modeled before a combination of riffles and ramps were found that would divide the flow between the mainstem and re-connected meanders and not cause upstream flooding. The final HEC-RAS profile at a 10 m³/s flow is shown in Figure 6.19.

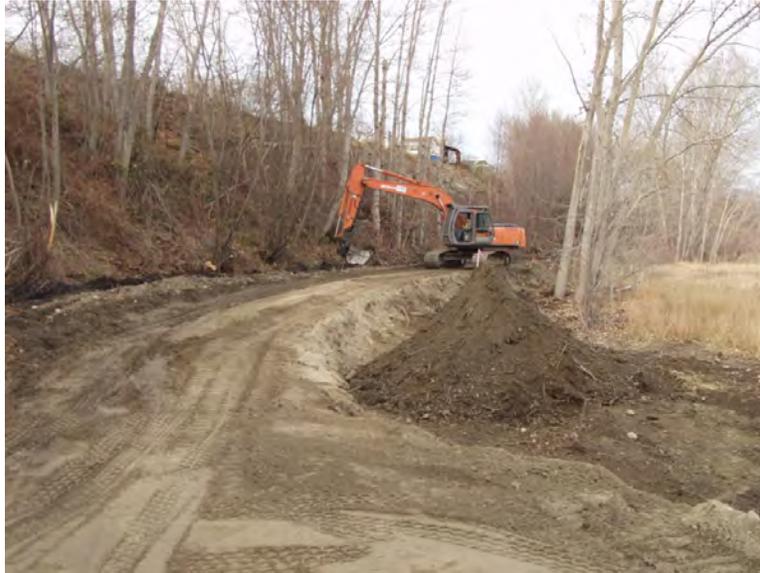
Figure 6.20. The setback dyke was constructed on the abandoned grade of the Kettle Valley Railway (V-Line Construction, Oliver BC).

4. Construction: Materials for the setback dykes were salvaged from the existing dykes and added to a pre-existing railway grade on the western side of the project area (Figure 6.20).

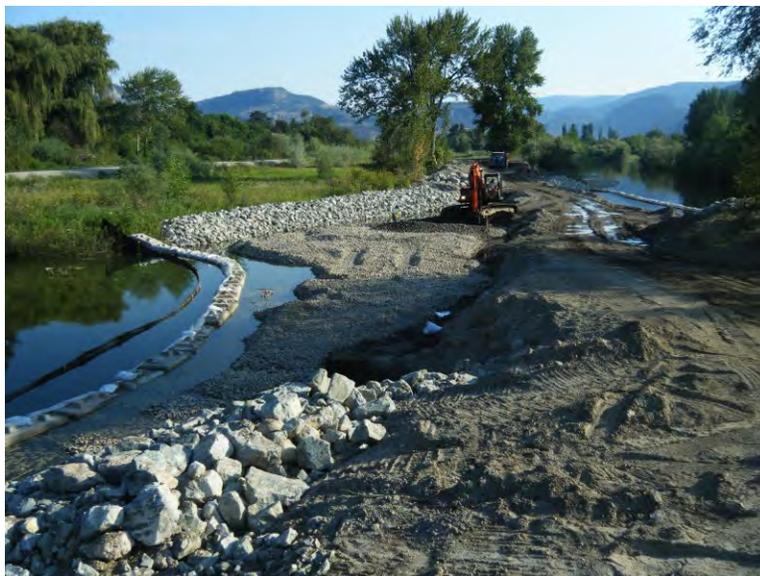
Figure 6.21: Excavation of the Lougheed meander entrance channel isolated by lock-block dams.

The channels connecting the meanders were isolated with lined lock-block dams during construction to limit the mainstem turbidity (Figures 6.21). Spawning gravels and large cover rocks were added to the connecting channels before the barriers were removed (Figure 6.22). The completed entrance channel is shown in Figure 6.23.

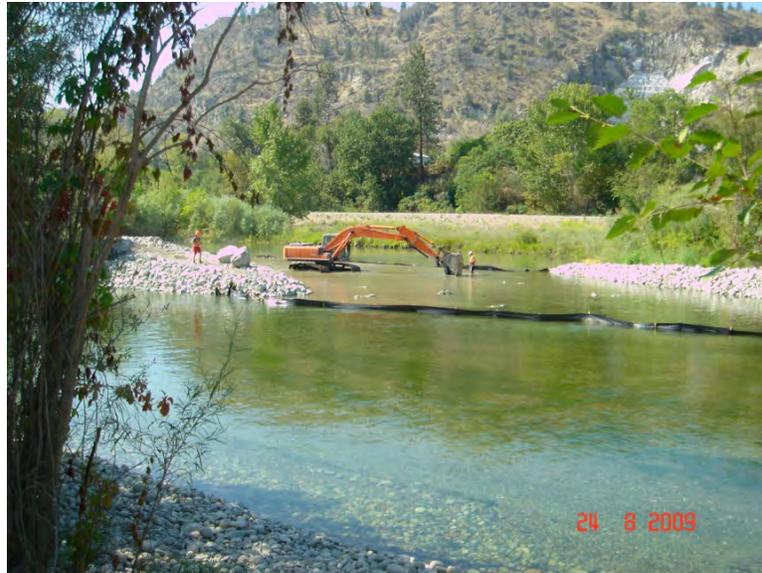
Figure 6.22: Placing cover rocks in the Nemes meander entrance channel before the lock block barriers are removed.

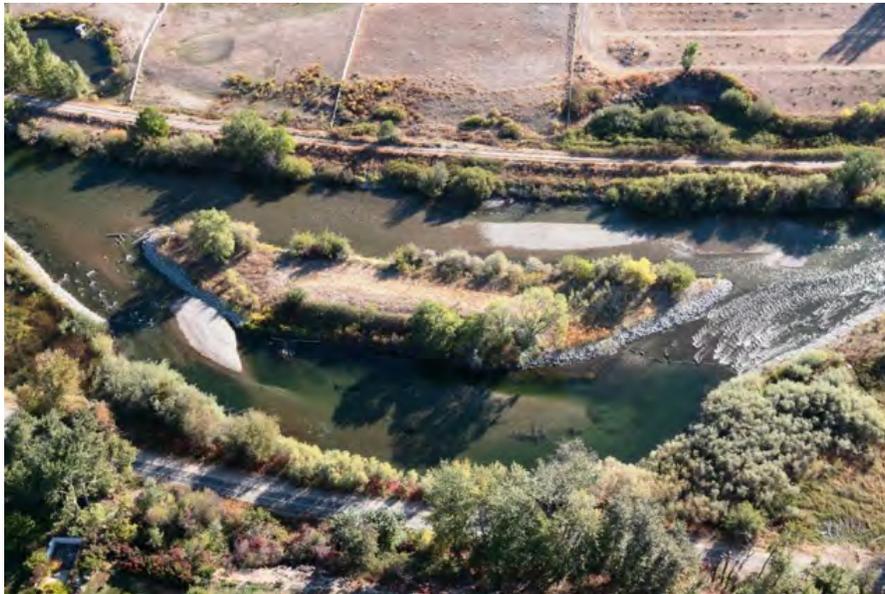
Figure 6.23: The completed Loughheed meander entrance and mainstem spawning platform 2 years after construction (2012). Peak flows exceeded the bankfull design stage in both years.

2. Reference Channel Configuration: Two design options were evaluated; a single thread meandering channel and a dual channel with approximately a 50-50 split in discharge between the reconnected meanders and the existing channel. Both options are limited in gradient because of backflooding by VDS 13. The dual channel option was adopted because more pool and spawning areas similar to those observed in the natural reach could be constructed. A dual channel segment in anastomosing section of the natural reach was used as a template for the reconnections and spawning bar features (Figure 6.15, as constructed Figure 6.23).

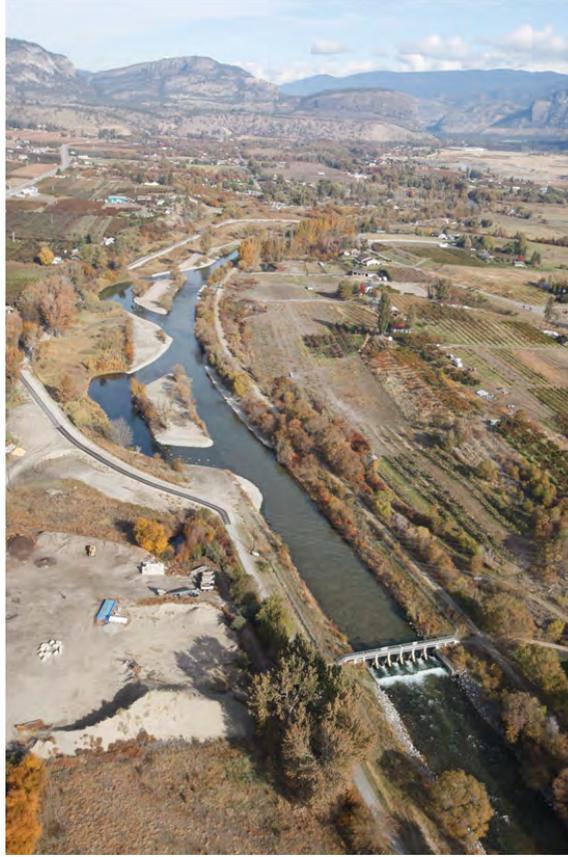
Figure 6.24: Phase I of the Okanagan River restoration project completed in 2009 (photo Kevin Dunn).

An aerial view of the completed Phase I segment of the project is shown in Figure 6.24. Sockeye salmon have utilized the mainstem spawning bar annually (Long and Rivard-Sirois 2010) (Figure 6.25).

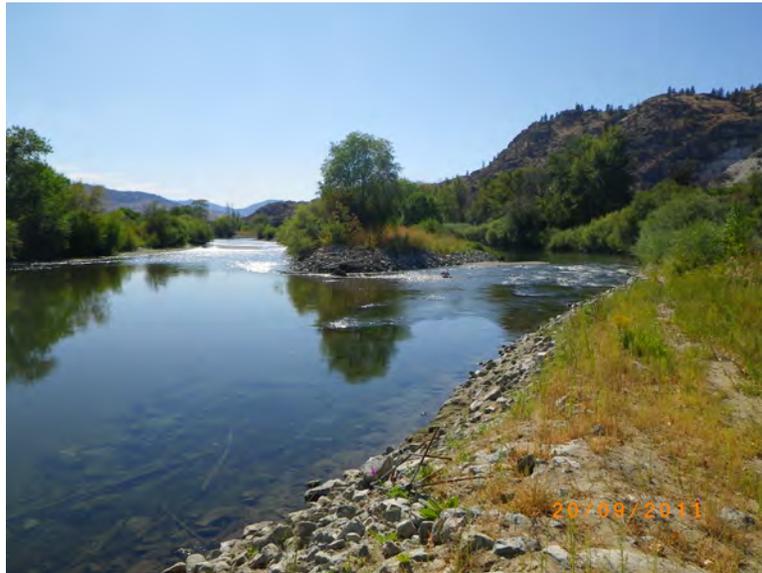
Figure 6.25: Spawning ramp in the mainstem and riffle elevation control entering the abandoned Lougheed meander on the right (October 2011).

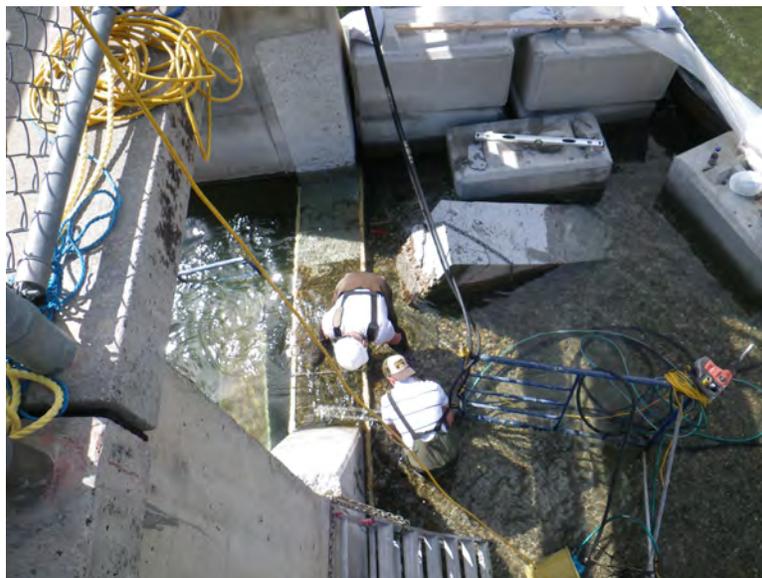
Figure 6.26: The v-shaped middle bays of drop structure 13 were widened to a rectangular shape to increase the hydraulic gradient in the lower end of the restoration reach (Mould Engineering 2013).

In 2013 portions of the downstream control structure crest (VDS 13) were removed to increase the gradient in the lower portion of the restored reach (Figure 6.26).

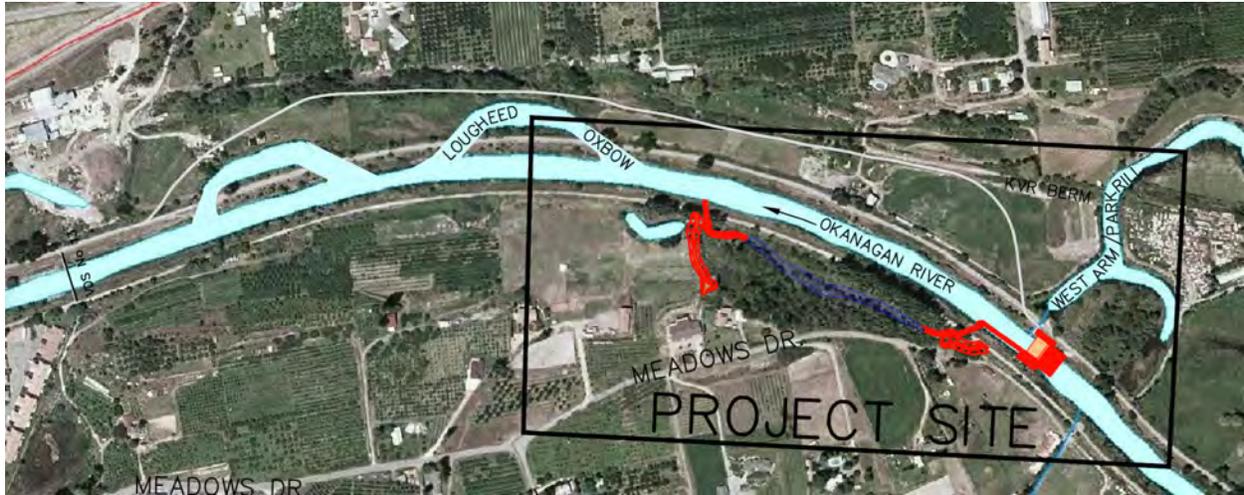
Figure 6.27: Plan showing the riffle weir, side channel entrance and return (red) to an abandoned section of the natural channel on the east side of the upper half of the Okanagan River restoration reach (Mould Engineering 2012).

PHASE II: In 2013 a riffle weir and off-take channel were constructed in the mainstem at the upper end of the restoration reach (Figure 6.27). The backwater elevation allowed low discharges to flow eastwards into an abandoned portion of the original channel (Figures 6.28 and 6.29).

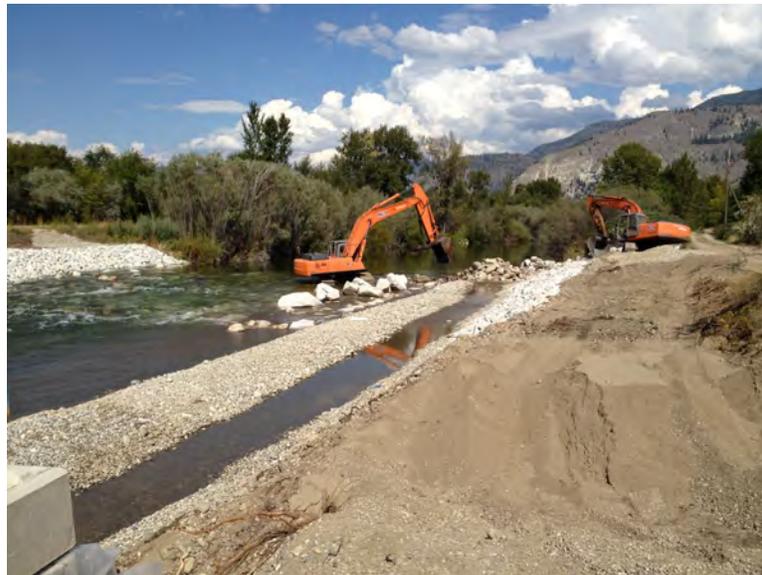
Figure 6.28: Construction of a mainstem riffle weir and side channel off-take to an abandoned segment of the natural channel on the east side of the restoration reach.

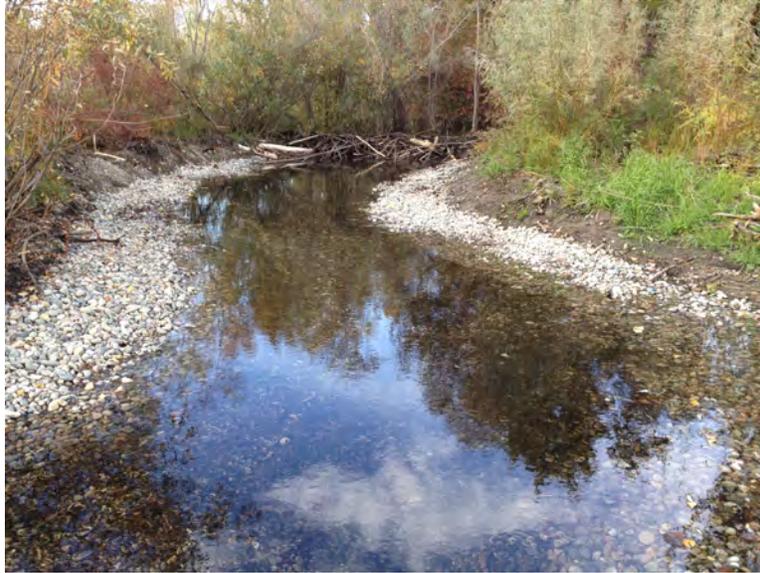
Figure 6.29: To provide pools and shading existing trees and beaver dams were not disturbed between the entrance and exit segments of the side channel.

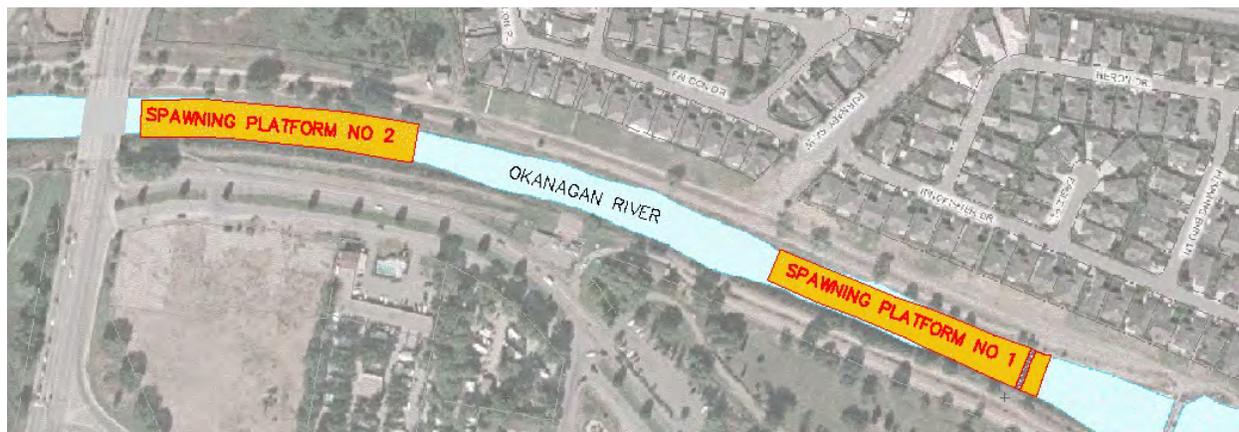
Figure 6.30: Spawning ramps (platforms) added to the channelized Okanagan River below the Okanagan Lake control dam in the city of Penticton BC. A third ramp below the highway bridge was added in 2015.

Okanagan River Spawning Platforms I Penticton BC (2014): Based on the successful use of the spawning ramps added to the mainstem in ORRI Phase I three additional ramps were added to the channelized river below the Okanagan Lake control dam in Penticton BC (Figure 6:30).

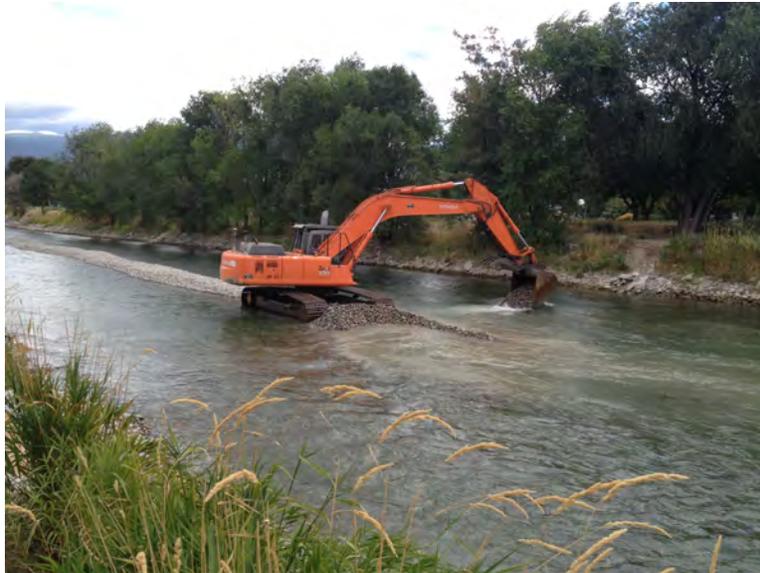
Figure 6.31: A central berm of spawning gravels was distributed to both sides of the channel to create the spawning platform.

Washed gravel up to 75 mm in diameter was added to the existing channel bottom (Figure 6:31)
The platform 1 profile is shown in Figure 6:32.

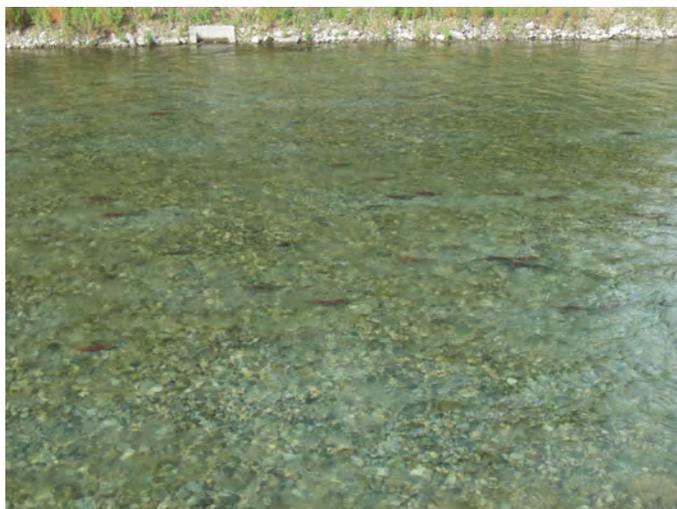
Figure 6.33: Spawning sockeye on platform 1, October 2014.

Froude numbers during the spawning period at river flows up to 12 cum/s ranged from 0.15 to 0.24. The spawning ramps were fully utilized in October 2014 and 2015 (Figure 6.33).

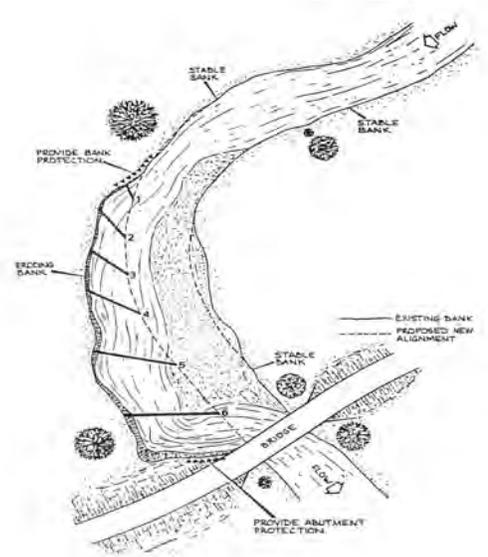
Figure 4.4⁵ Example of Final Retard Layout

Flow retarding bars similar to those proposed for navigation channels (Leliavsky 1955) have been adapted to stop bank erosion and re-align the thalweg of a river where meander progression has shifted the main flow away from fixed structures (Victoria Water 1991). Retarding bar projects on the Miramichi River NB: a bank cave-in caused by gravel extraction on the floodplain and a channel infill by sediments from an eroding riparian zone are detailed. Similar salmon pool restoration projects are summarized as well.

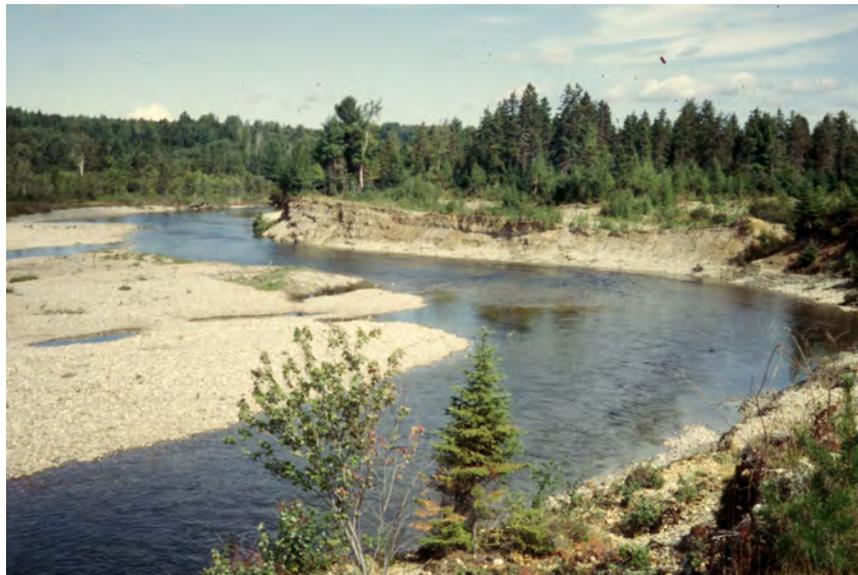
Figure 6.34: The "cave-in" reach of the Little SW Miramichi River prior to realignment.

1. Bank Cave-In, Little SW Miramichi River NB (2000): Bank failure and a channel shift occurred on the Little SW Miramichi River near Lyttleton, NB, locally called the "cave-in" site. Gravel pits near the edge of the entrenched channel filled with runoff and saturated the steep silty-clay banks leading to their collapse. The channel rapidly eroded the collapsed banks forming an almost right angle pocket in the floodplain (Figure 6.34).

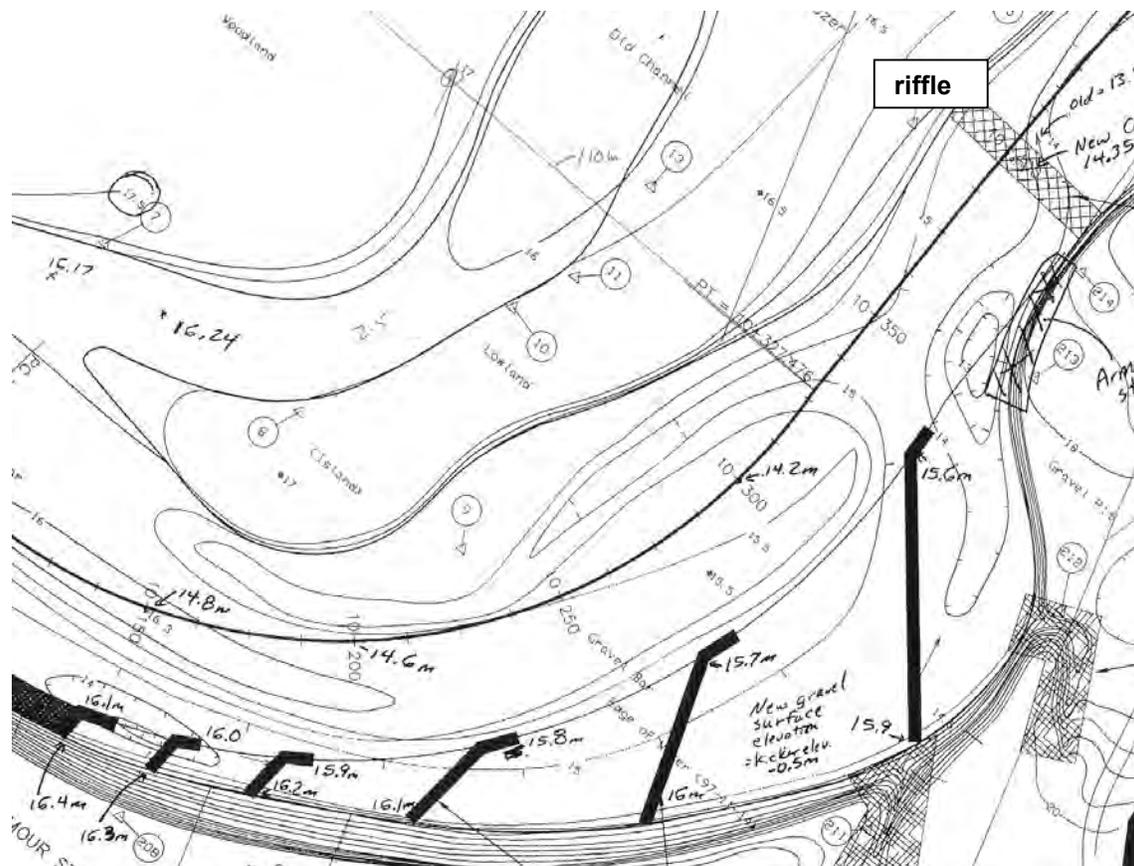
Figure 6.35: Flow retarding bars extend from the eroded bank to re-establish the original alignment of the channel, Little SW Miramichi River NB (R. Jenkins).

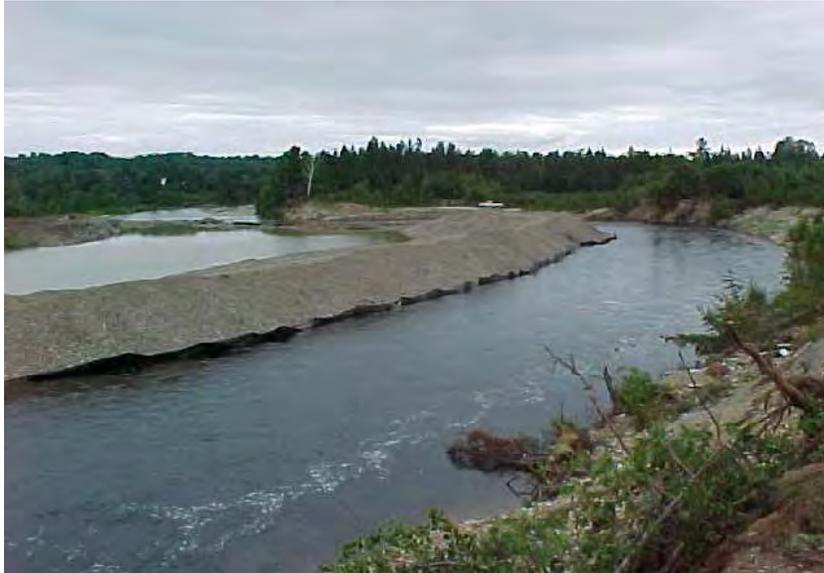
Figure 6.36: A mid-channel berm was formed with the materials excavated from the original channel alignment (photo R. Jenkins).

The re-aligned channel was constructed in stages. The original channel alignment was excavated by stockpiling the point bar materials in a mid-channel berm (Figure 6.36), isolating and seining the old channel segment to capture any stranded fish (Figure 6.37) and then infilling the channel to form the floodplain and install the rock retarding bars (Figure 6.38).

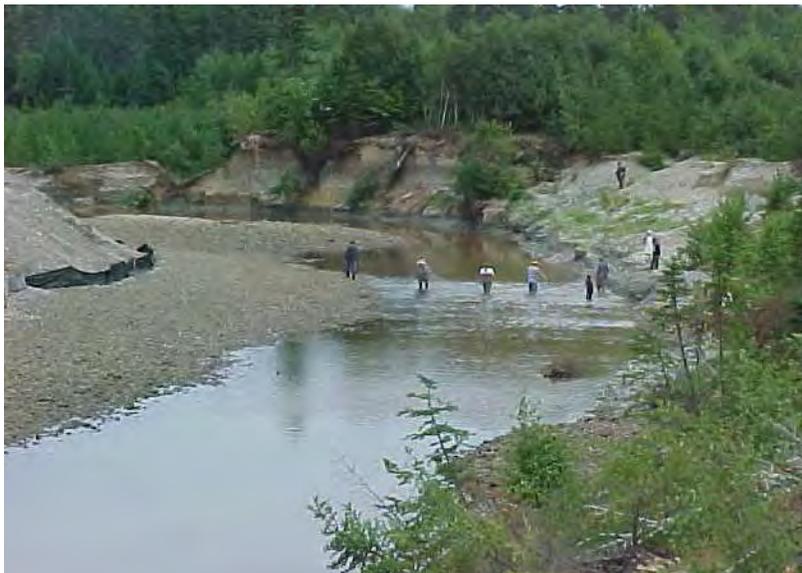
Figure 6.37: The old channel was sieved to remove trapped fish before it was infilled with the berm materials (photo R. Jenkins)

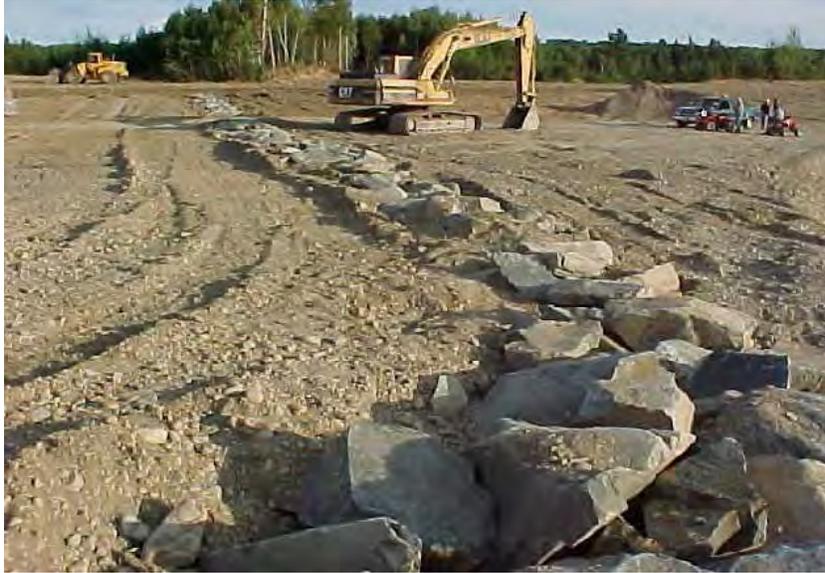
Figure 6.38: Rock retaining bars with end deflectors parallel to the flow were added to the in-filled floodplain (photo R. Jenkins).

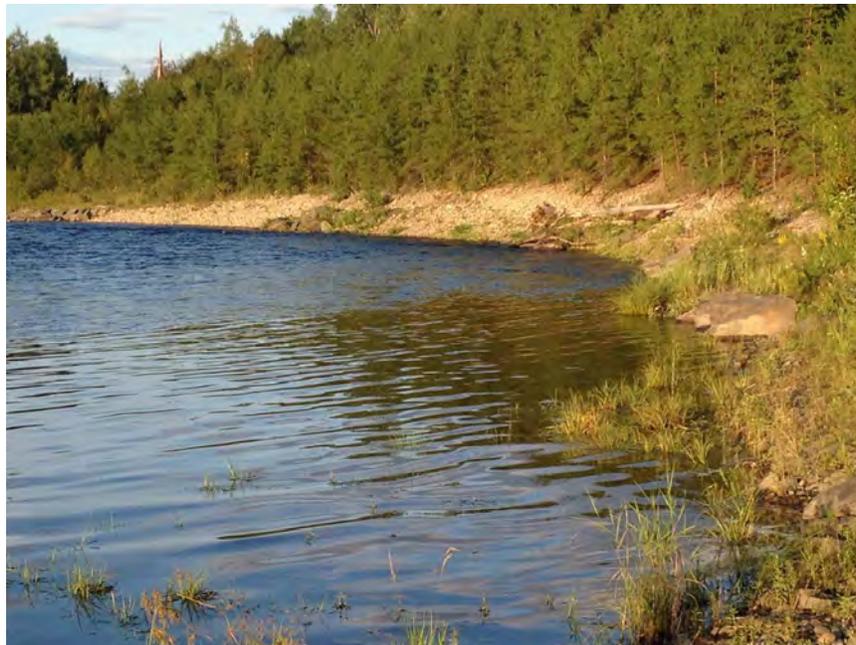
Following construction annual floods and ice movement shaped the channel into a smoothly curving parabolic meander cross-section. (Figure 6:39)

Figure 6.39 (2014): Fourteen years later only the tips of retaining bars are exposed on the edge of the infilled and re-forested floodplain.

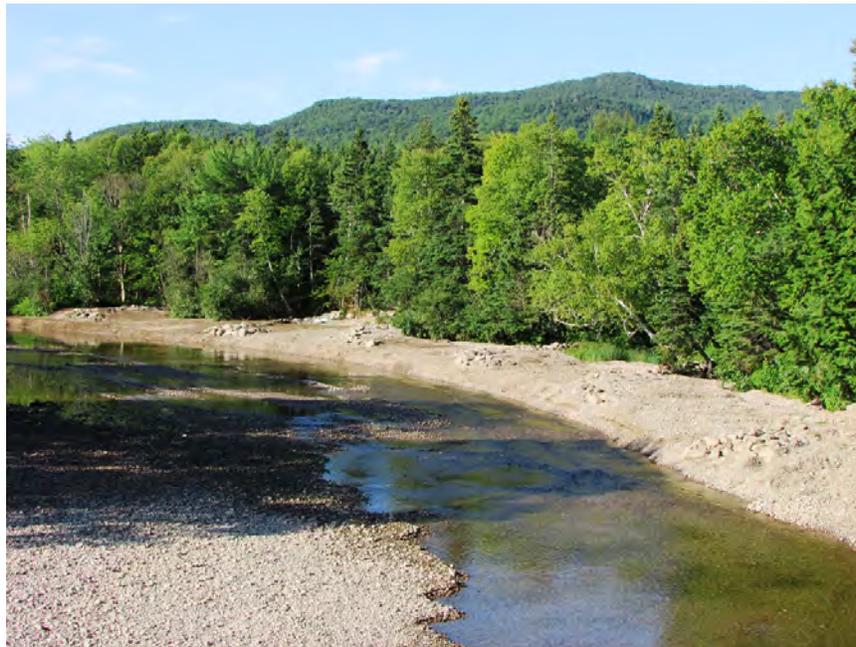
Figure 6.41: Clyburn River retarding bars under construction (2013). The elevation of the bars is set below the bankfull channel stage.

The heights of retarding bars is set below the median annual floodplain stage to avoid ice jams and excessive erosion from overtopping flows. For example, low reading bars were added to the Clyburn River NS to restore the channel alignment with the Cabot Trail highway bridge similar to the Australian plan (Figures 6.40 to 6.43).

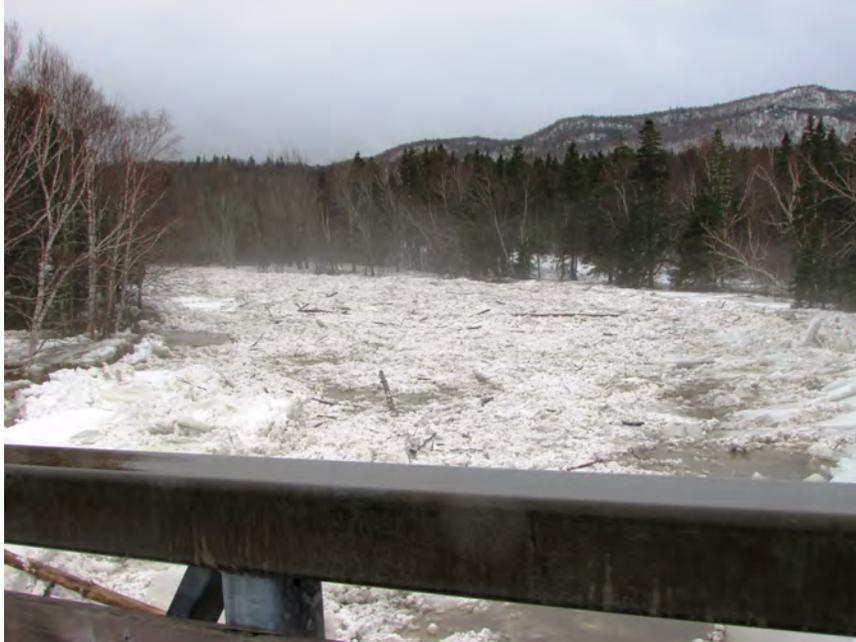
Figure 6.42: Ice jam and flood in the Clyburn River retarding bar reach, January 2014 (A. Buchanan).

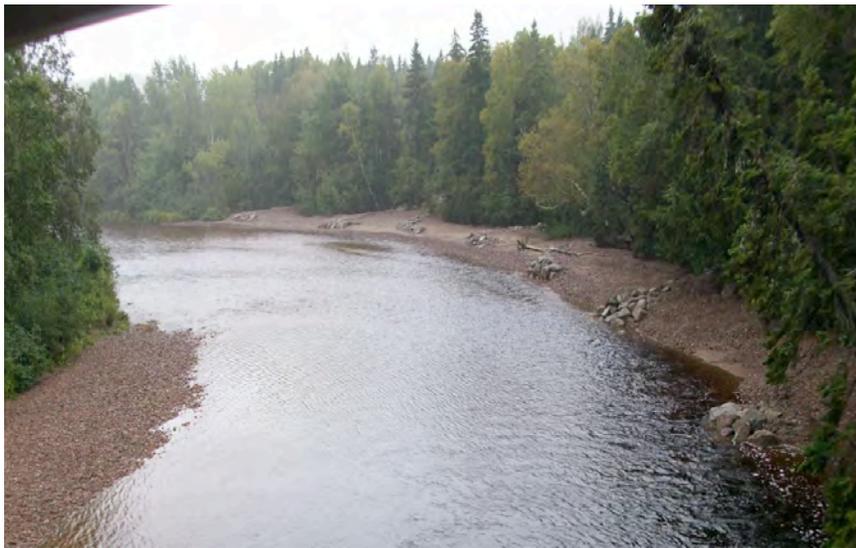
Figure 6.43: Clyburn River retarding bar reach after initial floods and ice jams have re-aligned the channel.

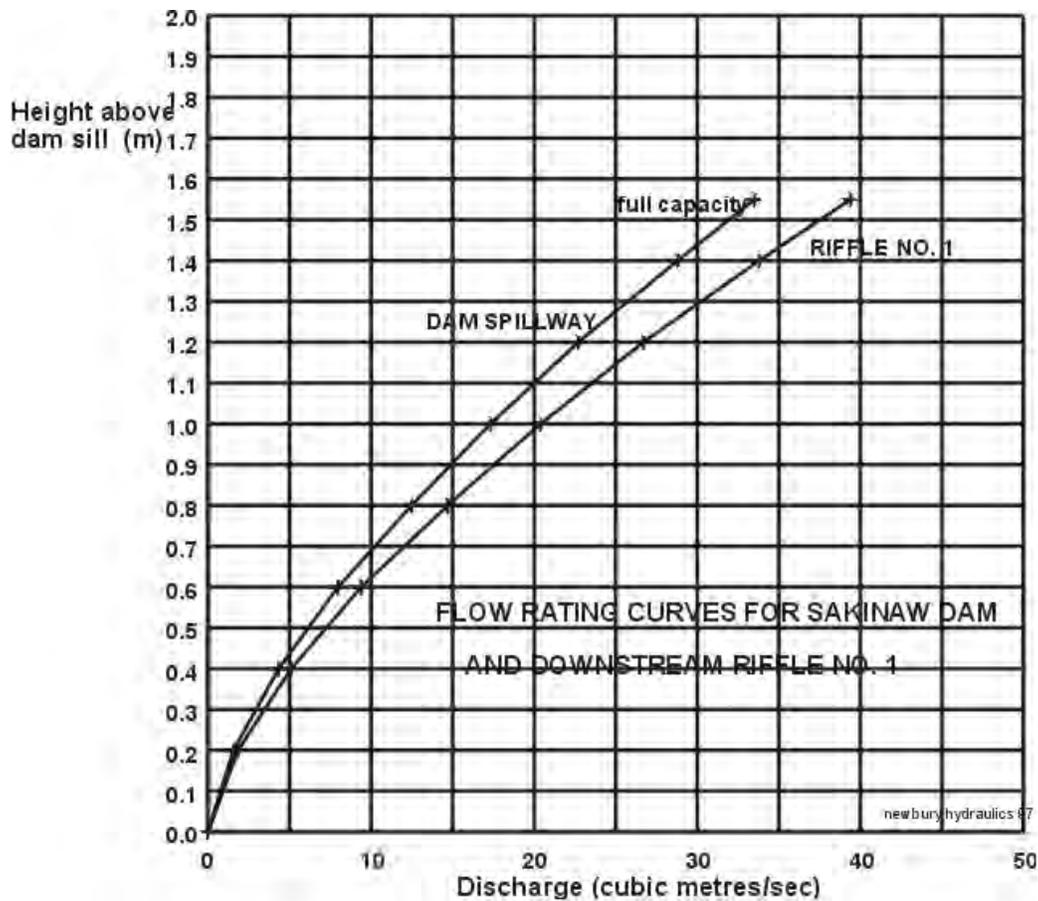
Figure 7.3: Rating curves for the Sakinaw Lake dam and the first riffle downstream.

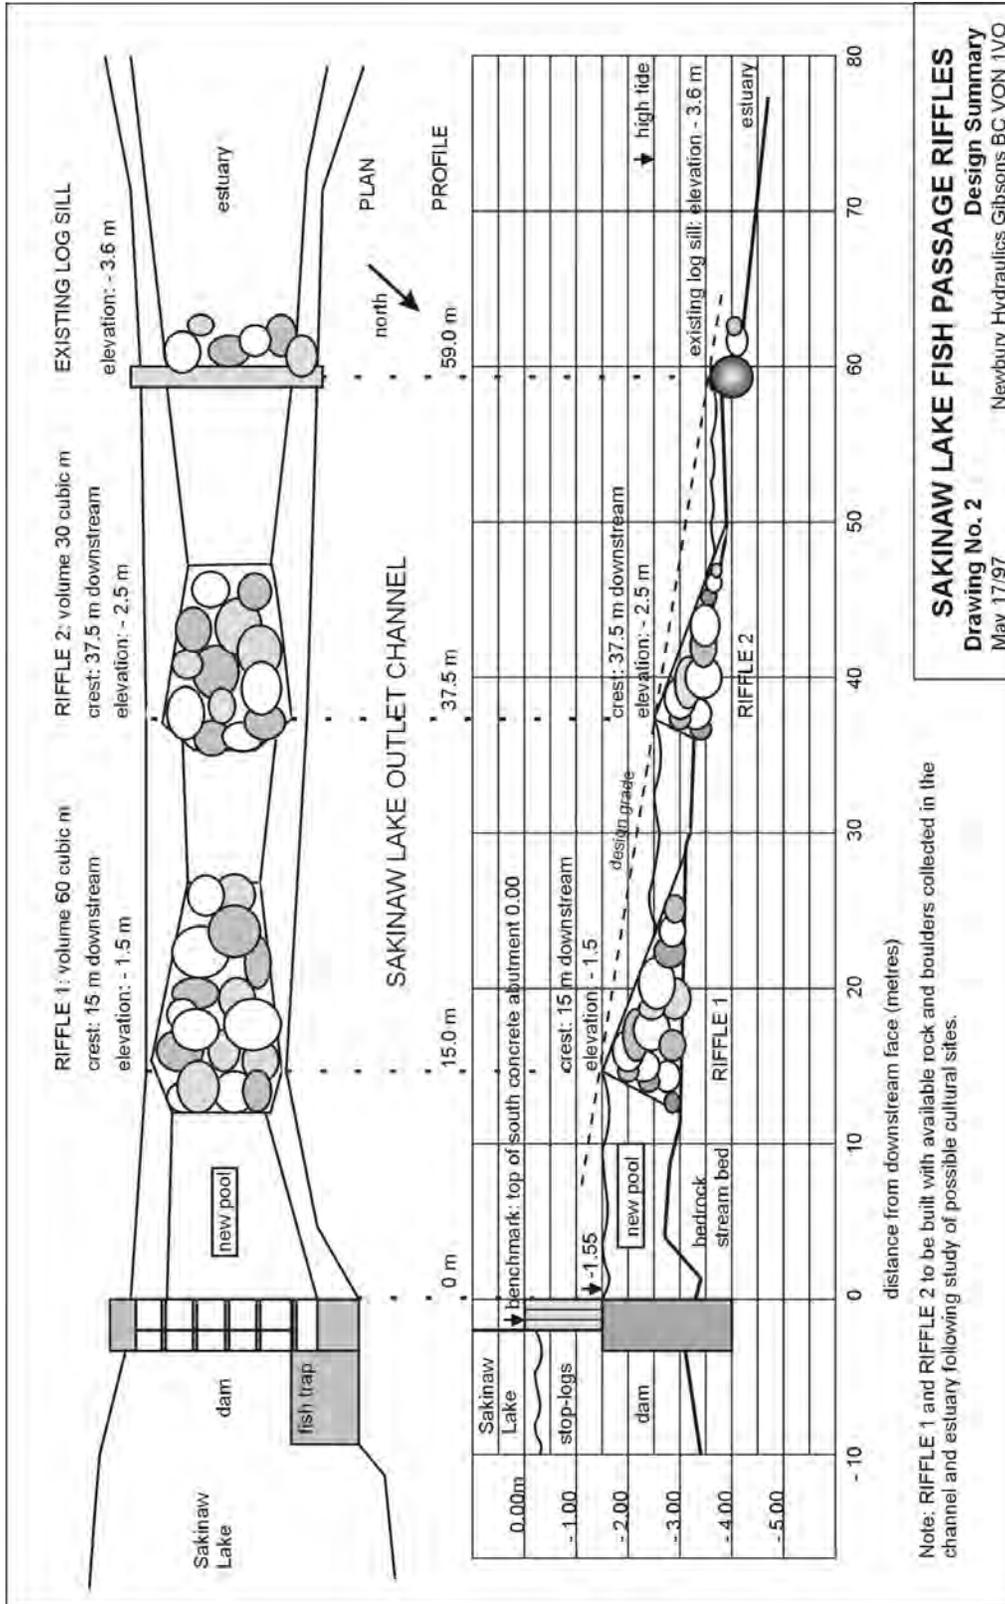
Figure 7.4: Plan and profile of the Sakinaw pool and riffle fish passage works.

3. Design and Construction: In 1997 two riffles were used to step the channel from high tide level to the launching pool (Figure 7.4). They were constructed with boulders, cobbles and gravel gathered from the channel and floodplains (Figures 7.5). The riffles were set to pass the maximum spillway capacity using the full width of the channel and floodplains. The minimum launching pool depth backflooded against the dam is 1.2 m under low flow conditions (Figure 7.6). Under flood conditions, there is no backwater effect on the dam spillway (Figure 7.7).

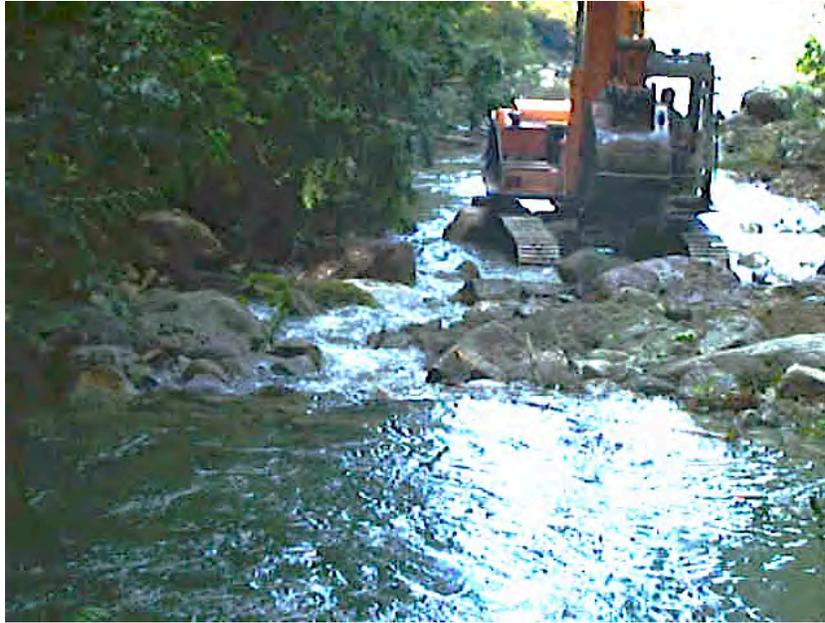
Figure 7.5: Riffle and pool construction below the Sakinaw Lake dam, 1997.

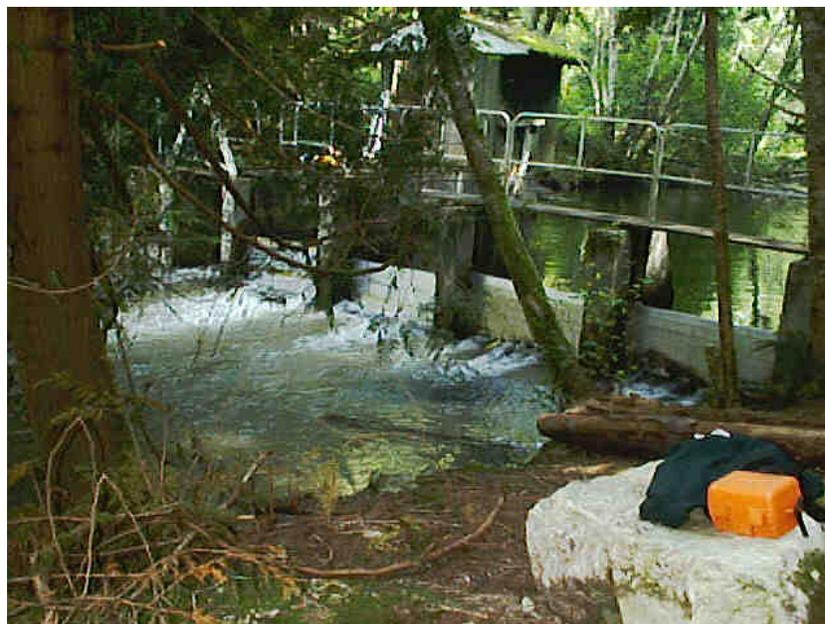
Figure 7.6: The pool formed below the dam spillway was 1.2 m deep under low flow conditions with the stop logs in place.

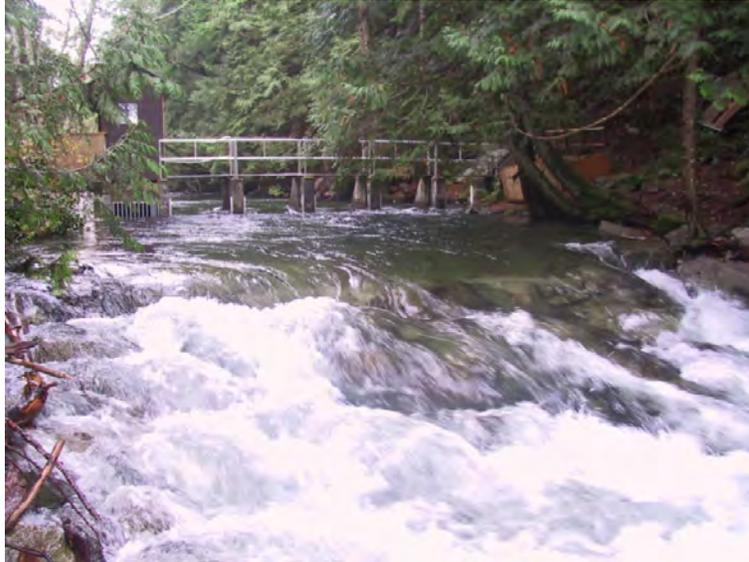
Figure 7.7: The pool below the dam is lower than the lake level controlled by the spillway at full capacity (stop logs removed).

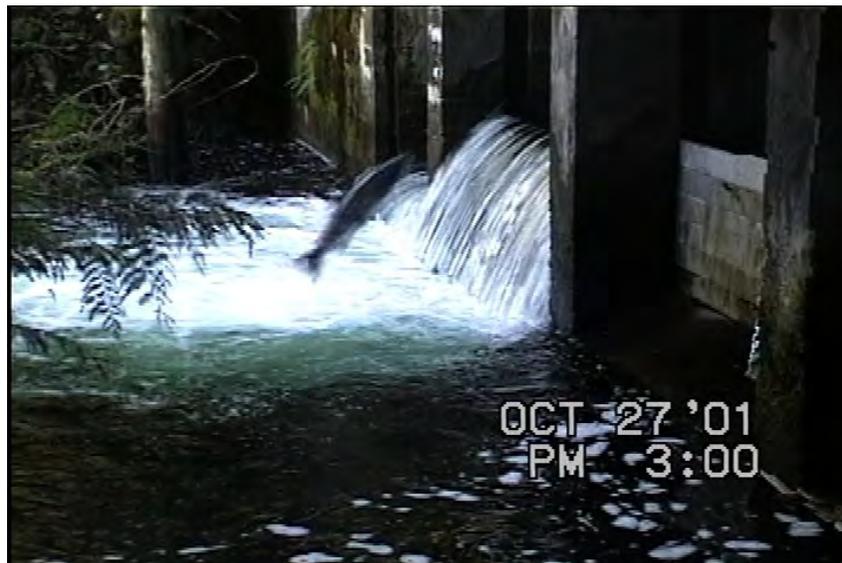
Figure 7.8: A Coho salmon launching from pool backflooded against the Sakinaw dam spillway.

4. Monitoring: Sockeye and Coho salmon have been observed spawning on both of the constructed riffles and in Sakinaw Lake after 1997. In 2001, the spillway stop logs were not removed to preserve the lake level as it was an extremely dry year. The salmon jumped the maximum height of the spillway from the downstream pool (video frames Figures 7.8 and 7.9).

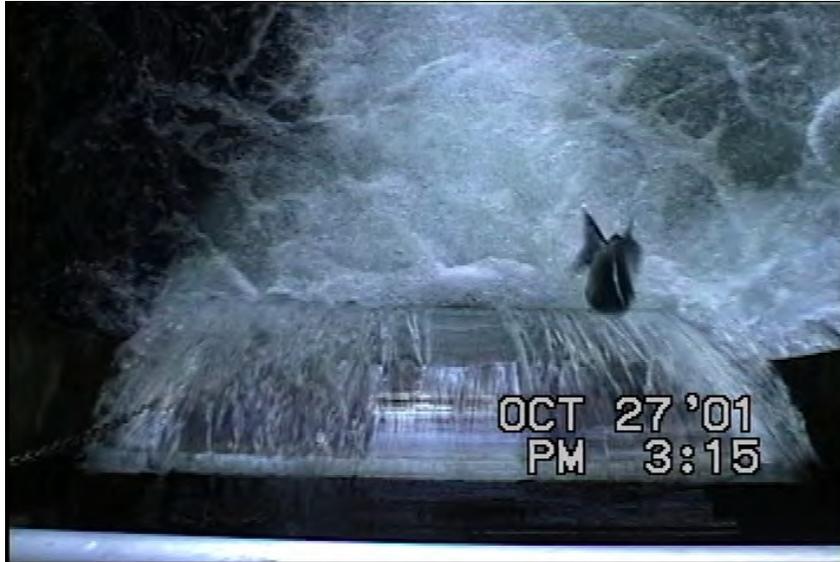
Figure 7.9: Almost vertical jumps are accomplished from the less turbulent margins of the launching pool below the Sakinaw dam.

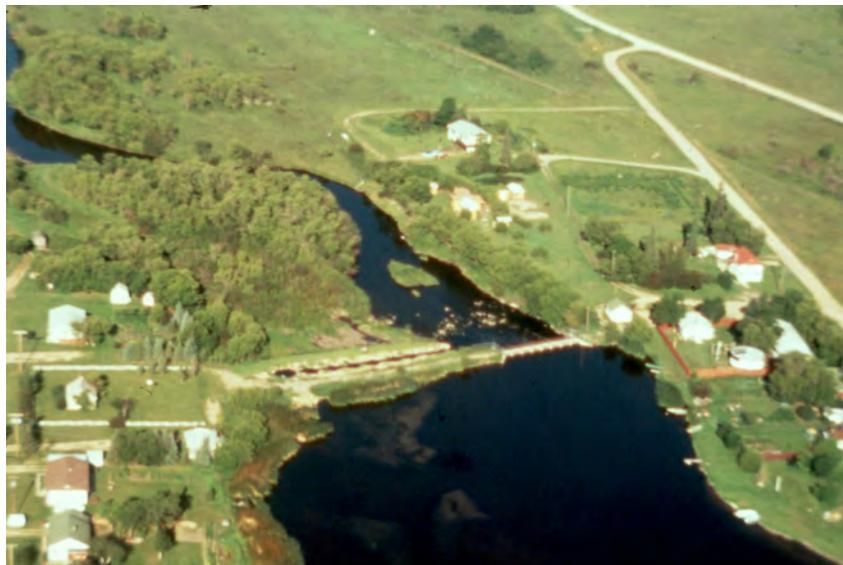
Figure 7.12: Aerial view of the reservoir and pool and riffle fishway on the earth fill portion of the Rapid City dam (left bank).

2. Side Channel Design and Construction: A pool and riffle side channel was constructed in 1992 from the crest of the dam down the lower face of the earth fill portion to the tailrace. The channel was designed to carry a maximum flow of $0.4 \text{ m}^3/\text{s}$ (Figures 7.12 and 7.13).

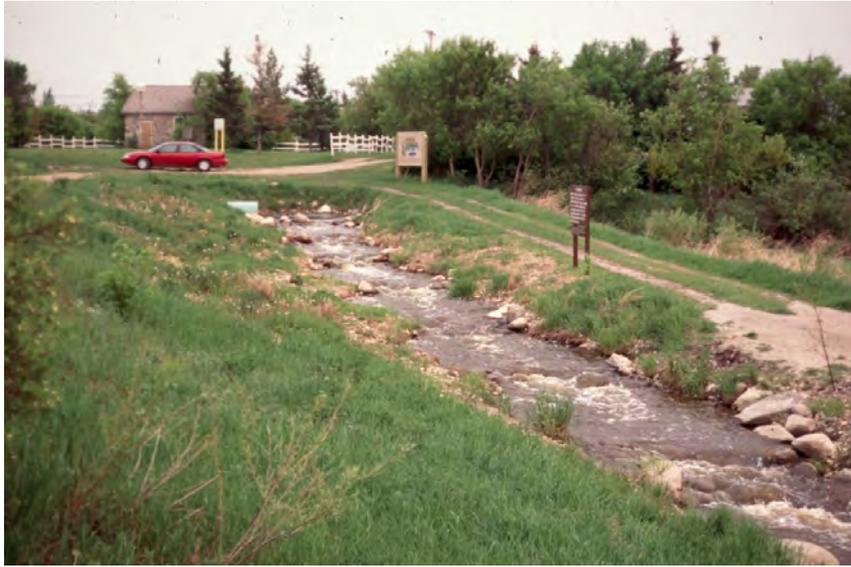
Figure 7.13: The Rapid City pool and riffle fishway channel two years after construction (1994).

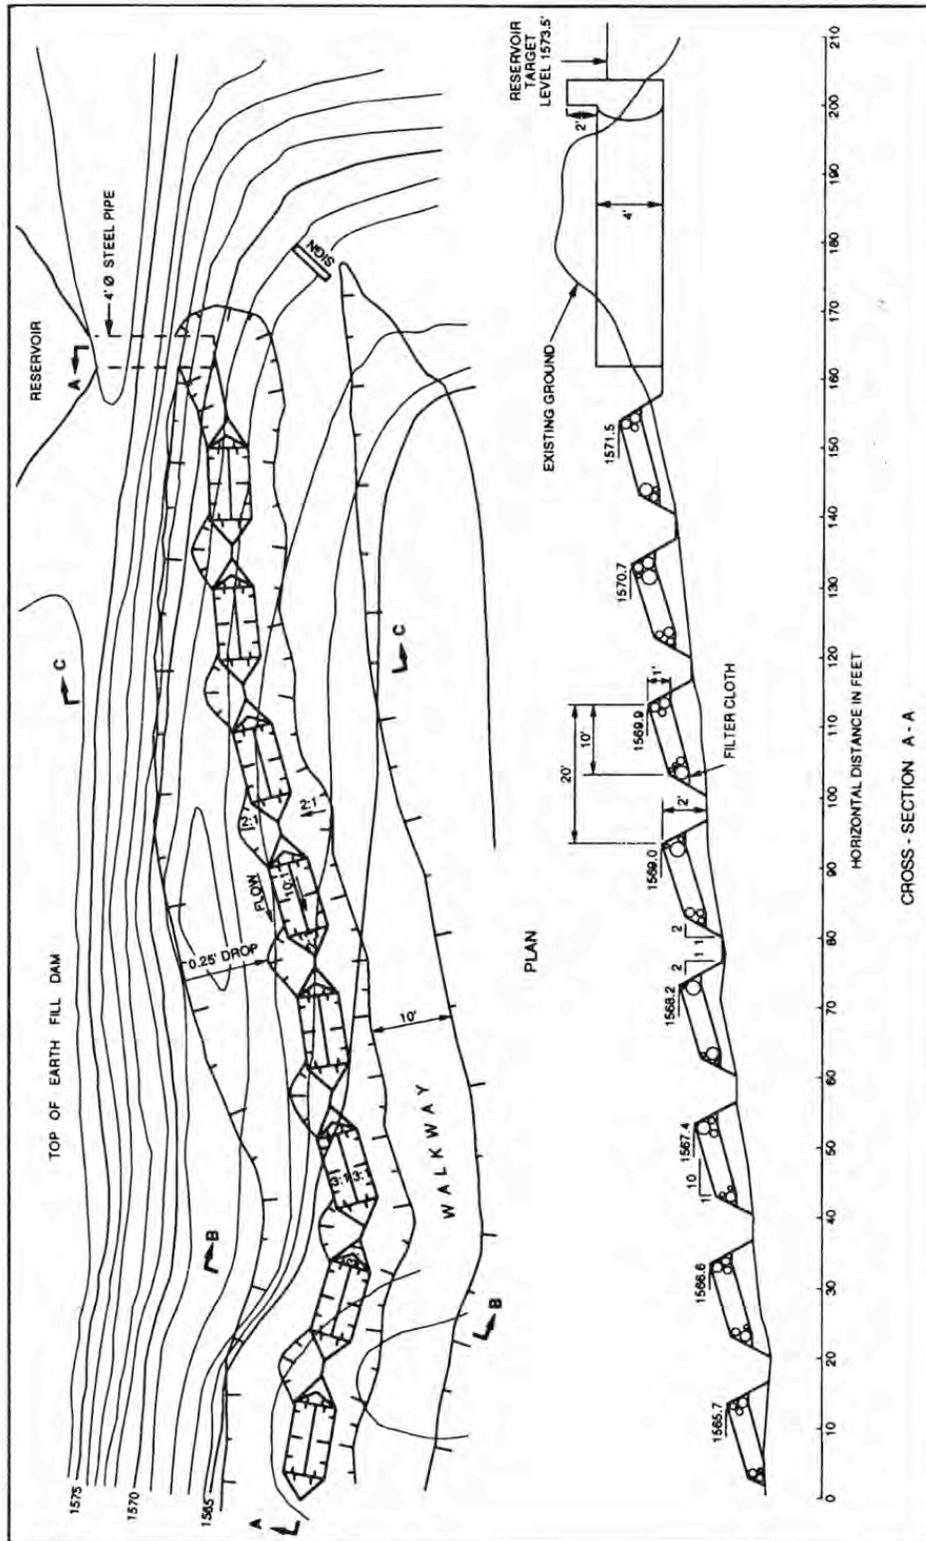
Figure 7.15: Plan and profile of the Rapid City fishway (drawing: Ewashko Consulting).
