Stream Restoration Hydraulics

Part 2: Applications

Chapter 5: Projects Restoring Pool and Riffle Channels

Design Example 1: Pool and Riffle 0.3% Gradient Stepped Channel for Walleye Spawning and Fry Returns to Downstream Lakes (Mink Creek MB 1985).

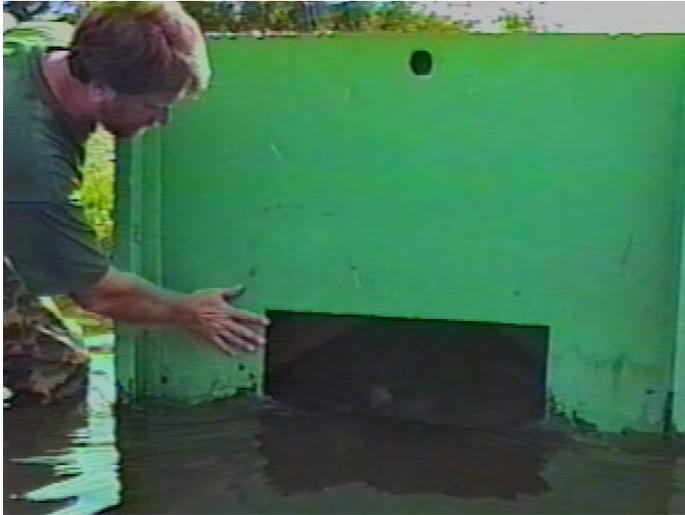
The size of the inlet opening was set to pass a design flow of $0.4 \text{ m}^3/\text{s}$ at the maximum reservoir level (Figure 7.16). The top of the inlet is set to the maximum elevation of the reservoir.

Figure 7.16: Entrance control on the culvert leading from the reservoir to the top pool of the fishway.

The crest of the riffle controlling the water level in the culvert is low enough to allow free overflow at the entrance. The inlet crest can be lowered to maintain the design flow at lower reservoir levels. With the top of the 2 foot square gate set at the water level, the critical depth spilling into the culvert is 0.41 m with a critical velocity of 2 m/s. The discharge is $0.4 \text{ m}^3/\text{s}$. The effective width of the inlet was reduced by the factor 0.8 to allow for the contraction of the flow (Brater and King 1976).

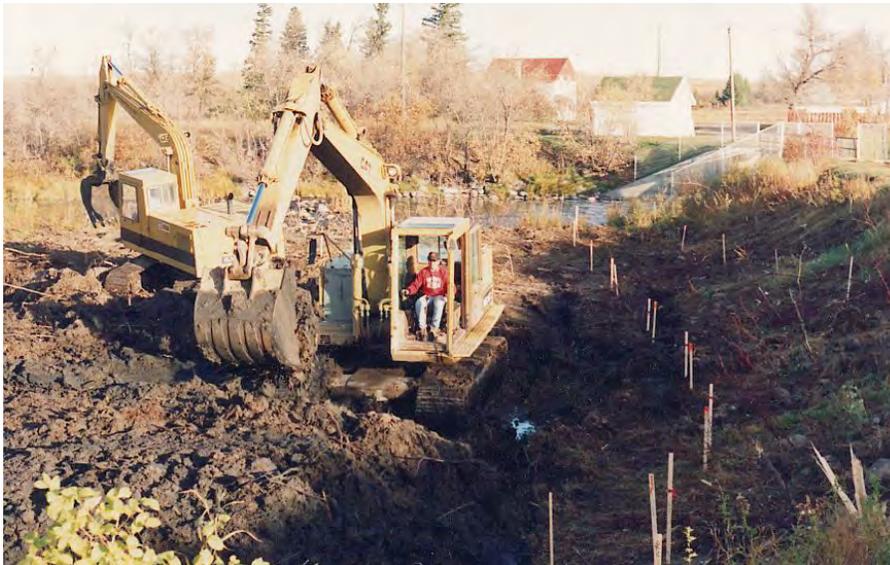
Figure 7.17: The pool and riffle fishway is built on impervious fill added to the earth fill segment of the dam. The structure toe drain has been extended beyond the new fill boundary (Figure 7.18).

The channel was built on the downstream face of the dam by adding compacted fill and a cobble toe drain without disturbing the original dam materials (Figure 7.17).

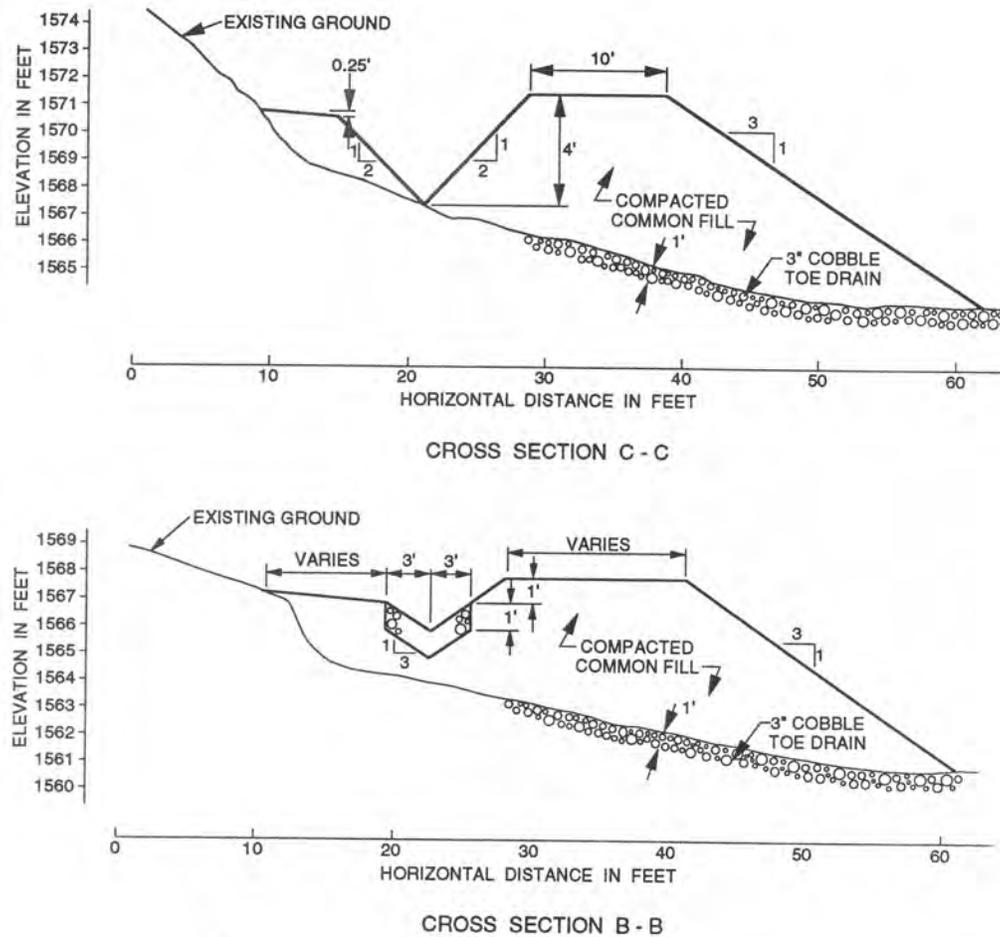
Figure 7.18: The fishway is built on new material added to the existing dam with a toe drain that joins with the original toe drain (drawing Ewashko Consulting).

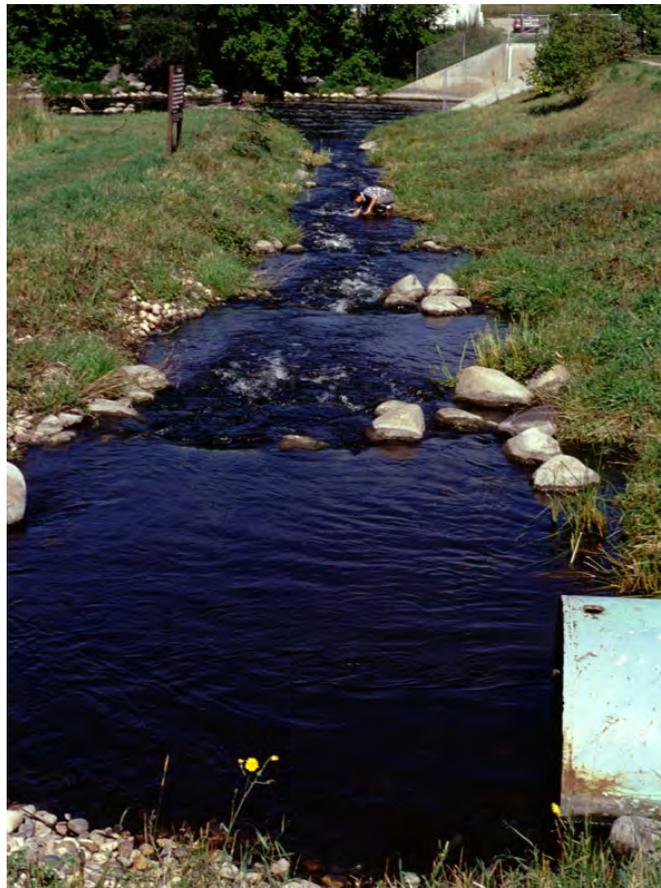
Figure 7.19: Rapid City pool and riffle fishway, July 2000.

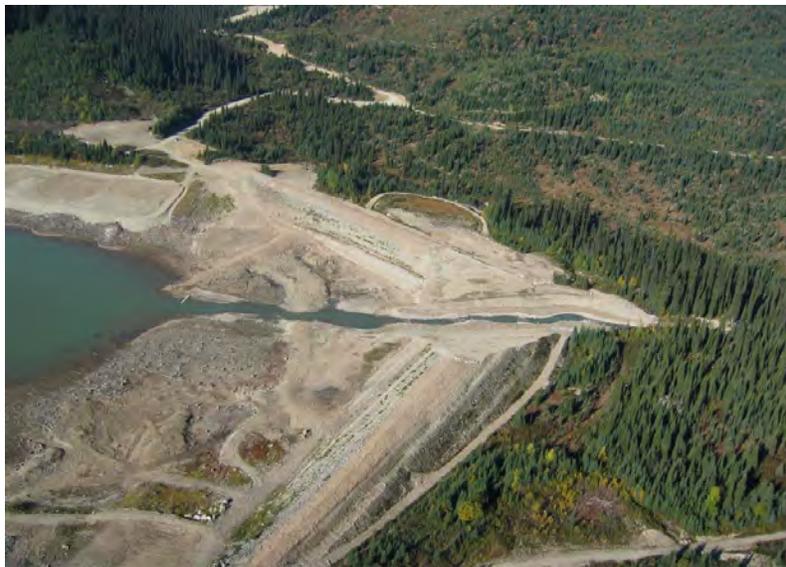
Figure 7.20: A stable notch was excavated through the old Revelstoke City dam to re-connect Cranberry Creek in 2003 by BC Hydro (photo W. Seyers).

1. Dam Breaching: Occasionally there are projects such as dam breaching or complete dam removal that require stepped channels to restore the connection to the river. The geometry is based on creating a stable fish-passable connection and may vary from the spacing and curvatures observed in natural channels. A typical breaching project was undertaken to re-connect Cranberry Creek by removing the old Revelstoke City dam in southern British Columbia. After the reservoir was de-watered, a wide stable notch was excavated through the dam to the level of the valley bottom (Figure 7.20). The project was reviewed several times over 10 years before it was undertaken in 2003 by BC Hydro (Seyers 2004). The original sketch design proposed in 1994 is shown in Figure 7.21. A stepped channel with 1 metre high riffles was built through the notch, climbing from the level of the first natural pool below the dam to the former shoreline of Coursier Lake impounded under the reservoir (Figure 7.22). The emergent rock spacing and low flow channels on the surface of the steep rock riffles were adjusted for fish passage prior to commissioning by pumping 0.5 m³ from Coursier Lake into the head of the channel (2003, Figure 7.23). Fish passage has been observed in subsequent years.

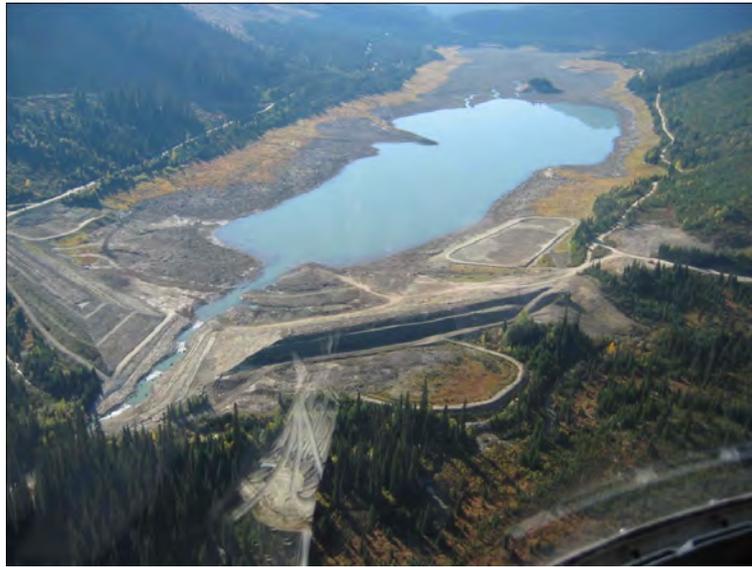
Figure 7.22: The level range of Coursier Lake was re-established by setting the elevation and width of the upstream riffle entering the stepped channel (photo W. Seyers).

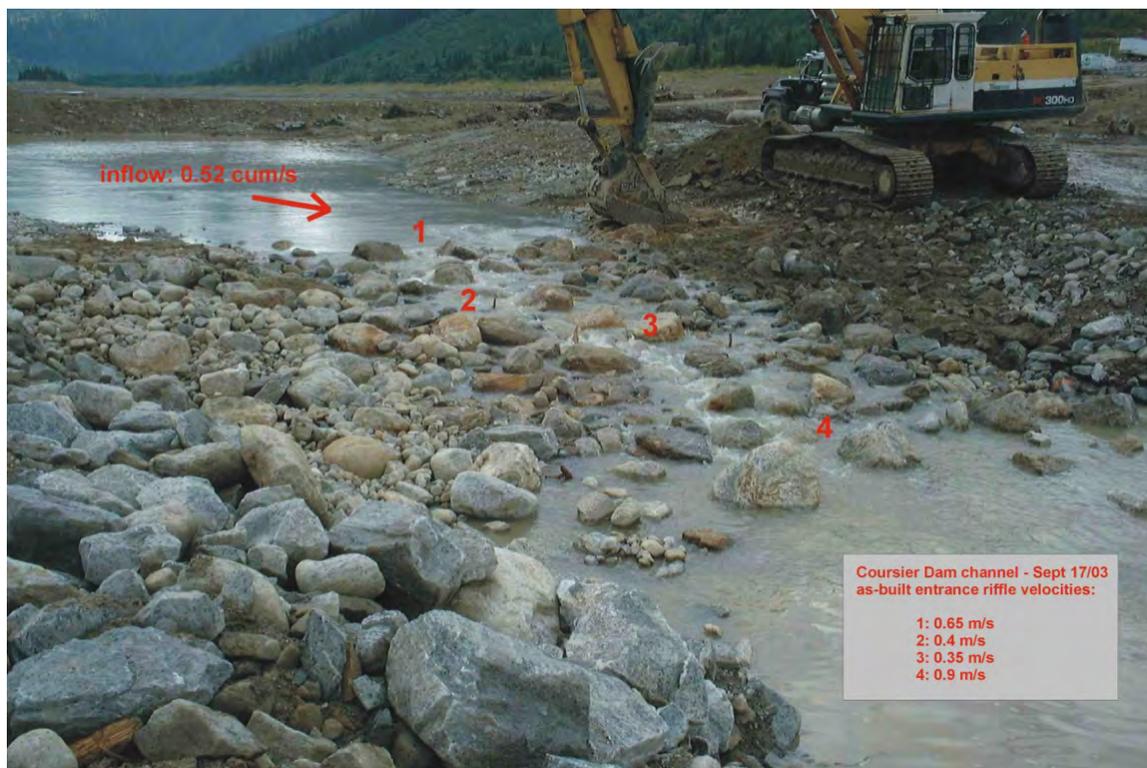
Figure 7.23: Low flow channels on the rock riffles were measured and adjusted for fish passage prior to the commissioning of the connecting channel with a pumped flow of $0.52 \text{ m}^3/\text{s}$ (2003).

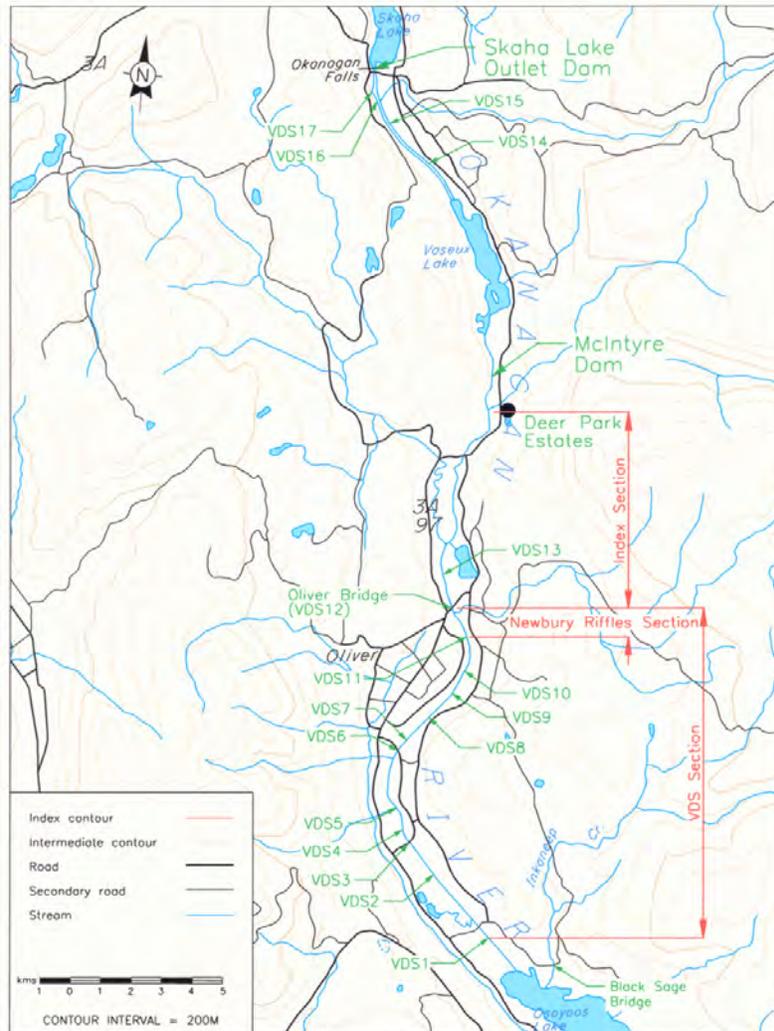
Figure 7.24: Seventeen vertical drop structures (VDS) are required to control erosion of the steeper channelized and dyked southern reach of the of the Okanagan River, a spawning tributary for Columbia River sockeye salmon (Long 2003A).

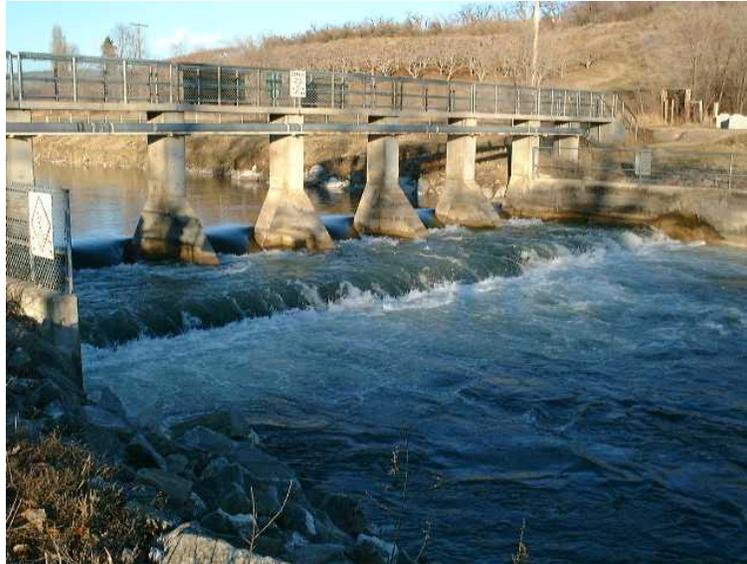
Figure 7.25: Vertical drop structure #13 on the channelized section of the Okanagan River near Oliver BC.

A common structure design was used with a shallow concrete platform below the spillway that drops into a stilling basin (Figure 7.25). During the fall migration period salmon pass through the structure by launching from the stilling basin, landing on the platform and bursting over the spillway crest.

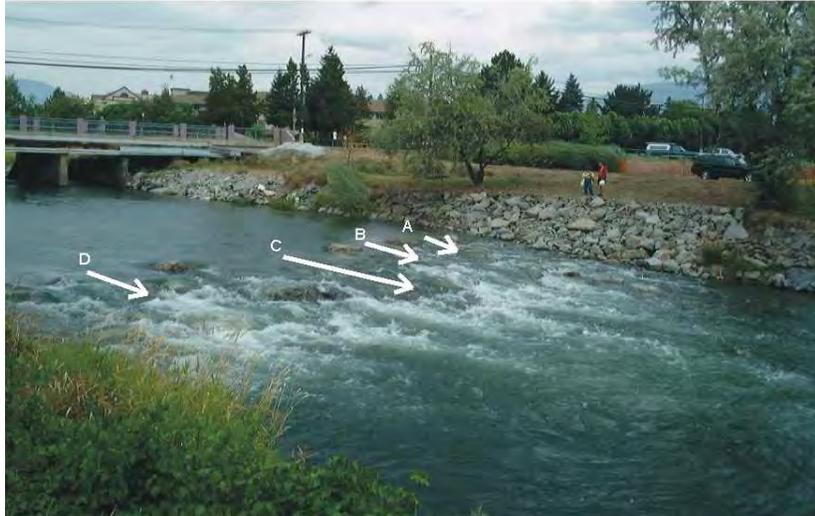
Figure 7.27: The upper riffle below VDS 13 as constructed in 2001.

To reduce the fish passage effort, a pilot project was undertaken in 2001 backflooding VDS 12 in Oliver BC. Four riffles were constructed downstream from the structure to gradually step up to the backflooding elevation. The crest of the highest riffle was set low enough to not affect critical flow over the structure crest. The design profile and completed upper riffle are shown in Figures 7.26 and 7.27. The velocity measurements in several chutes constructed on the riffle surface were taken at a discharge $8 \text{ m}^3/\text{s}$, typical of the flows during the Fall spawning migration period.

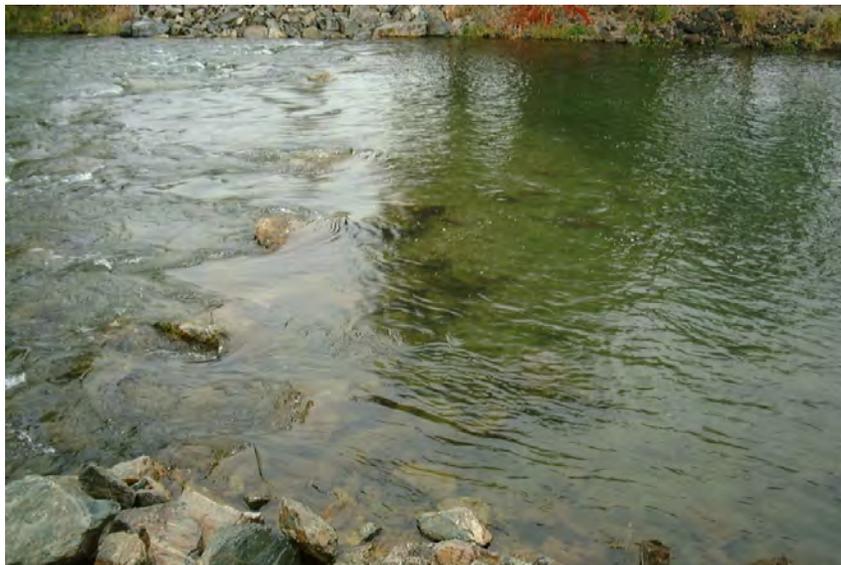
Figure 7.28: Spawning sockeye on the upstream slope of the first riffle below VDS 13 (2001).

Sockeye salmon spawned on the upper gravel slope of the riffles as soon as they were constructed. (Figure 7.28, Long 2003A).

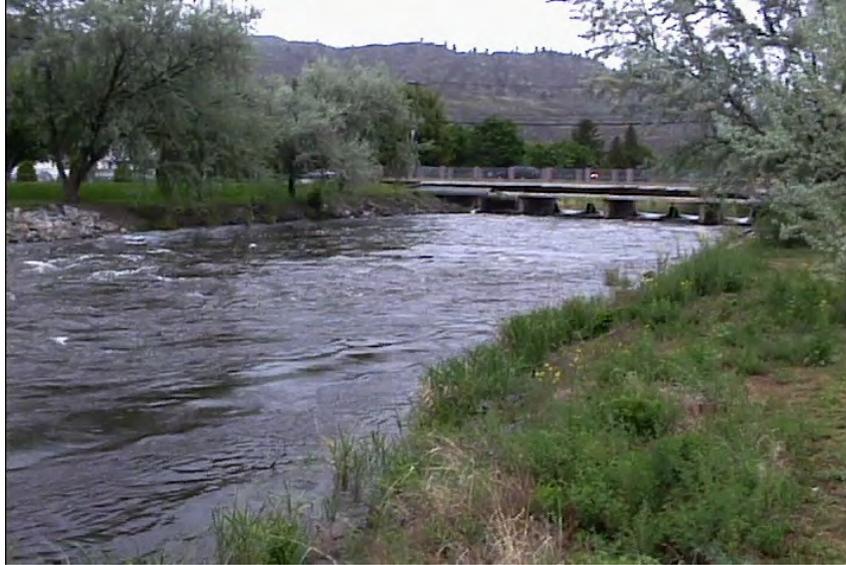
The upper riffle passing a flood discharge of $70 \text{ m}^3/\text{s}$ in May 2006 is shown in Figure 7.29. The v-shaped surface of the riffle forms a central torrent with low-velocity back-eddies on the banks.

Figure 7.29: The upper riffle below VDS 13 at a flood discharge of $70 \text{ m}^3/\text{s}$ (2006).

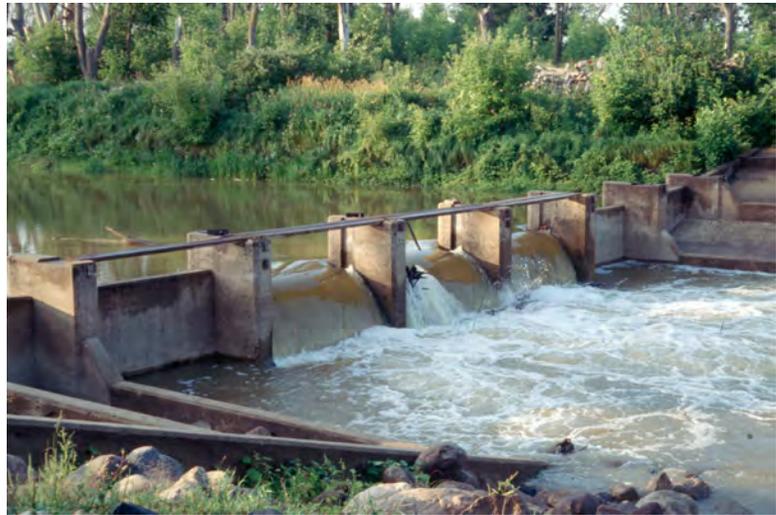
Figure 7.30: The Dominion City water supply dam on the Roseau River MB.

Example 2 Roseau River MB (freshwater species): The Roseau River is a tributary of the Red River rising in northern Minnesota. A wide range of freshwater species including northern pike, walleye, goldeye, rockbass, drum, catfish and lake sturgeon utilize the river. In 1957 a typical water supply dam was built on the river for Dominion City MB (Figure 7.30). Fish migration over the dam (no stop

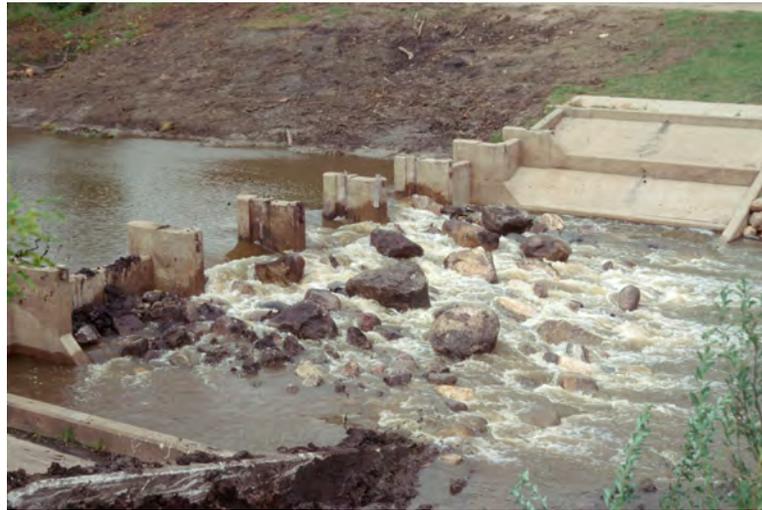
Figure 7.31: A rock ramp with low flow channels was added to the dam stilling basin leading up to the spillway crest. A few oversize rocks from nearby fields were enthusiastically added after the initial construction.

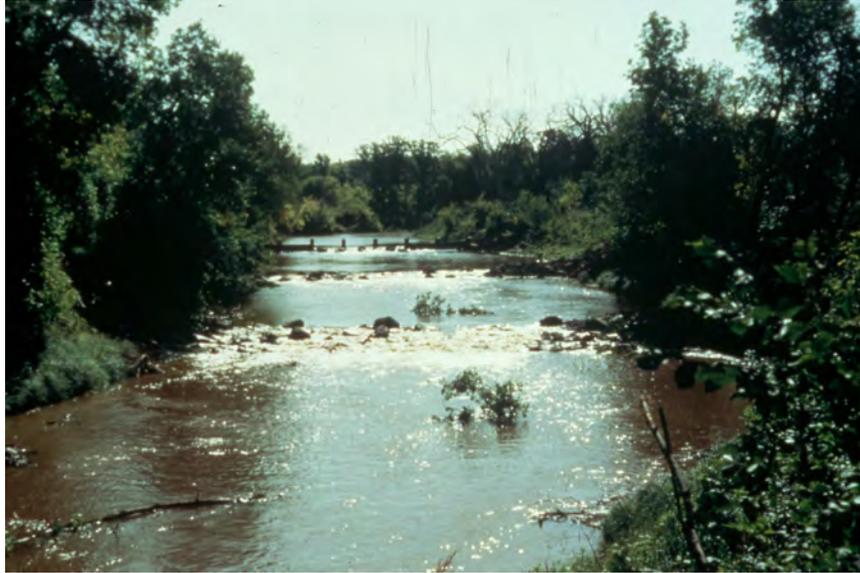
Figure 7.33: Upstream view of the two riffles and ramp back-flooding the Roseau River dam.

passage over the crest under all flow conditions. The construction detail and an upstream view of the completed project are shown in Figures 7.32 and 7.33.

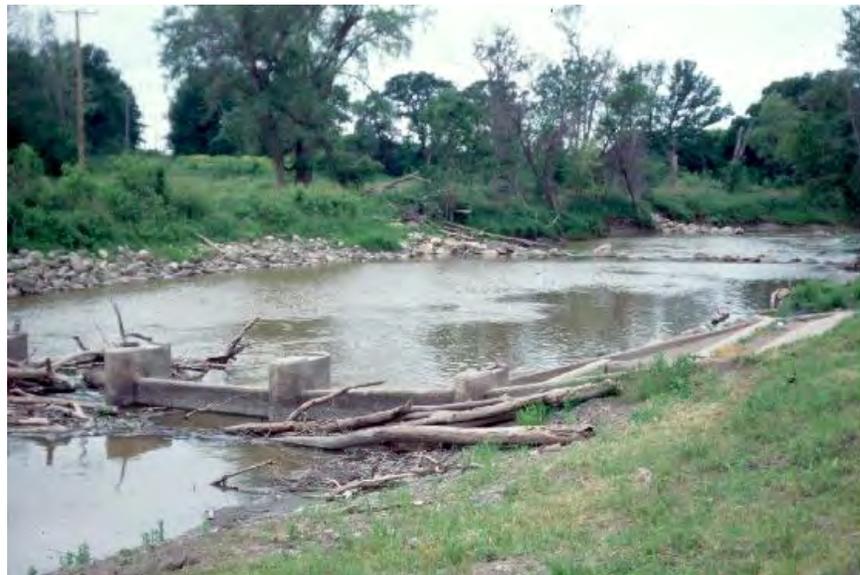
Figure 7.34: The Roseau River fish passage works following the maximum Red River basin flood on record in 1997.

No re-construction was required after the Red River maximum flood of record (144 year return period, Burn and Goel 2001) occurred in 1997. Debris from the flood was removed from the ramp and riffle sites after the flood (Figure 7.34).

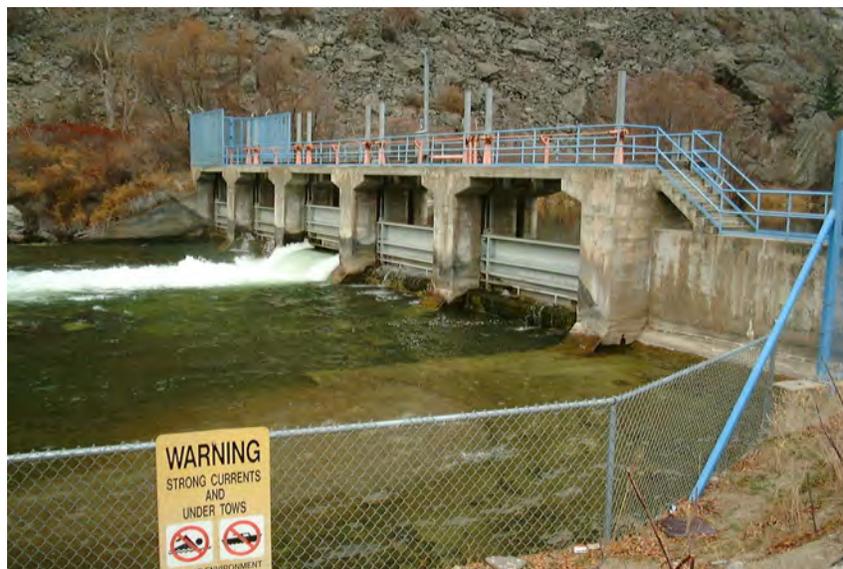
Figure 7.35: Five undershot gates on the McIntyre dam spillway (Okanagan River BC) before replacement with overshot gates in 2009.

3. Overshot Gate Passage: When impounded water is released under vertical gates, the upstream head is almost entirely converted into kinetic energy. The shallow high velocity flow under the gates exceeds fish burst speeds. Passage may be restored by replacing the “undershot” gates with overflowing gates and a deep launching pool in the stilling basin below the dam. For example, the vertical gates on the McIntyre dam on the Okanagan River below Vaseux Lake BC blocked the upstream progress of Columbia River sockeye salmon for over 60 years (see location Figure 7.24). Shallow flows shooting under the gates during the low flow migration period reached velocities of 7 m/s (Figure 7.35). The aerated plunge pool in the shallow stilling basin was impassable. To replace the gates the dam piers in each bay were extended downstream to form a passage that could be blocked by a gate hinged to the lower lip. The gates are raised or lowered from above with a power driven spindle and cables.

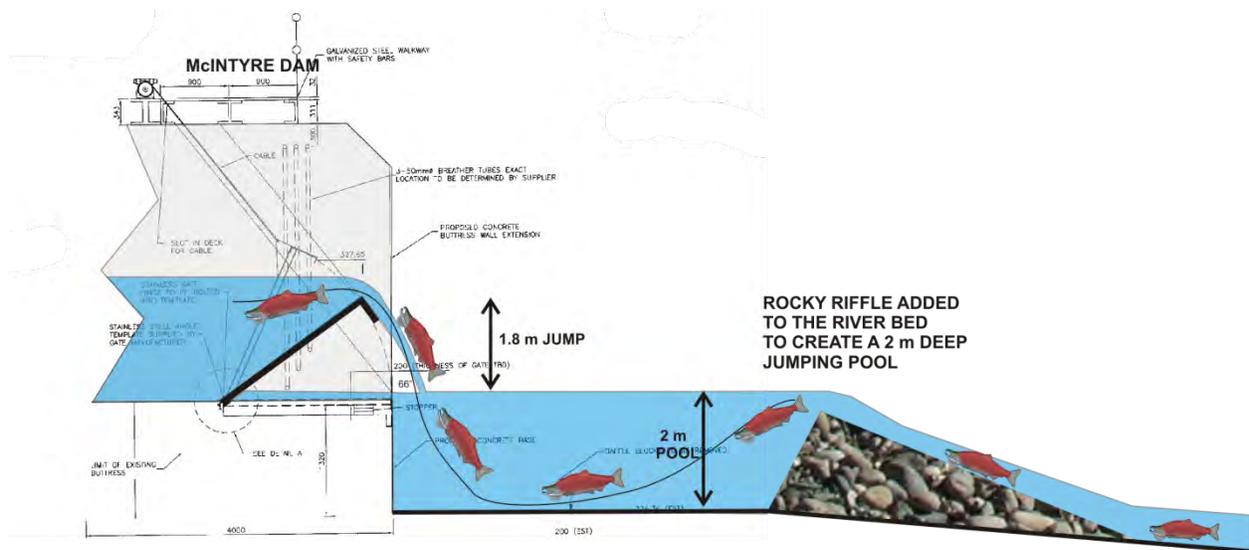
Figure 7.36: Fish passage over the McIntyre dam gates was achieved by creating a 2 m deep launching pool and setting gate discharges that would allow the fish to navigate under and through the aerated portion of the new plunge pool (background dam drawing Associated Engineering Ltd. BC).

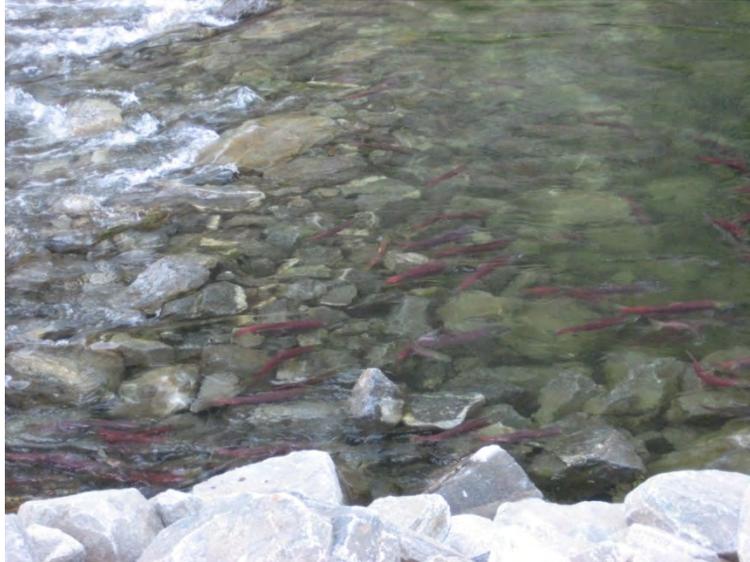
Figure 7.38: Sockeye salmon swimming over the crest of the riffle into the backflooded jumping pool (photo R. McLean).

A 1.9 m high river-wide riffle was built below the dam to create a launching pool that is 1.1 times the height of the maximum jump in depth (Figures 7.36 and 7.37). Salmon successfully swam up the riffle and launched over the gates as soon as they were opened (Figures 7.38 and 7.39). Ground and aerial surveys above the dam found over 4000 redd sites in gravel bars and riffles between VDS 14 and VDS 17 in the Vaseux Lake to Okanagan Falls reach (Figure 7.24) (pers. com. Camille Rivard-Sirois, ONA).

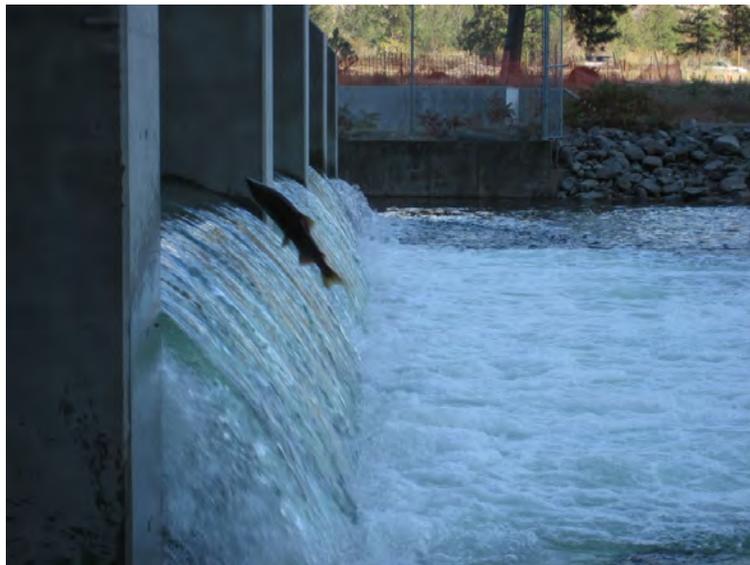
Figure 7.39: Sockeye salmon passing the overshot gates set at approximately 2 cum/s (photo: R. McLean).

Tests during the spawning run indicated that gate openings greater than 2 m³/s created too large a pool of aerated flow in the flooded stilling basin that limited the zone of solid swimmable water necessary to achieve exit velocities below the gates (Figure 7.40 and 7.41).
